BOARD OF INQUIRY REPORT

**Investigation of a paragliding accident
which occurred at Milk Hill in Wiltshire,
on 27th August 2005
in which the pilot
was fatally injured.**

BHPA investigation serial number: IR 05/093

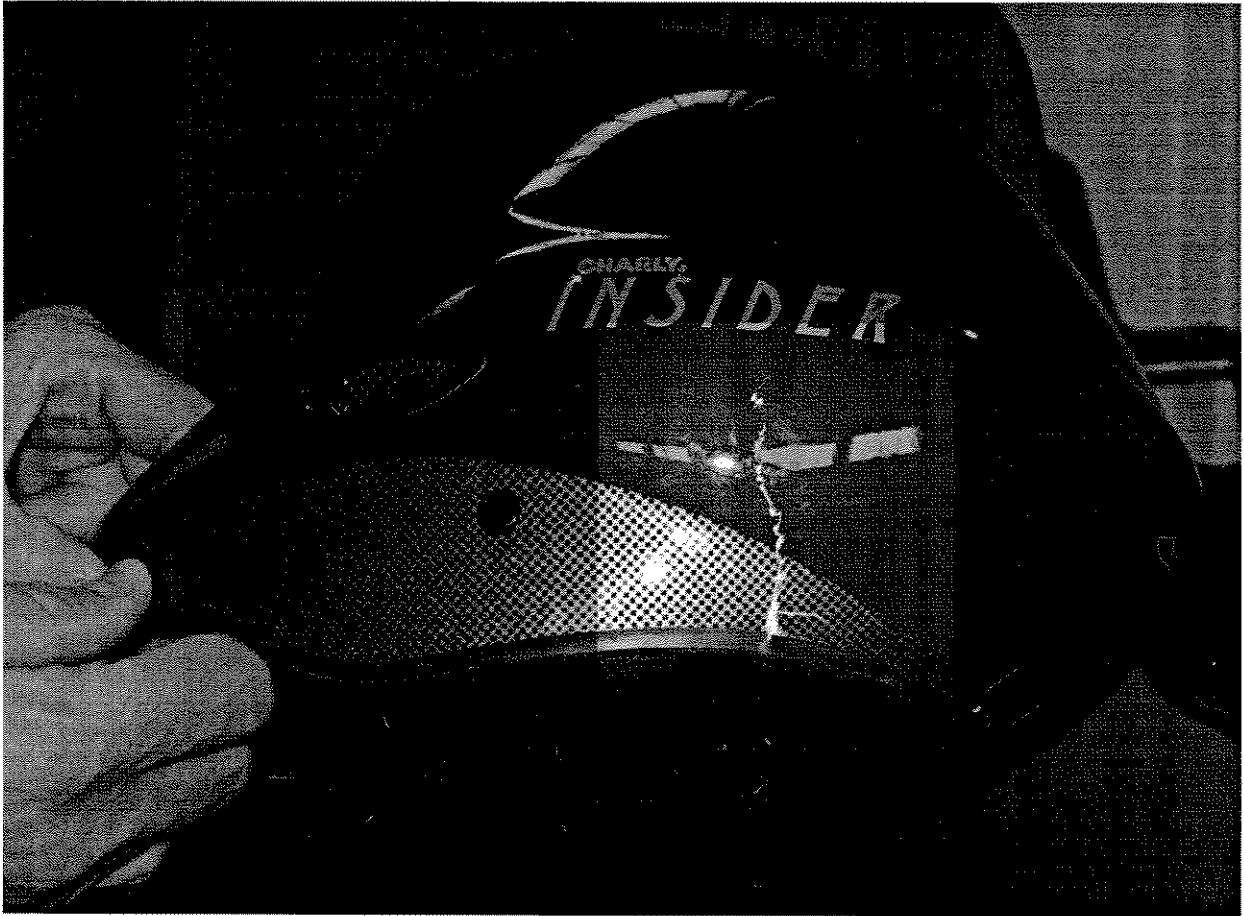
Appendix A
Helmet photo

There was some damage to the harness as a result of it having been cut from the pilot by the emergency services. The helmet worn by the pilot was extensively damaged, indicative of a severe impact from the front (see Appendix A).

The helmet used by the pilot was a 'Charley Insider' full-face helmet certified (EN966) for airborne activities. The helmet suffered severe damage as a result of the impact (see Appendix A) consistent with having sustained a heavy impact on the chin-guard/frontal area of the helmet. There were also significant deposits of soil and grass lodged in the chin piece trim indicating a frontal impact.

Due to the nature of the injuries sustained by the pilot, the Board considered the effectiveness of the helmet. The Board concluded that the force of the impact was well in excess of the design and test criteria for the helmet and therefore find that the helmet was not a factor in this incident.

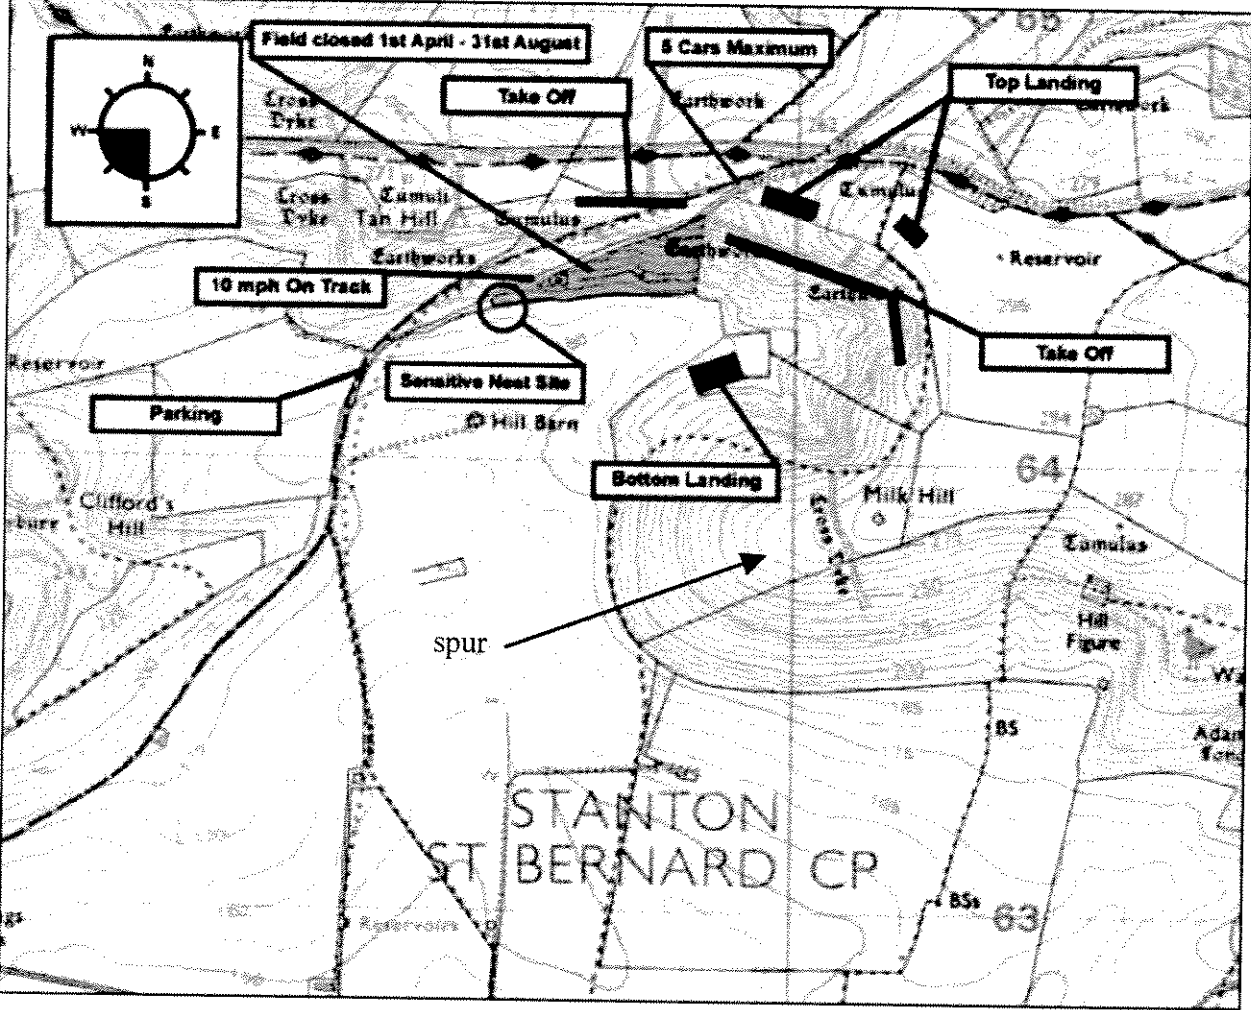
Appendix B
Site diagram and Site photo

Milk Hill is situated in Wiltshire and is controlled by the Thames Valley Hang Gliding Club (TVHGC). The TVHGC site guide describes the site as being suitable for 'all levels of pilot.' The site itself consists of a grassy ridge leading to a bowl of approx 100m in height (above bottom landing area). Best wind direction is west through southwest. Under 'Hazards' the guide goes on to say, "Consider the airflow caused by the spur (labelled Milk Hill on the map) in different wind and thermic conditions. As well as the hazard of rotor caused directly by the spur in a southerly, it is possible to get turbulence in thermic conditions when thermals leave the south slope of the spur and draw air in from both the north and south sides of the spur." (See Appendix B for site photo and diagram). One of the witnesses states that he experienced turbulence on several occasions in the area of the incident, which he suspects was due to airflow coming over the southern spur.

The incident occurred in the bowl area of the site close to the normal takeoff area. This area is sloping and grassy and would be generally regarded as ideal for paragliding.
