## ACCIDENT

<b>Aircraft Type and Registration:</b>	UP Makalu wing and Sup'air X-Alps harness	
<b>No &amp; Type of Engines:</b>	None	
<b>Year of Manufacture:</b>	2003	
<b>Date &amp; Time (UTC):</b>	26 May 2007 at 1402 hrs	
<b>Location:</b>	Wether Fell, Hawes, North Yorkshire	
<b>Type of Flight:</b>	Private	
<b>Persons on Board:</b>	Crew - 1	Passengers - None
<b>Injuries:</b>	Crew - 1 (Fatal)	Passengers - N/A
<b>Nature of Damage:</b>	None	
<b>Commander's Licence:</b>	Pilot (Hill)	
<b>Commander's Age:</b>	45 years	
<b>Commander's Flying Experience:</b>	Regular flying since 2002, actual hours unknown	
<b>Information Source:</b>	AAIB Field Investigation

## Synopsis

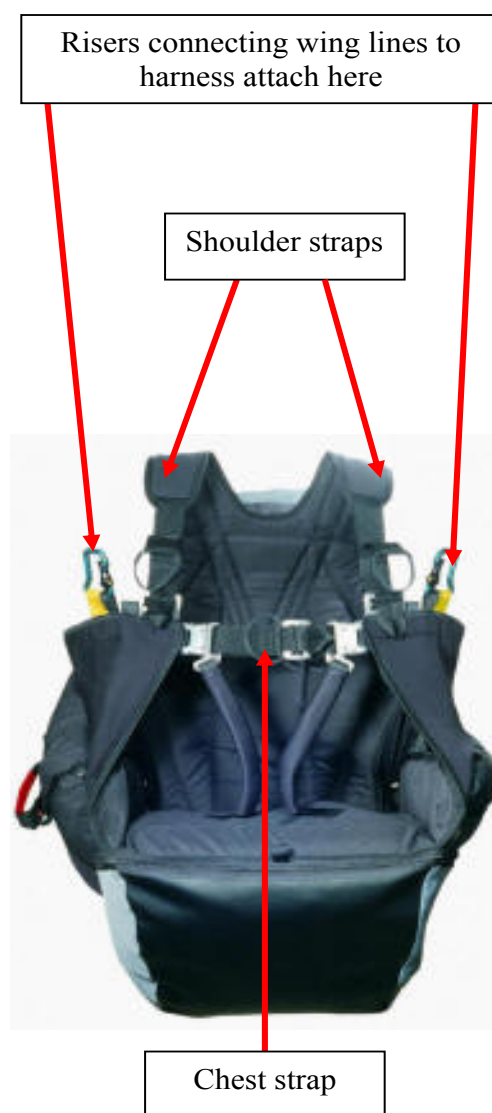
**Figure 1**

Typical harness layout

The chest belt performs the further function of adjusting the distance between the two risers. Correct setting of this strap is important in determining the flight characteristics of the wing. Fully tightened, it gives the sensation of more security but can make the paraglider easier to spin. Too 'open' a setting (whereby the risers are held relatively far apart) makes the wing less stable, less likely to recover automatically from a partial collapse and makes recovery from spiral dives and partial collapse less certain – no longer within the parameters of a certified glider.
