**ACCIDENT**

<b>Aircraft Type:</b>	Paramotor (comprising a 'Revolution' wing and 'PAP1400AS' paramotor unit), no registration	
<b>No &amp; Type of Engines:</b>	1 'SNAP100' two-stroke piston engine	
<b>Year of Manufacture:</b>	Wing manufactured in 2006	
<b>Date &amp; Time (UTC):</b>	11 June 2007 at 1920 hrs	
<b>Location:</b>	Chavenage Green Airstrip, near Tetbury, Gloucestershire	
<b>Type of Flight:</b>	Private	
<b>Persons on Board:</b>	Crew - 1	Passengers - None
<b>Injuries:</b>	Crew - 1 (Fatal)	Passengers - N/A
<b>Nature of Damage:</b>	Paramotor unit extensively damaged	
<b>Commander's Licence:</b>	N/A - licence not required	
<b>Commander's Age:</b>	24 years	
<b>Commander's Flying Experience:</b>	In excess of 350 hrs hours paramotor Last 90 days - Not known Last 28 days - Not known	
<b>Information Source:</b>	AAIB Field Investigation, with assistance from the BHPA and the BMAA

**Synopsis**

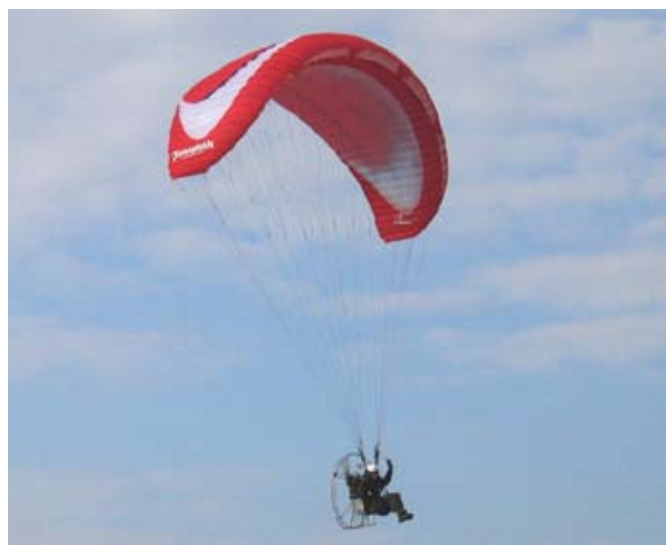
**Figure 1**

The aircraft was a foot-launched, powered paraglider, comprising a non-rigid fabric 'Paramania Revolution' parafoil, red and white in colour, attached to a 'PAP1400AS' paramotor unit (Figure 1). The paramotor unit is worn in a similar manner to a backpack and consists of a stainless steel metal chassis, to which are attached the engine and the pilot's seat and harness assembly. The pilot must stand to launch and land the aircraft, but may adopt a seated position in flight.

Photograph of paramotor aircraft
