ACCIDENT

| Wing: | Paramania Revolution 23 | |
| Paramotor unit: | Modified H & E Paramotores R120 series | |
| Location: | Middle Barn Farm, Bexhill, East Sussex | |

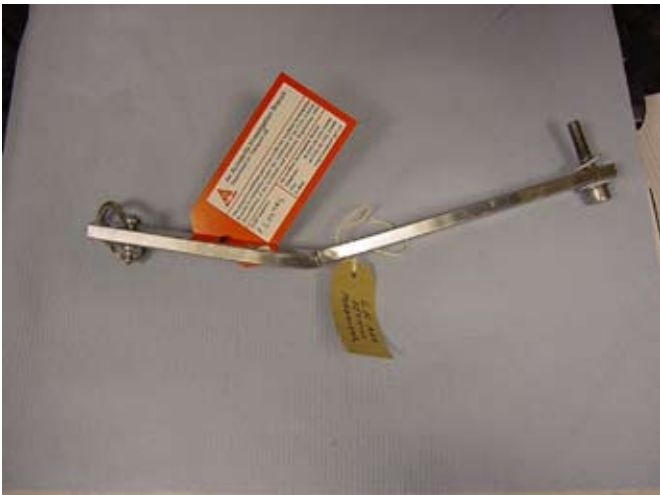
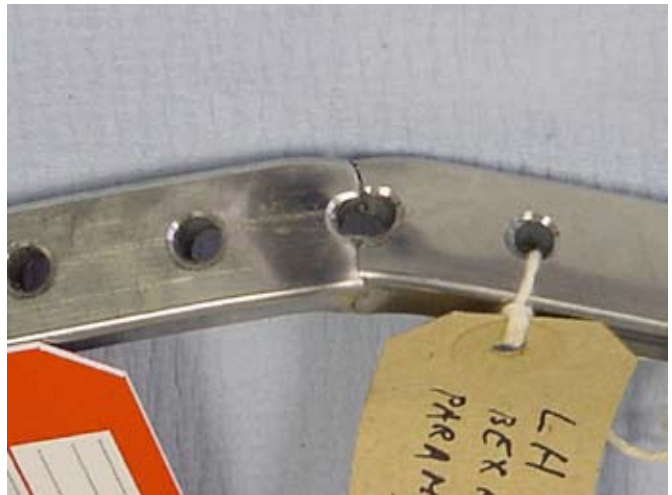
Left lift arm, from above

Left lift arm, outboard surface

The left arm had suffered a complex failure where the shackle-pin passed through the hole in the arm

(Figures 2 and 3). This appeared to be a bending failure in two axes allowing the clevis pin to break out of the hole but, after the failure, some remaining material in the box section surrounding the hole had allowed the forward end of the failed arm to remain united with the hinged end of the arm.

Following this accident unusual damage, not consistent with ground impact was found in the failures of both lift arm attachments, and of the plywood seat. This damage appeared consistent with the behaviour of the paramotor observed by the witnesses on the ground. The calculations of the likely failure loads on the two sides, and the distortion of the hardware, indicated that the right-hand attachment fitting probably failed first. This

could have precipitated the failure of the left lift arm, at the hole in that arm supporting the clevis pin carrying the flight loads.

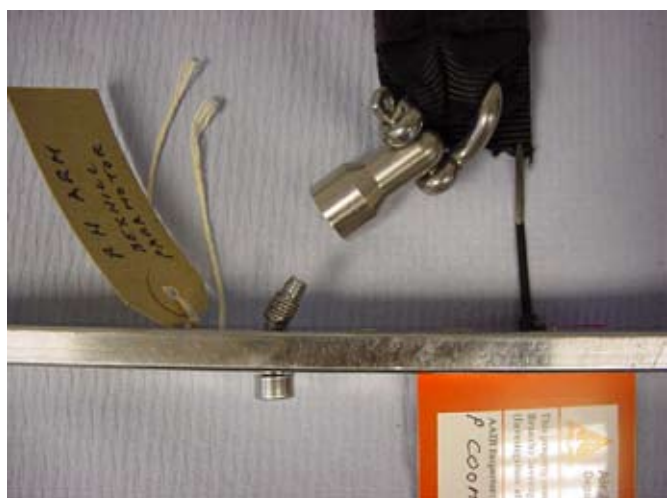
The additional fitting on the right side consisted of an internally-threaded cylindrical component, tapering to a reduced diameter cylindrical end section (Figure 4). This incorporated an eye-end through which passed a clevis pin, supporting a shackle to which the right-hand webbing was attached. The shackle was of the ‘right-angle’ type, with the portion to which the webbing was attached orientated at 90° to the shackle-pin axis. Although the shackle initially appeared to have been deformed to this condition by loading, shackles with this geometry are available from, for instance, suppliers of yacht equipment.

The fitting had been secured to the arm by means of a bolt passing through a hole in the arm and into the internally threaded section of the body of the fitting. It was attached to the body via a helical thread insert.

The right arm was not significantly damaged but the additional fitting, described above, had ‘pulled out’

Right lift arm, threaded connection

(Figure 4) as a result of the threaded insert failing to retain the bolt within the body of that fitting, under the influence of an axial load component. This bolt was also found to be severely bent.

Examination and sectioning of the right-hand load attachment fitting revealed that only two threads were fully engaged and a further four were only partly engaged. This would significantly reduce the failure load. In addition, a series of other variable factors would influence the strength of the attachments:

The bending of the bolt during the failure of the fitting on the right arm indicated a substantial load component at right angles to the bolt axis. This suggested a failure load range falling only slightly above the lowest range of the figures predicted for a direct lateral bolt load. Circular regions of compressive distortion of the material of the right arm surrounding the shackle holes were evident. These indicated that the bolt had been torque-tightened into the fitting on a number of occasions, whilst mounted in a number of different holes. The hole occupied by the bolt on the occasion of the failure was amongst those with significant compressive distortion. Calculations showed that a reduction of load-carrying capacity would have

been created by elevated stresses in the thread form produced by the pre-load forces of the tightened bolt. The small number of threads engaged would also have reduced the attachment strength.

In summary, the conclusion from the calculation of the failure loads was that it was probable that the failure of the bolted attachment (the right side of the paramotor unit) occurred first and load transfer to the shackle/pin attachment (the left side) followed. This sequence was further indicated by the bending directions of the failed left-hand arm, suggesting its failure load occurred after the seat and occupant had rotated about a longitudinal axis following failure of the right-hand attachment.
