**Investigation of a hang gliding accident
which occurred at Clatter, Mid Wales,
on 27th June 2010
in which one pilot suffered serious injury.**

BHPA investigation serial number: IR 10/060

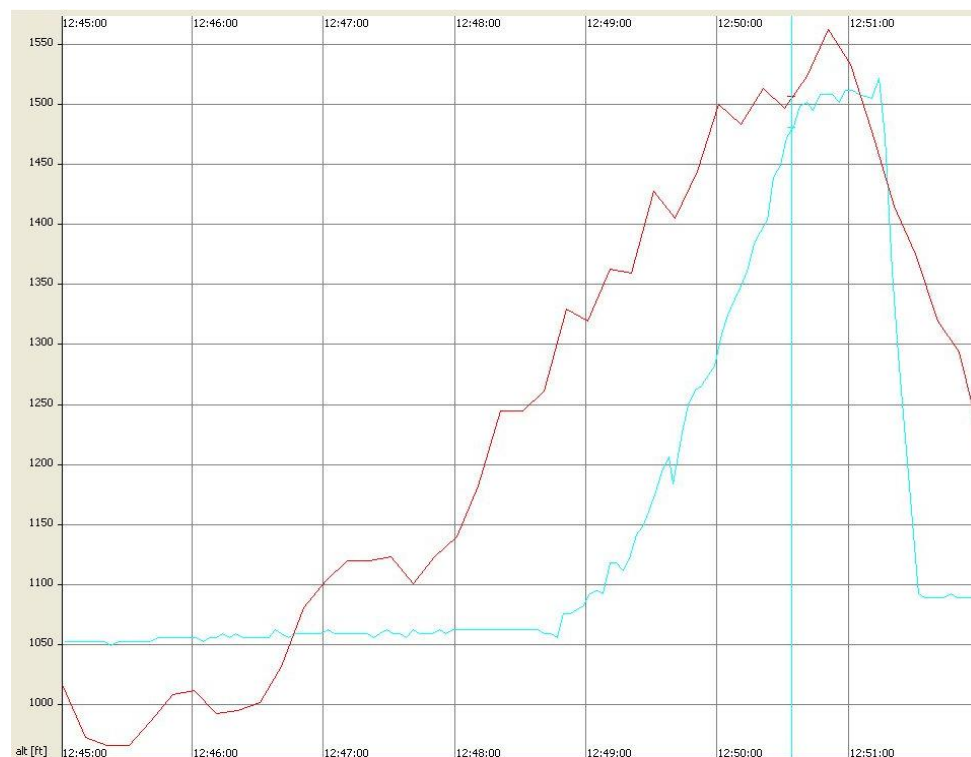
Barograph traces for the two pilots. Red trace = Pilot A, Blue trace = Pilot B
