## **BHPA Incident Report: GBR-2014-1313**

### **INCIDENT**

<b>Aircraft Type:</b>	Sky Atis 3 paraglider. Size large.
<b>Certification:</b>	EN B
<b>Manufacture Date:</b>	2011. 140 hours flown.
<b>Location:</b>	Combe Gibbet, Berkshire.
<b>Date and Time:</b>	29th July 2014. 12:14 BST
<b>Type of Flight:</b>	Ridge soaring.
<b>Persons Involved:</b>	Paraglider pilot.
<b>Injuries:</b>	Fatal.
<b>Nature of Damage:</b>	No damage.
<b>Pilot's Rating/Licence:</b>	BHPA Club Pilot (novice) Rating.
<b>Pilot's Age:</b>	64
<b>Pilot's Experience:</b>	152 logged hours since June 2011. 34 hours in previous 6 months.
<b>Information Source:</b>	Witness statements, Met Office report.

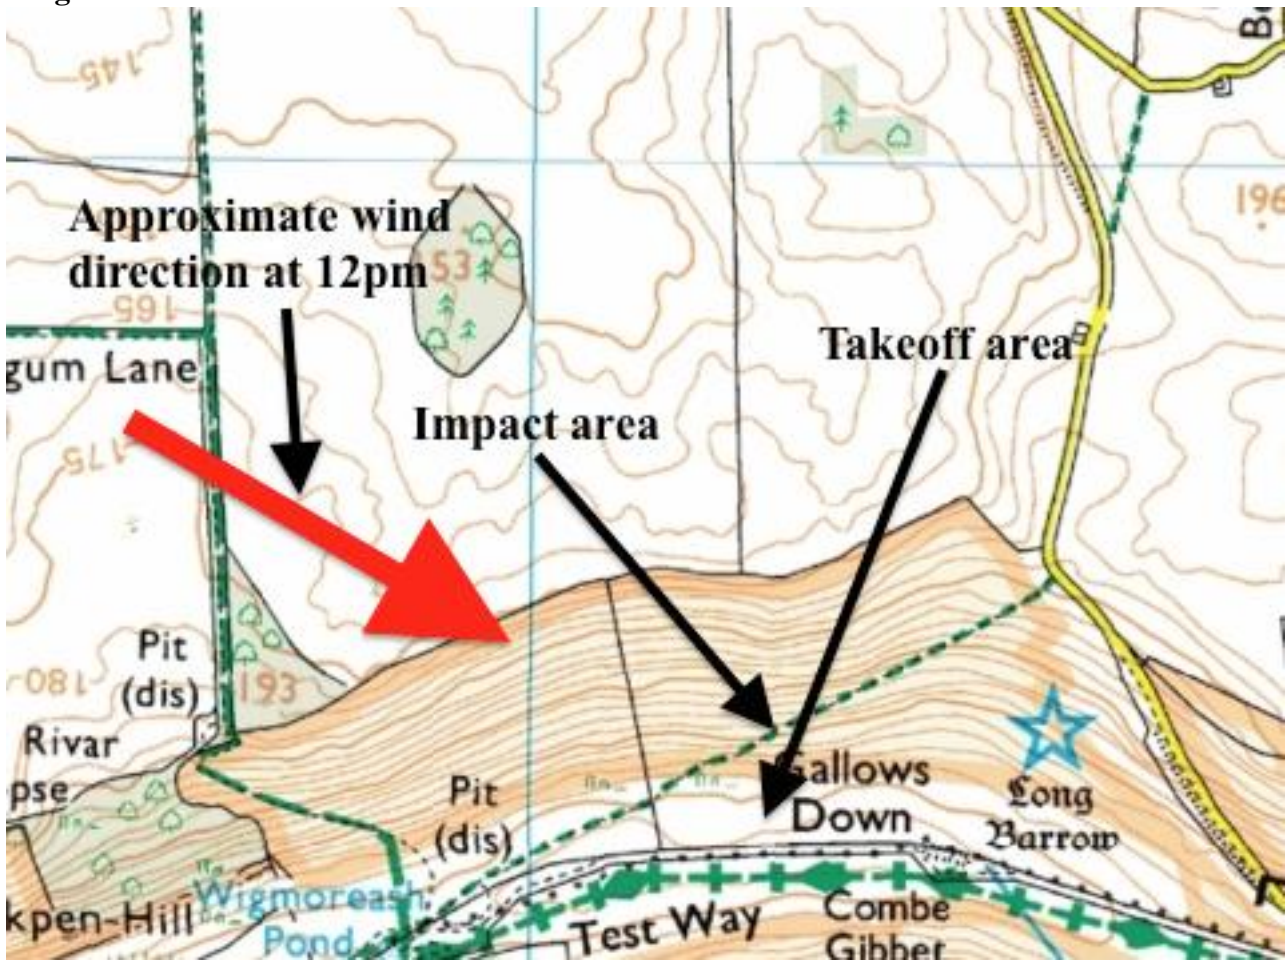
**Diagram 1**

To a large extent statements from the pilots present on the day were in line with the Met Office report. Conditions in the morning were favourable for paragliding with a steady north northwesterly 10 to 14mph breeze. There was some early thermic activity (enough for pilots to get to cloudbase) but the thermals were not considered to be rough. This was probably due to the time of day and the fact that the wind was directly on the hill. As the morning progressed however, the wind backed further to the west and the thermals became progressively stronger and more turbulent as the sun became higher in the sky. A number of pilots commented that they experienced progressively rougher conditions as the morning went on. Because of this some decided to stop flying and considered moving to another flying site more suitable to the westerly wind direction. At the time of the incident the Chief Coach for the local club had noticed that the air felt "fresher" (colder) and that the wind was at times in excess of 45 degrees off the slope to the west. This may possibly have been as a result of the weak front mentioned by the Met Office, as the apparent change in air temperature was accompanied by a more definite line of established cumulus cloud. He also commented that the thermals were strong and gusty. The combination of the wind being significantly off the hill, the air mass becoming cooler and the thermals becoming stronger meant the air had become particularly turbulent and potentially dangerous in the area in front of launch. (see diagram 1 below).

The investigation found that the incident occurred as a result of Pilot A encountering severe turbulence in the area in front of take-off and losing control of his glider at an altitude that made recovery unlikely.
