## **BHPA Incident Report: GBR-2016-2971**

While on a cross country flight in the Lake District a paraglider pilot lost control of his paraglider when in close proximity to the fell side on Fleetwith Pike, near Buttermere. The pilot was unable to regain control of the glider before impacting the slope where he sustained fatal injuries.

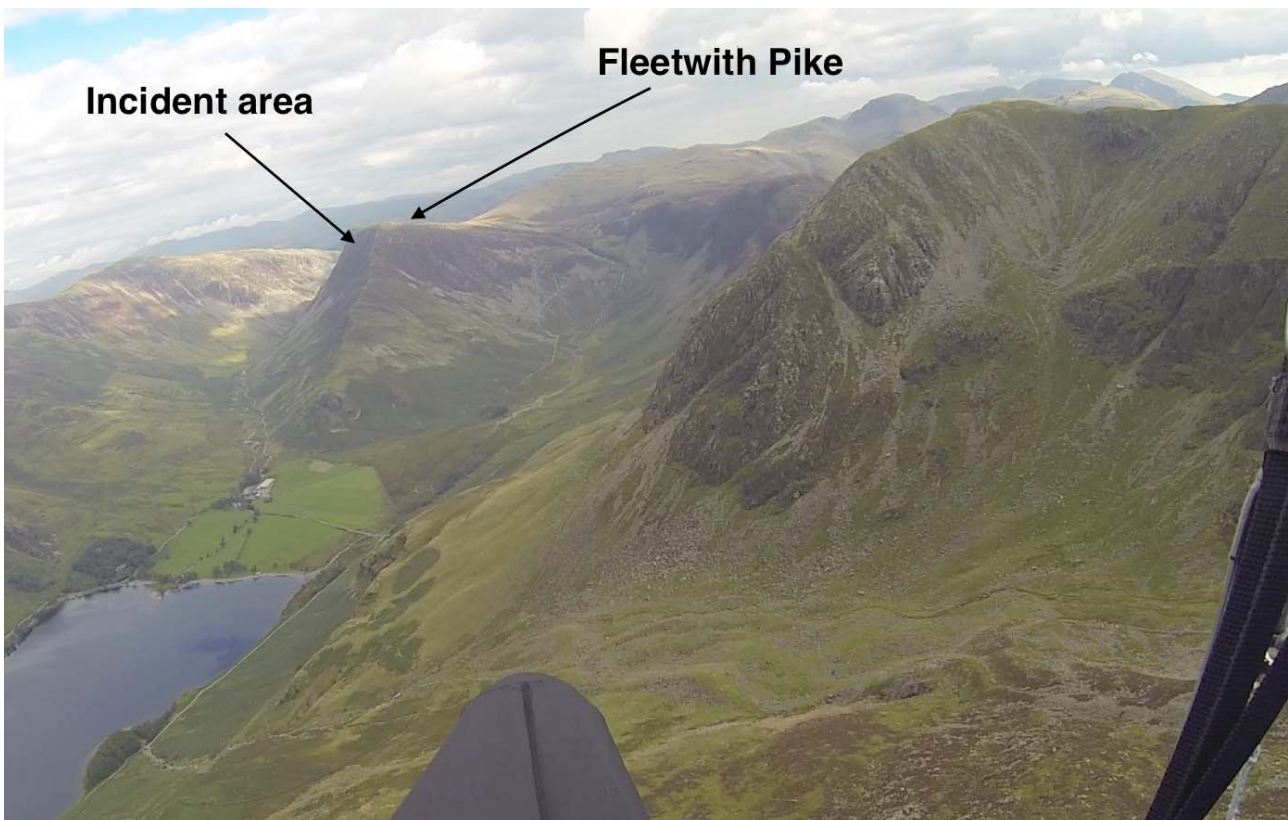
The photo above is a still image taken from the video footage on Pilot A's Go-Pro camera. It shows Pilot A flying towards Fleetwith Pike with High Crag in the foreground. The still is taken at 4pm approximately ten minutes before the incident occurred. Pilot A turned off the Go-Pro camera before making the glide to Fleetwith Pike. There was no further footage. When Pilot A reached Fleetwith Pike he was approximately 100m below the summit. He began soaring the north-facing slope. Having completed two beats and flying in a westerly direction, Pilot A lost control of his paraglider and impacted with the steep ground in the area of Burnt Scarth on Fleetwith Pike, where he sustained fatal injuries. The incident occurred at 4.10pm. There were no witnesses to the incident. Pilot A's body was found by the Cocker mouth Mountain Rescue team early the following morning.
