BHPA Incident Report: GBR-2016-2971

Aircraft Type:	Ozone Delta 2. Size ML (85-105kg). Serial number DML-0-02C-135. Advance Lightness 2 harness with Skyman 'Ultra Cross 100' emergency parachute.
Certification:	EN C
Manufacture Date:	25.01.2015 Hours flown unknown
Location:	Fleetwith Pike, Buttermere, Cumbria.
Date and Time:	Friday 18 th September 2015 at 16.10 BST
Type of Flight:	Cross country flight.
Persons Involved:	Paraglider pilot.
Injuries:	Fatal
Nature of Damage:	The glider and harness were damaged as a result of the incident with further damage to the glider being sustained during the recovery of the pilot.
Pilot's Rating/Licence:	BHPA Club Pilot (novice) rating awarded in October 2009.
Pilot's Age:	38
Pilot's Experience:	The pilot's total hours are unknown. However, analysis of the pilot's flight instrument shows twenty flights logged since 11 th August 2015 totalling approximately 20 hours. Data from the UK Cross Country flying league shows the pilot logged 15 cross country flights since 2013 totalling over 1000km and including two flights well over 100km. The four most recent were logged in August and September 2015.

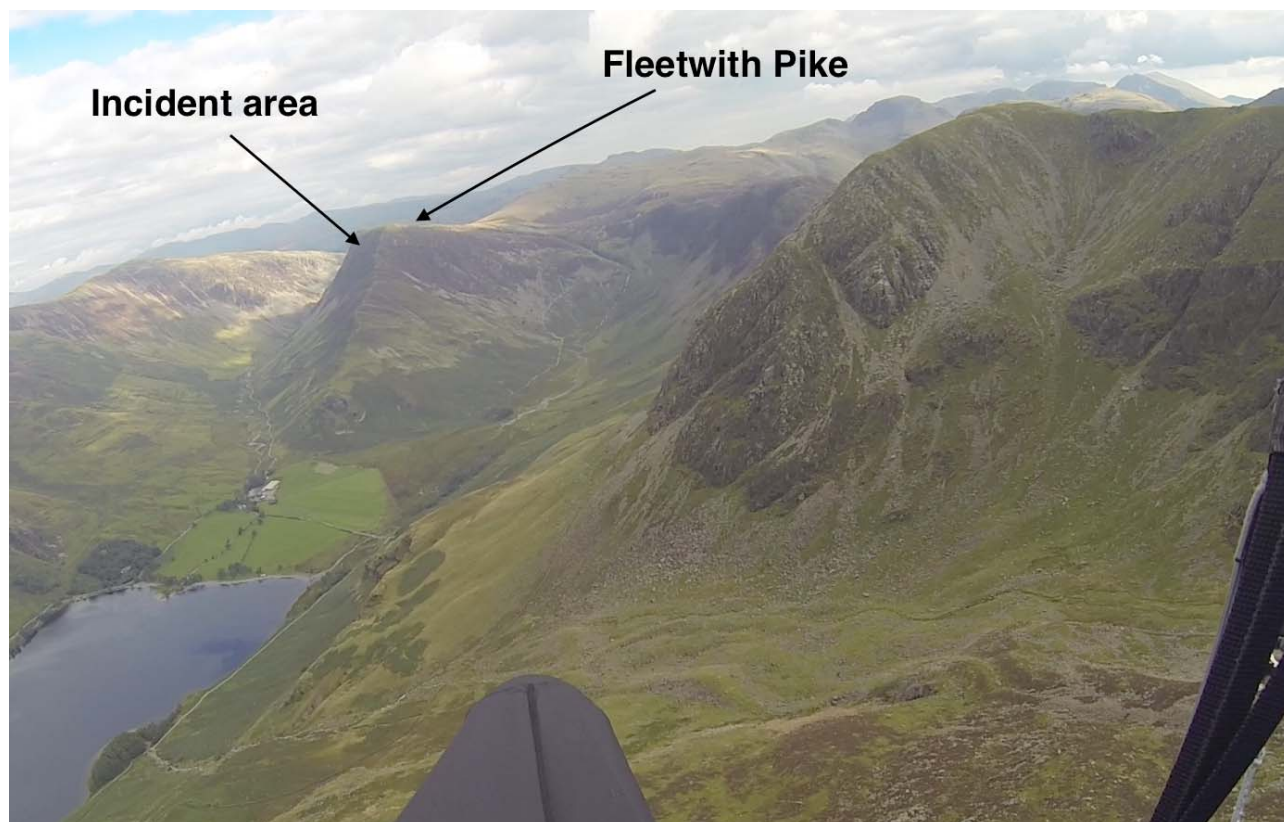
The photo above is a still image taken from the video footage on Pilot A's Go-Pro camera. It shows Pilot A flying towards Fleetwith Pike with High Crag in the foreground. The still is taken at 4pm approximately ten minutes before the incident occurred. Pilot A turned off the Go-Pro camera before making the glide to Fleetwith Pike. There was no further footage. When Pilot A reached Fleetwith Pike he was approximately 100m below the summit. He began soaring the north-facing slope. Having completed two beats and flying in a westerly direction, Pilot A lost control of his paraglider and impacted with the steep ground in the area of Burnt Scarth on Fleetwith Pike, where he sustained fatal injuries. The incident occurred at 4.10pm. There were no witnesses to the incident. Pilot A's body was found by the Cocker mouth Mountain Rescue team early the following morning.
