British Hang Gliding and Paragliding Association

**Investigation of a paragliding accident
which occurred at Staddon Heights, Plymouth,
on 28th August 2010
in which the pilot suffered fatal injury.**

BHPA investigation serial number: IR 10/127

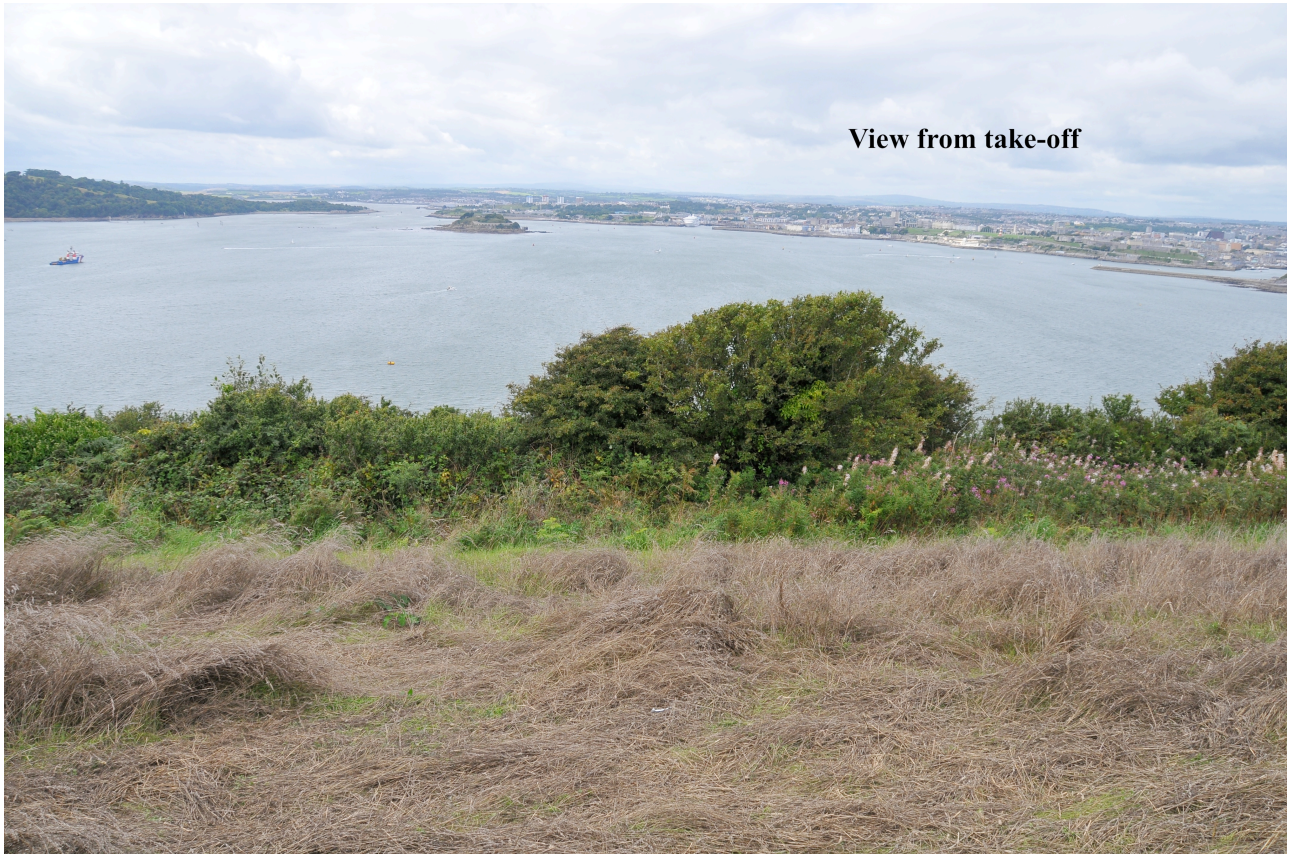
The pilot launched from an area known as Jennycliff on Staddon Heights, Plymouth. The actual take-off area chosen by the pilot comprised of wheat crop that had been flattened by recent storms. Immediately in front of the chosen launch area is a row of mature hawthorn bushes forming a barrier between the field and the coastal path just below.

The hill then drops off more steeply into coastal scrub and then cliffs before dropping down to the bay. The hawthorn bushes were up to four metres high in places, and in a position on the brow of the slope such that wind associated turbulence would reasonably be expected.

The Investigation considered the choice of take-off area. The pilot took off from an area immediately behind a row of mature hawthorn bushes. The row of bushes was high enough to disrupt any air flowing up and over the hill, giving rise to obstacle-induced turbulence. Given the strength and gustiness of the wind on the day the area behind the bushes would have been extremely turbulent, possibly explaining why the pilot had difficulty in attempting to launch. The investigation considered the choice of take-off area in conjunction with the prevailing weather conditions to be a major factor in this incident.
