## Manufacturer's Safety Notice

### Sup'Air Altix and Evo XC harnesses

#### **Reserve deployment issue**

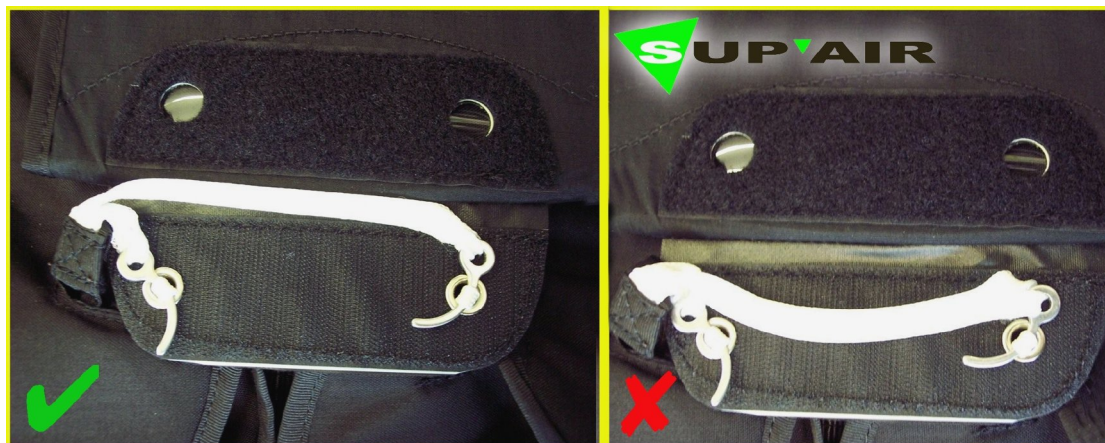
The white nylon braided cord attached to the deployment pins has become entangled between the velcro flaps over time, making the force required to release the pins excessive. We recommend all owners of these harnesses to check their system and ensure that this cord does not run between the velcro flaps as shown in the attached picture.

Alternative solutions of masking the male velcro side or sleeving the cord have also been used effectively. We advise all pilots to check their pins and ensure that the braided cord is not trapped by the velcro at least two or three times per season.
