Garmisch-Partenkirchen, May 28th 2009

Safety Notice UP Ascent 2 and Kantega XC

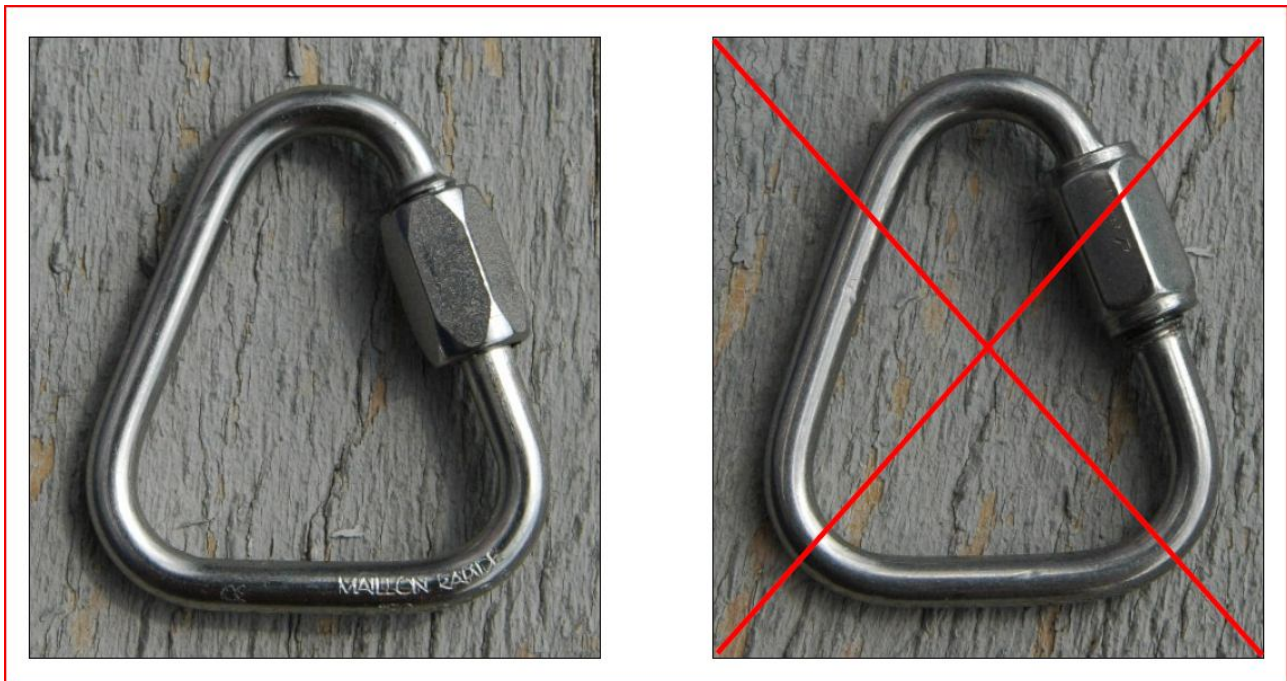
The problem with the King Snap maillons is, should excessive force be applied to the closure nut it is possible to turn it past the "closed" position and even to open it from the wrong end – if flown in this configuration the maillon is not strong enough, and may open under tension.

King Snap

No stamp, and notice the thread coming out of the bottom of the closure nut

We ask all owners of Ascent 2's and Kantega XC's to check their line connections and, should King Snap maillons be fitted, to send the Serial Number of the wing to the distributor for a free exchange. The distributor will also be able to help with detailed instructions on how to do the actual exchange.

We apologise for this inconvenience and ask all pilots to not fly their Ascent 2 or Kantega XC wings until the maillons have been checked and maybe exchanged. See below how you can easily identify the two different maillon types:
