Garmisch-Partenkirchen, May 28th 2009

## Safety Notice UP Ascent 2 and Kantega XC

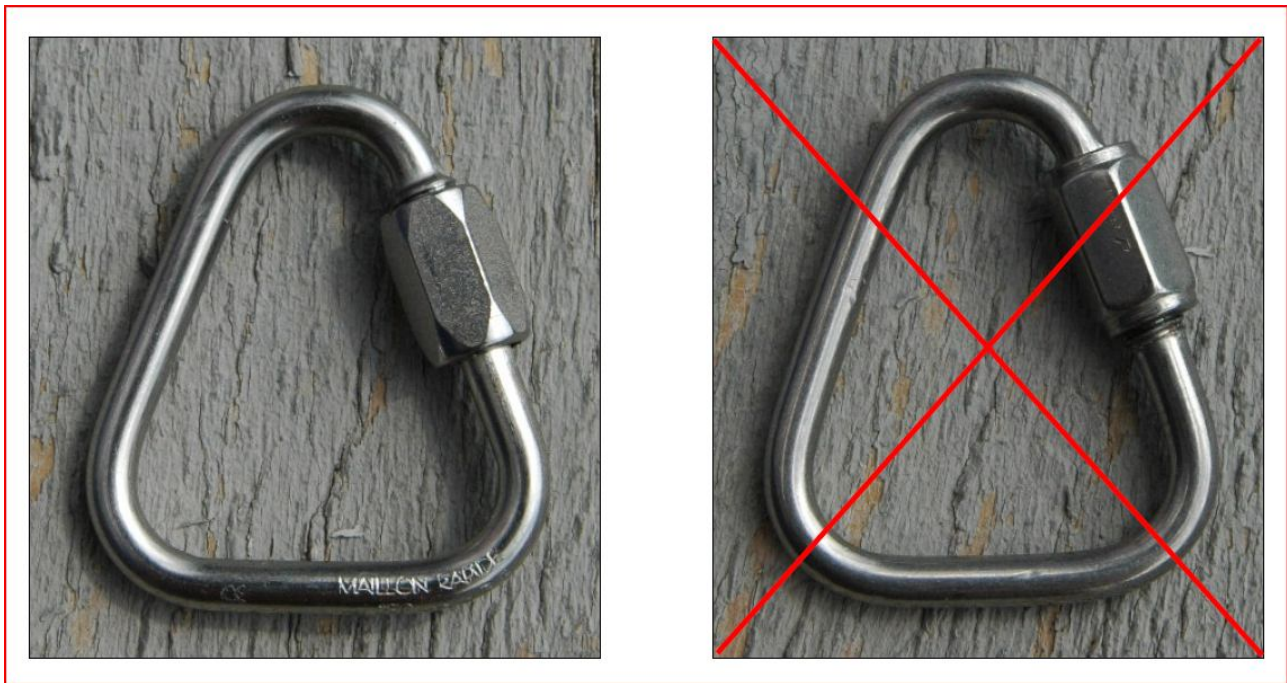
The problem with the King Snap maillons is, should excessive force be applied to the closure nut it is possible to turn it past the "closed" position and even to open it from the wrong end – if flown in this configuration the maillon is not strong enough, and may open under tension.

Easy to recognise from the Maillon Rapide stamp

No stamp, and notice the thread coming out of the bottom of the closure nut

We ask all owners of Ascent 2's and Kantega XC's to check their line connections and, should King Snap maillons be fitted, to send the Serial Number of the wing to the distributor for a free exchange. The distributor will also be able to help with detailed instructions on how to do the actual exchange.

We apologise for this inconvenience and ask all pilots to not fly their Ascent 2 or Kantega XC wings until the maillons have been checked and maybe exchanged. See below how you can easily identify the two different maillon types:
