Eisenberg, February 26th 2018

Safety note concerning: Deployment bags for reserve parachutes

Status: OBLIGATORY

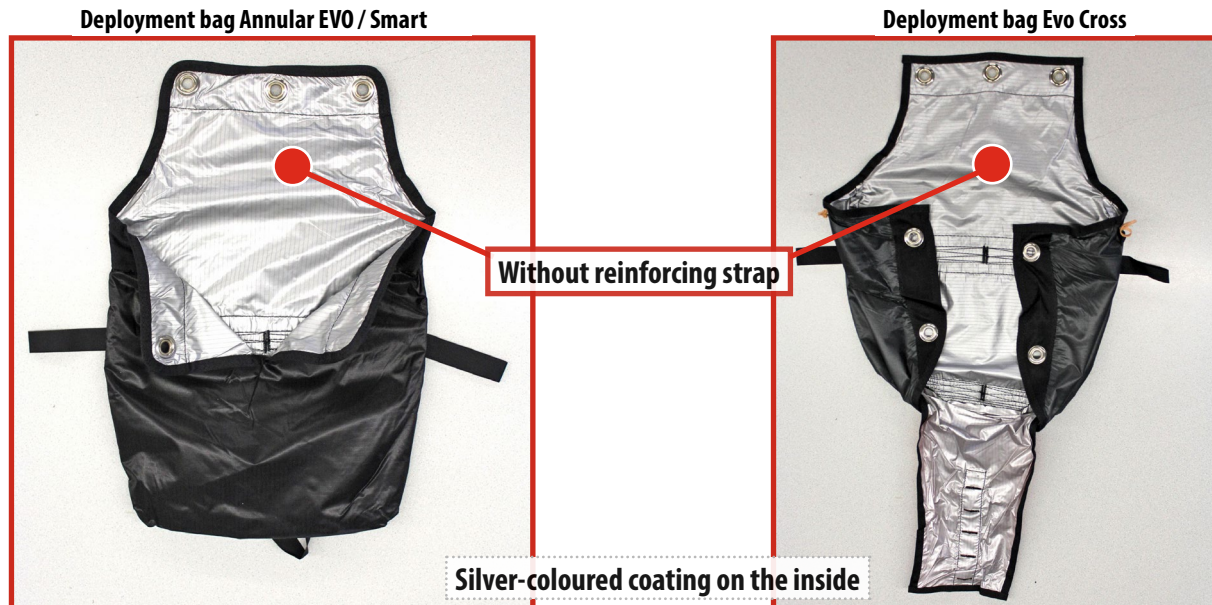
CONCERNED DEPLOYMENT BAGS

At the seam-line of the isolated upper loop, which is used to attach the deployment handle, a perforation could possibly cause a material weakening of factory delivered deployment bags. This seam-line, if properly processed, has to be able to bear a load of 70 daN. Yet it was proven that a lower strength of this component can occur.

The affected deployment bags can be distinguished either by the year of manufacture or their serial number. The best visible indication which distinguishes concerned bags, is their silver-coloured coating on the inside of the deployment bag, if it does not have a reinforcing strap (as can be seen below).

The owners of affected deployment bags are obliged to check before flight, whether the **isolated upper loop** of the deployment bag is in use. If it is in use, the deployment bag needs to be replaced immediately!

If the isolated upper loop is in use, **immediate replacement** is obligatory!

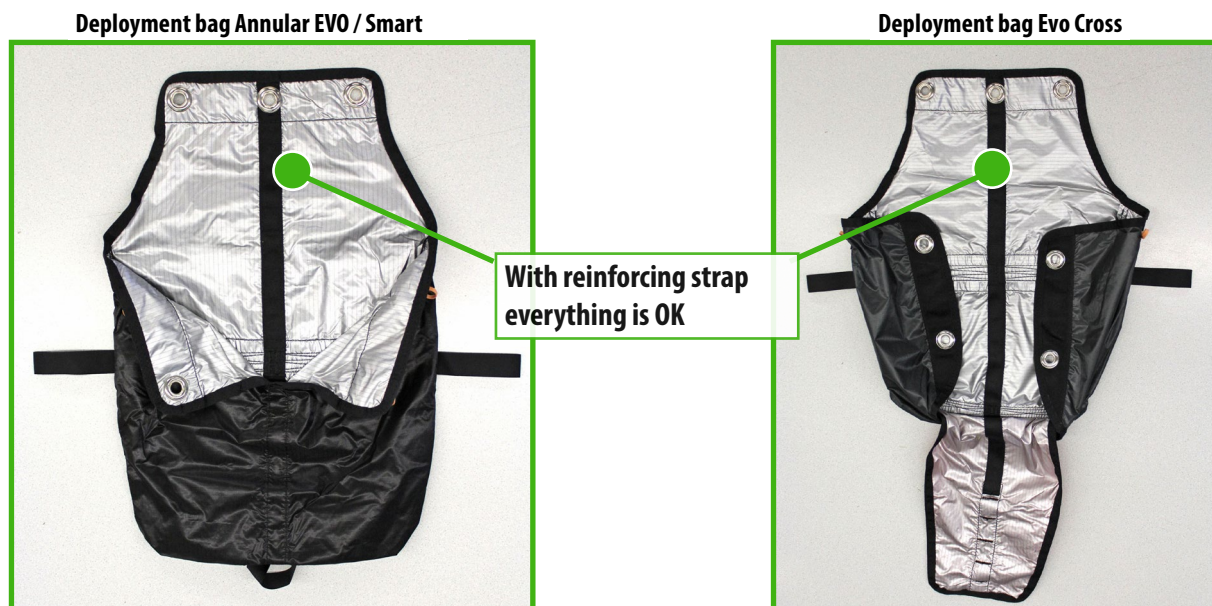
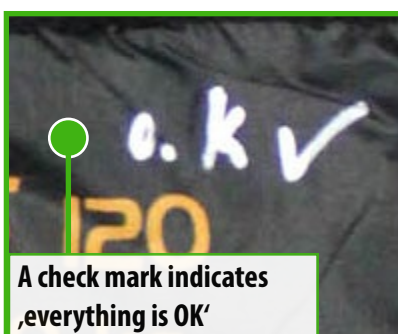
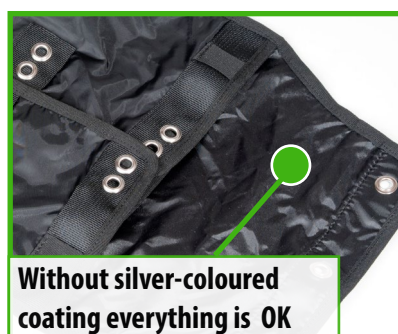
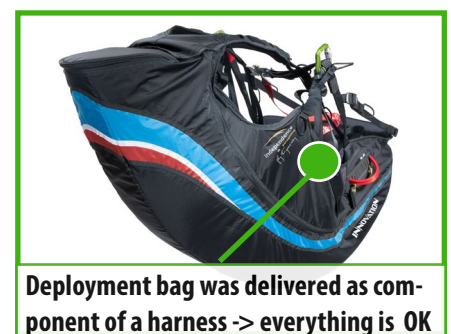
DEPLOYMENT BAGS NOT CONCERNED

Not concerned are earlier items which can clearly be recognised by the missing silver-coloured coating on the inside. Not concerned are all items which have been delivered as of February 2018. These new deployment bags are clearly marked with a check mark (OK) and can be recognised by the additional reinforcing strap on the inside. Furthermore deployments bags which have been delivered as component of a harness are not concerned.

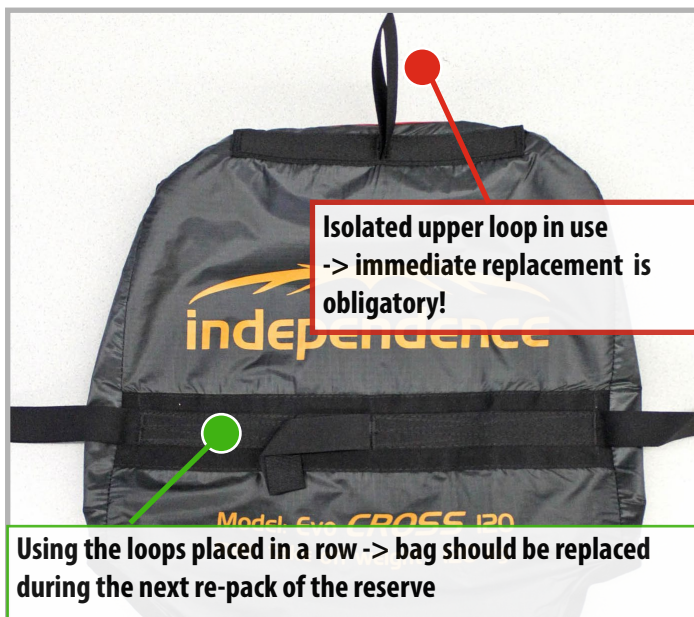
If one of the **three loops in a row**, which are placed between the labellings, is in use, the deployment bag does not necessarily need to be replaced. **These three loops don't show any faults and are not concerned by this safety note** (see image on the left).

If one of the lower 3 loops placed in a row is in use: Replacement should take place latest during the next re-pack of the reserve.
