British Hang Gliding and Paragliding Association

BOARD OF INQUIRY REPORT

**Investigation of a hang gliding accident which occurred
at Harting Down, West Sussex on 4th April 2003,
in which the pilot was fatally injured**

BHPA investigation serial number: IR 03/027

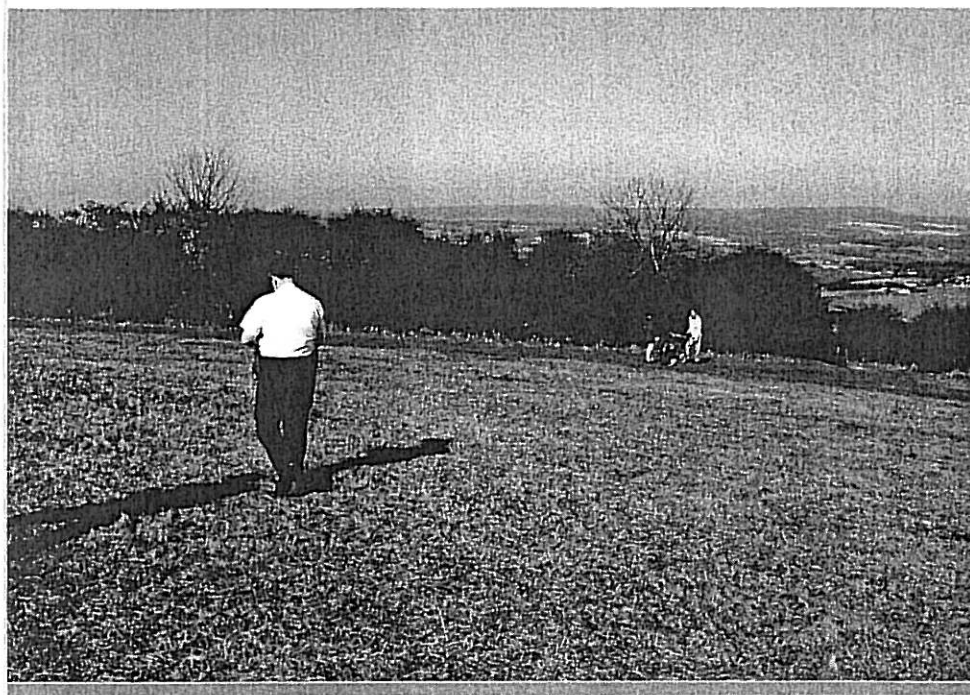
Appendix C

At the accident site at the time of the accident there was little cloud and the wind was approximately 15 m.p.h and occasionally 20 m.p.h. from the north. The witness who was out walking described the wind as gusty but one of the two other hang glider pilots present described it as smooth. In the impact area there was virtually no wind but the tops of the trees at the front of the hill could be seen bending over.

The point of impact was on Harting Down at OS grid SU 79996 18415. This is a smooth grassy area of gentle downslope with no obstructions other than the line of trees at the northerly (downslope) end. The area is known as Round Down and marked on OS maps as such. Impact was approximately half a kilometre to the east of the launch point and not in an approved landing area. Even if it were convenient and approved by the NT this area would not be considered suitable due to the possibility of turbulence associated with the line of trees at the front edge of the hill. The area in front of Round Down is a steep, wooded bowl which often generates good dynamic lift.

View north from point of impact
