BOARD OF INQUIRY REPORT

**Investigation of a tandem powered paragliding accident
which occurred near Flagg, Near Buxton,
on the 15th May 2004
in which both the pilot and passenger
were seriously injured**

BHPA investigation serial number: IR 04/062

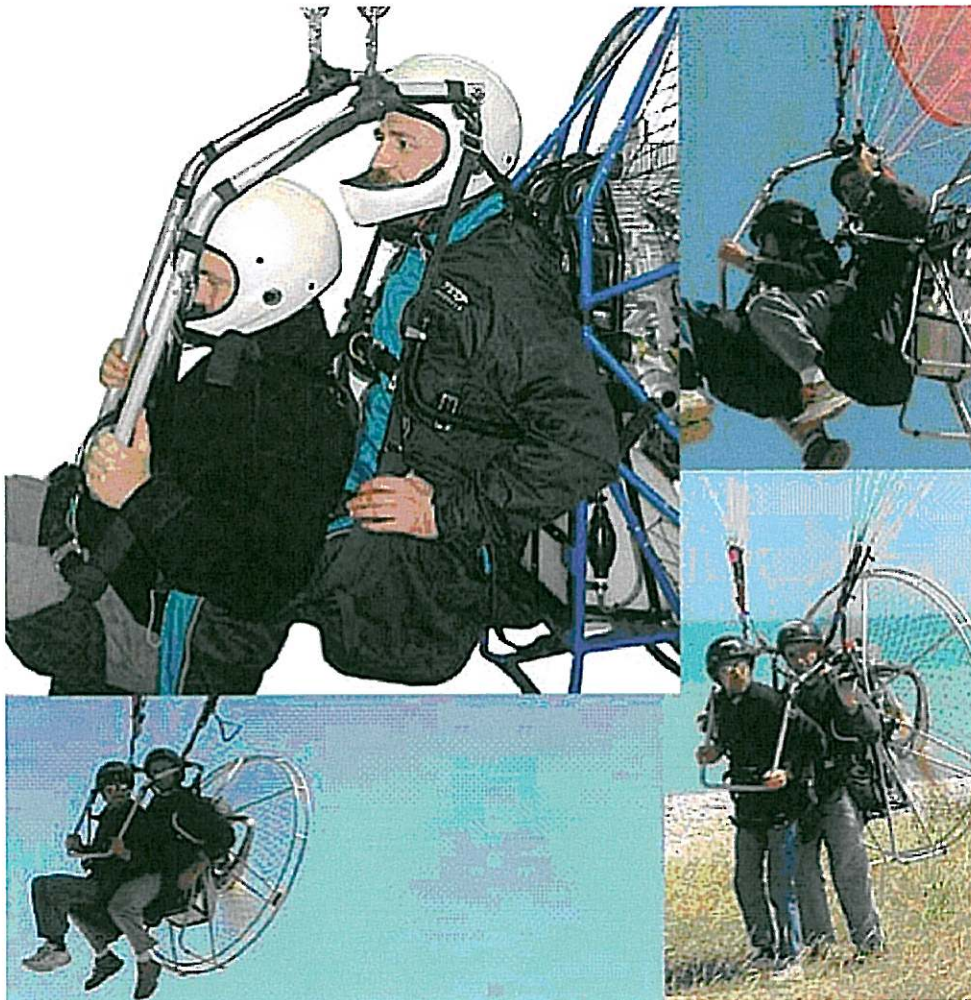
Photo 1: Fly Products publicity material showing the tandem paramotoring equipment general arrangement and the spreader bar / 'U' bar assembly.

The manufacturer was contacted and has stated that the 'U' bar is a 'passenger hand grip' and its removal would have no adverse effect in flight.

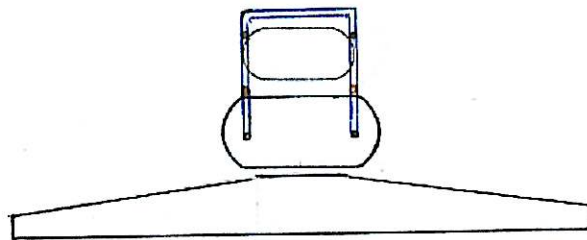
Diagram 1: 'U' bar installed – motor, pilot and passenger held in alignment.

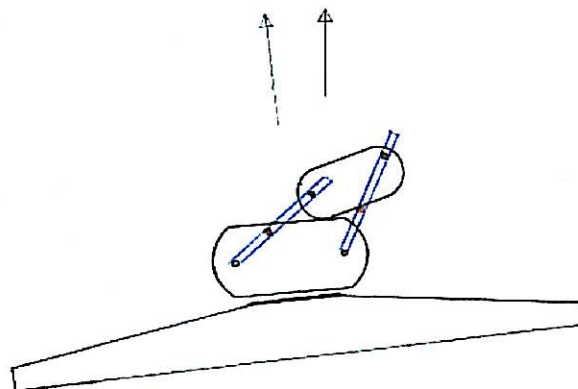
Thrust line misalignment effects arising from the lack of rigidity in the passenger/pilot/motor combination: removing the damaged 'U' bar removed the only rigid fixing of the two spreader rails in fore and aft alignment with each other. With the 'U' bar removed the motor/pilot/passenger combination was able to move out of alignment with each other, thus offsetting the thrust line.

Diagram 2: 'U' bar removed – motor, pilot and passenger out of alignment. Thrust line offset to direction of flight.

It should be noted that the spreader bars are the only rigid members in the motor/pilot/passenger assembly, and that those three components are suspended from the spreader bars on webbing straps. The possible range of movement is quite large – diagram 2 is only indicative. The amount of misalignment could have been greater.

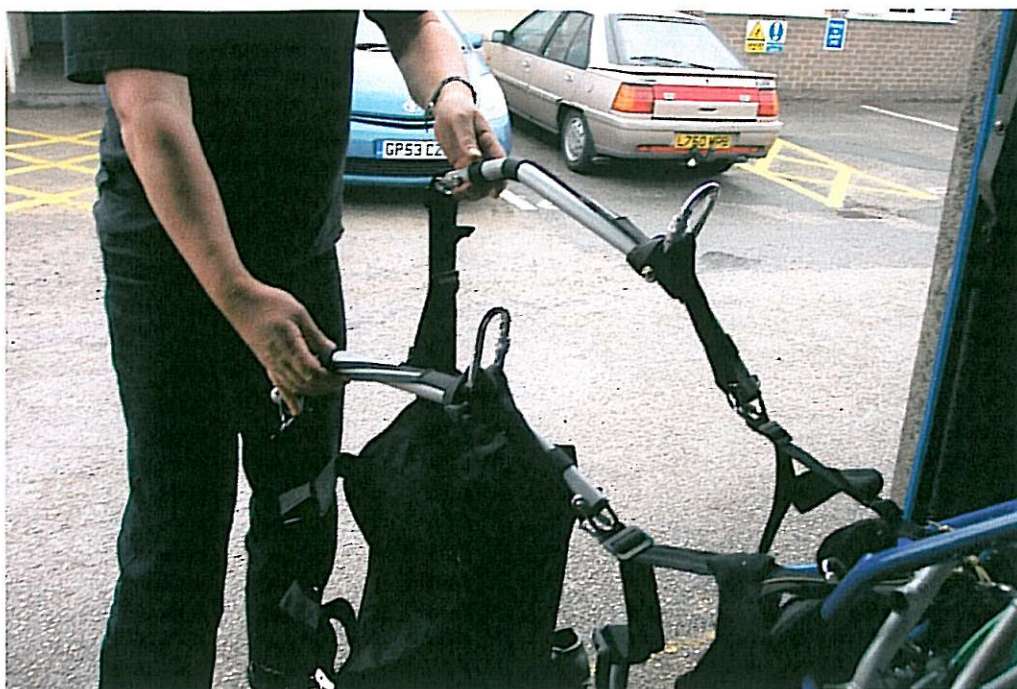
Photo 2: Degree of independent spreader bar movement available without the 'U' bar assembly in place.

To sum up: the probable chain of events was that as the pilot was wriggling into his harness some weight shift and fore and aft motions were applied to his suspension points. The spreader bars slid out of fore and aft alignment and, with the powerful motor in use, the misaligned thrust was able to instantaneously drive the suspended load round in a 360 degree swivel under the wing. (It is quite possible that this swivelling was anything up to three and a half full rotations.)

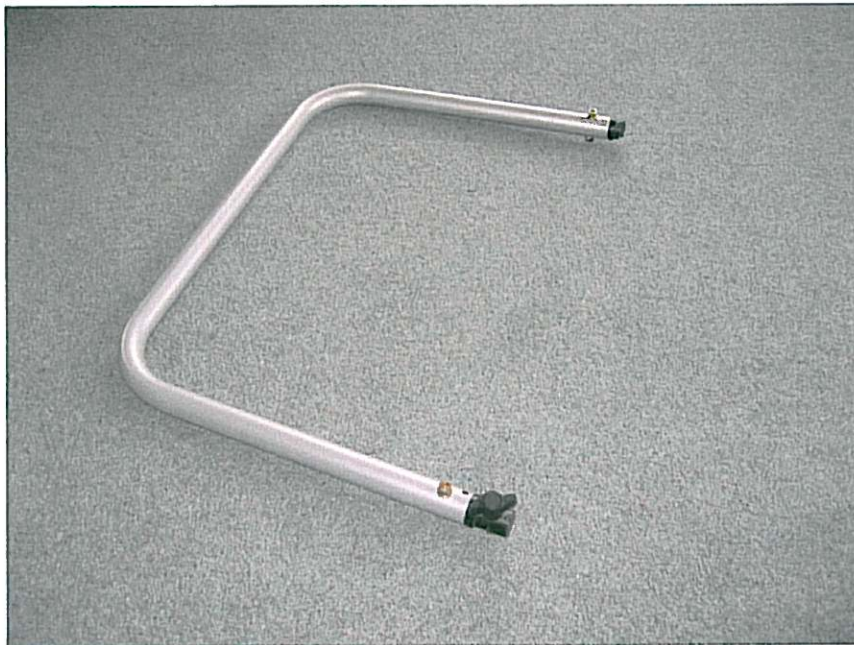
The 'U' bar was removed before the accident flight as its attachment at one end had been broken during the landing/post-flight stages of the previous flight. The 'U' bar attaches to the spreader bars by bolting through a simple nylon spigot joiner. Given the amount of movement available at the rear ends of the spreader bars (limited only by the webbing harness and motor attachment straps) it would seem inevitable that substantial bending loads will be applied to the nylon spigot joiner during the ground handling stages. Breakage of the spigot joiner would seem to have been something that was bound to happen sooner or later.

Photo 3: 'U' bar assembly. Broken attachment furthest from camera.

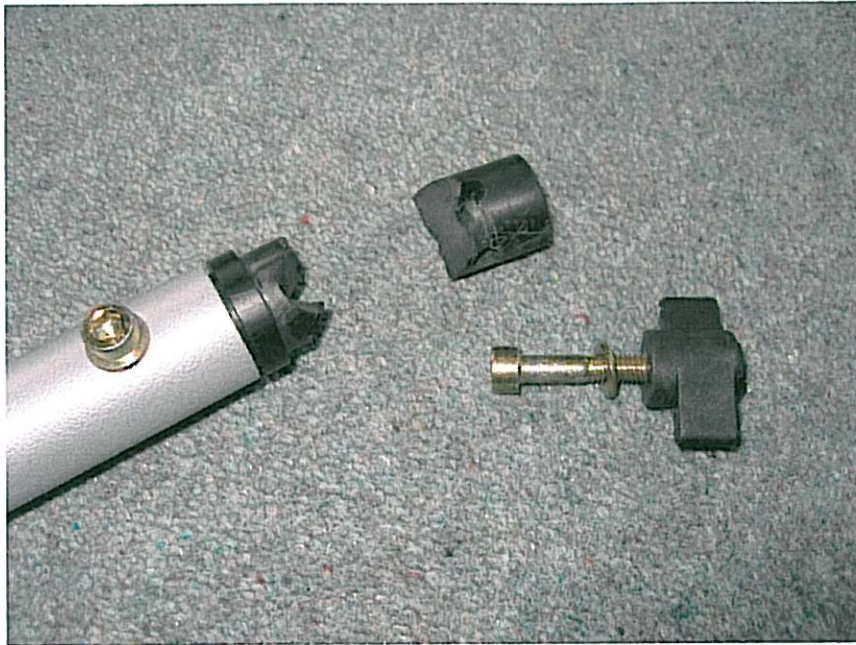
Photo 4: Broken nylon spigot joiner.
