## **BOARD OF INQUIRY REPORT**

**Investigation of a Paragliding accident  
which occurred at Bo Peep, Sussex,  
on 12<sup>th</sup> July 2005  
in which the pilot  
was fatally injured**

BHPA investigation serial number: IR 05/066

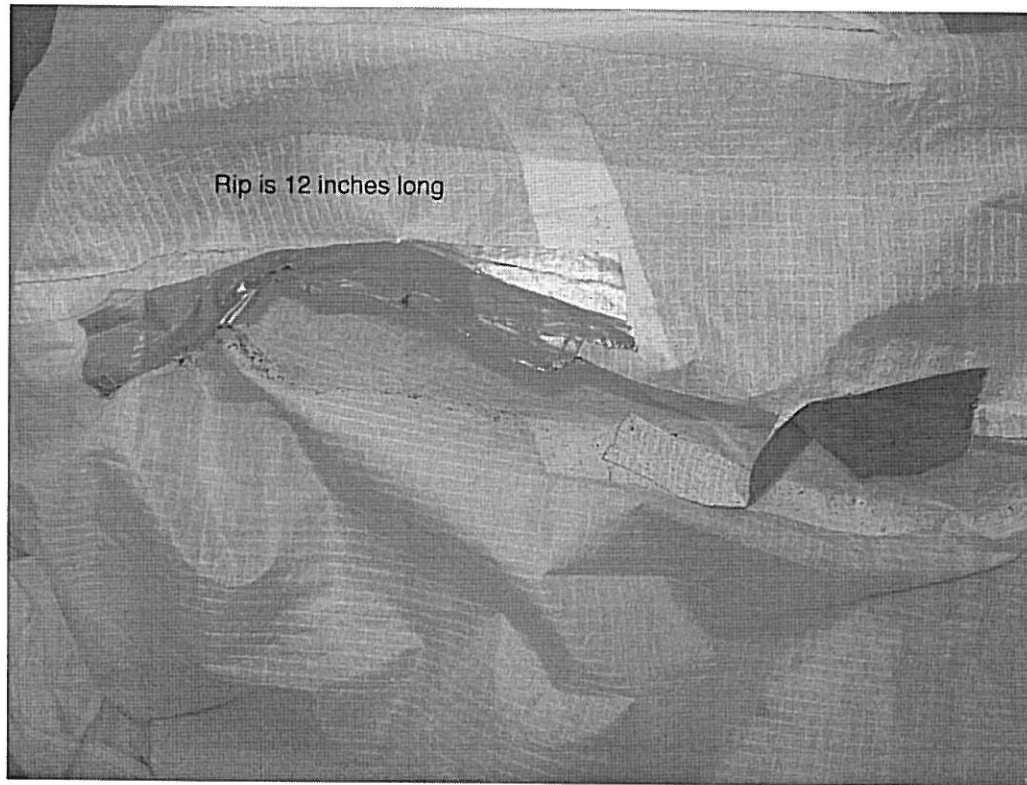
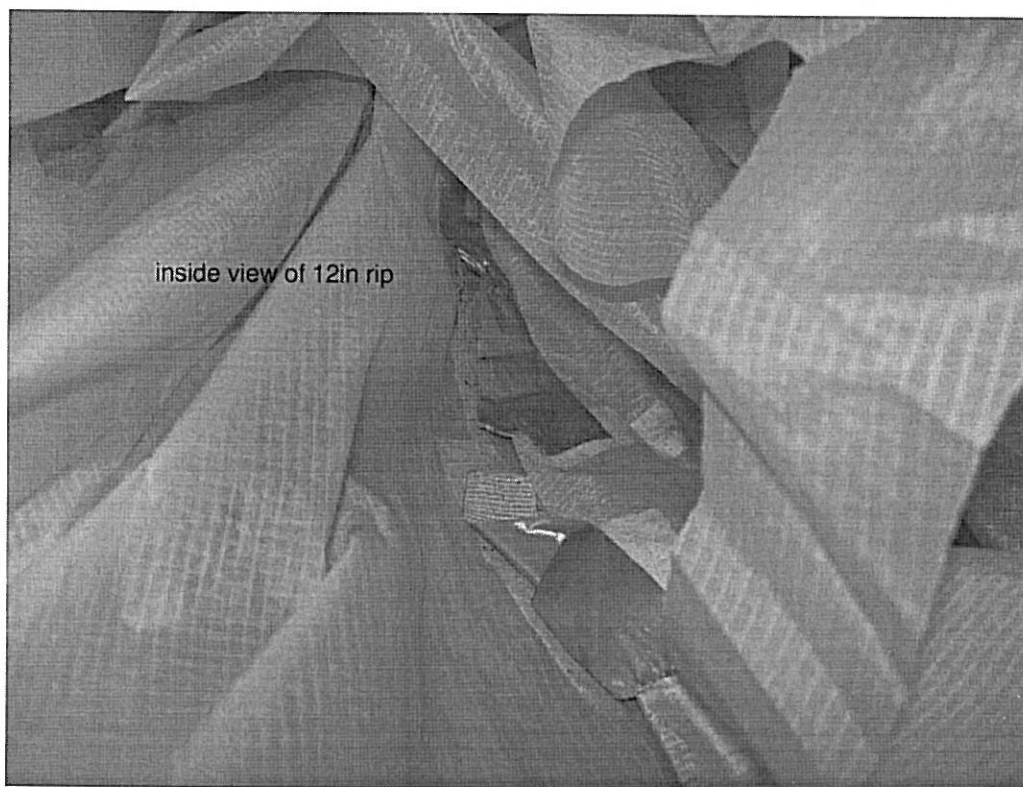
**APPENDIX A**  
Structural photos.

Subsequent to the incident the glider was inspected by an independent paraglider 'service and repair' centre and also by a BHPA Technical Officer. Several poorly completed 'DIY' repairs to the internal structure were uncovered which, in the opinion of both the service centre and the Technical Officer, rendered the glider un-airworthy (see Appendix A). The glider was also found to be in a poor overall state with dozens of small rips to the upper surface (few if any as a result of the incident) and significant staining to the fabric.

The glider was inspected after the accident. The inspection revealed that a number of repairs to the internal structure of the wing (vertical ribs) had been made using "gaffer" tape (see Appendix A). This is not a recommended or approved repair technique. Given the condition of the wing and the poorly completed repairs, the Board decided against test flying the glider. It is therefore not possible to fully establish the effect of these repairs.

The repair to the glider described in 1.16 would not, in the Board's view, have had the effect of improving the recovery characteristics of the glider once the partial collapse occurred – it may even have made matters worse. However, the Board also conclude that the behaviour of the glider, and its collapse, was in line with what could reasonably be expected of such a wing flown in the prevalent meteorological conditions on the day. It is for this reason that the effects of the repair have not been explored more fully. Put another way, under the same circumstances a glider without such a repair would almost certainly have impacted the hill in a similar way as the time and height for recovery was insufficient.

The Board recommends that the Flight Safety Committee continues to remind pilots, via Skywings, of the dangers associated with flying paragliders with little or no inherent stability. The Board would also wish for a reminder to be made that any structural repairs related to flying equipment should only be undertaken by a suitably qualified person.
