ACCIDENT

Wing:	Paramania Revolution 23	
Paramotor unit:	Modified H & E Paramotores R120 series	
Year of Manufacture:	2005	
Date & Time (UTC):	8 July 2007 at 1950 hrs	
Location:	Middle Barn Farm, Bexhill, East Sussex	
Type of Flight:	Private	
Persons on Board:	Crew - 1	Passengers - None
Injuries:	Crew - 1 (Fatal)	Passengers - N/A
Nature of Damage:	Substantial	
Commander's Licence:	None required	
Commander's Age:	42 years	
Commander's Flying Experience:	5 years (paramotors)	
Information Source:	AAIB Field Investigation

Synopsis

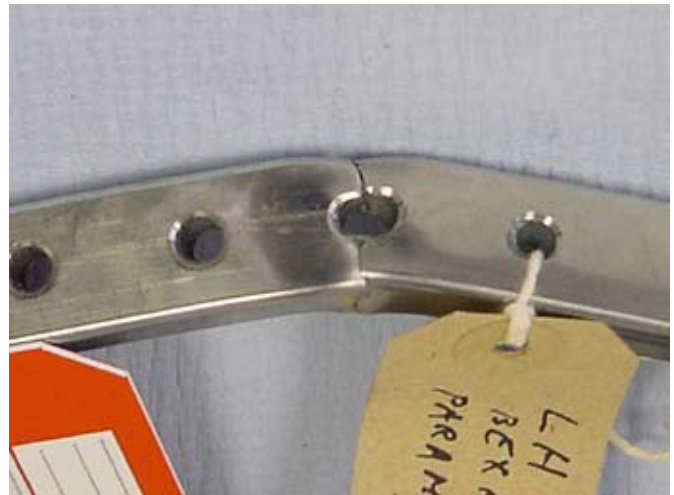
Left lift arm, from above

Left lift arm, outboard surface

The left arm had suffered a complex failure where the shackle-pin passed through the hole in the arm

(Figures 2 and 3). This appeared to be a bending failure in two axes allowing the clevis pin to break out of the hole but, after the failure, some remaining material in the box section surrounding the hole had allowed the forward end of the failed arm to remain united with the hinged end of the arm.

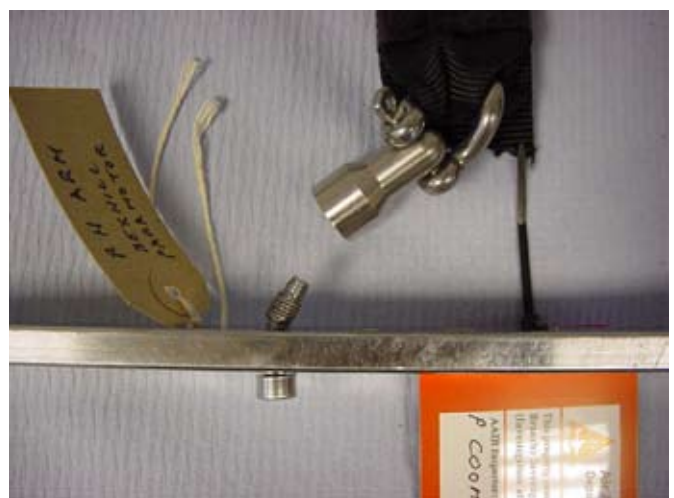
The additional fitting on the right side consisted of an internally-threaded cylindrical component, tapering to a reduced diameter cylindrical end section (Figure 4). This incorporated an eye-end through which passed a clevis pin, supporting a shackle to which the right-hand webbing was attached. The shackle was of the ‘right-angle’ type, with the portion to which the webbing was attached orientated at 90° to the shackle-pin axis. Although the shackle initially appeared to have been deformed to this condition by loading, shackles with this geometry are available from, for instance, suppliers of yacht equipment.

Right lift arm, threaded connection

(Figure 4) as a result of the threaded insert failing to retain the bolt within the body of that fitting, under the influence of an axial load component. This bolt was also found to be severely bent.

Examination and sectioning of the right-hand load attachment fitting revealed that only two threads were fully engaged and a further four were only partly engaged. This would significantly reduce the failure load. In addition, a series of other variable factors would influence the strength of the attachments:

The bending of the bolt during the failure of the fitting on the right arm indicated a substantial load component at right angles to the bolt axis. This suggested a failure load range falling only slightly above the lowest range of the figures predicted for a direct lateral bolt load. Circular regions of compressive distortion of the material of the right arm surrounding the shackle holes were evident. These indicated that the bolt had been torque-tightened into the fitting on a number of occasions, whilst mounted in a number of different holes. The hole occupied by the bolt on the occasion of the failure was amongst those with significant compressive distortion. Calculations showed that a reduction of load-carrying capacity would have

In summary, the conclusion from the calculation of the failure loads was that it was probable that the failure of the bolted attachment (the right side of the paramotor unit) occurred first and load transfer to the shackle/pin attachment (the left side) followed. This sequence was further indicated by the bending directions of the failed left-hand arm, suggesting its failure load occurred after the seat and occupant had rotated about a longitudinal axis following failure of the right-hand attachment.
