British Hang Gliding and Paragliding Association

**Investigation of a paragliding accident which
occurred at the Long Mynd, Shropshire,
on the 8th August 2009 which resulted in the
death of one pilot and serious injury
to the other who died nine days later.**

BHPA investigation serial number: IR 09/065

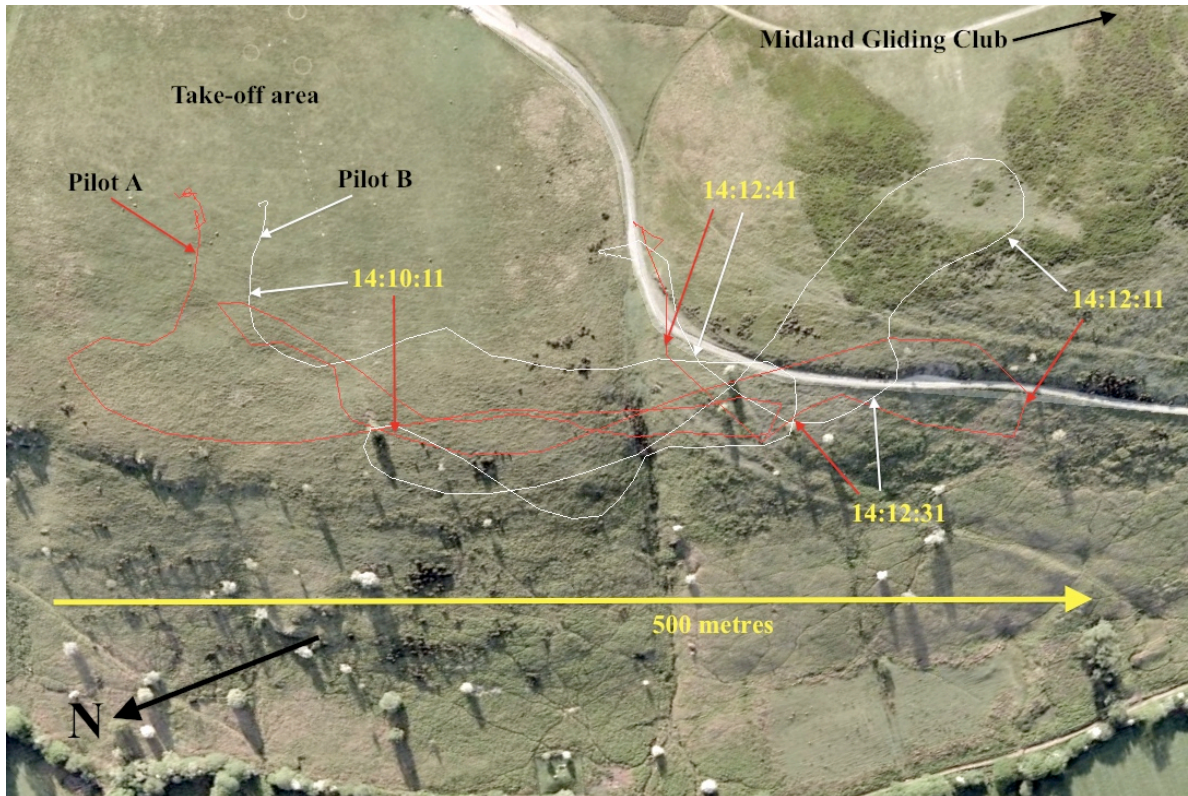
‘Pilot A’ took off at 2.09pm shortly followed (within a minute) by ‘Pilot B’. Both pilots began to beat back and forth along the front of the hill in an attempt to gain height (see Photo 1, below).

Photo 1, showing the flight paths of Pilots A and B and their positions at points in time.

‘Pilot A’ took off at 14:09:00 (all times are BST). He flew away from the hill then briefly north before heading south down the ridge. ‘Pilot B’ took off at 14:09:50, flew away from the hill and then turned left in a southerly direction. The two pilots continued to beat back and forth along the ridge (see Photo 1.) until at 11 seconds before the collision where they were in the positions shown in Photo 2 and highlighted in Photo 4, below. Approximately 10 seconds later having been in the air for between three and four minutes and while on a north-easterly track, at between 14:12:41 and 14:12:50, the two pilots collided and became entangled with each other (see Photo 4, Below). While on the north-easterly track, in the moments leading up to the collision, Pilots A and B were no more than twenty metres apart.

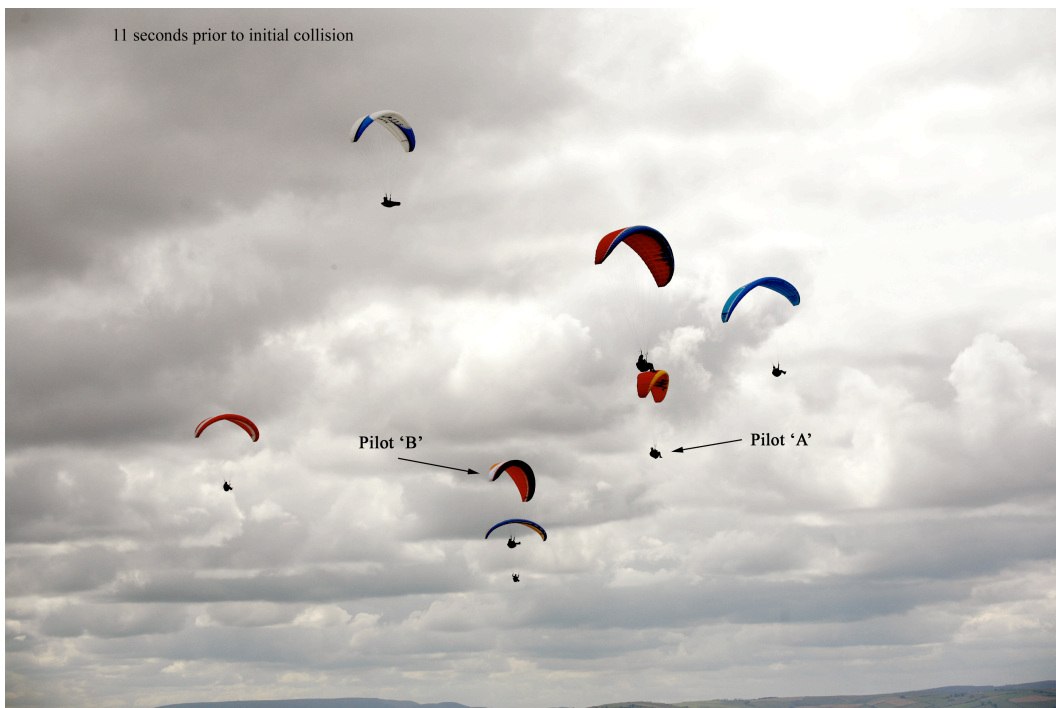
Three minutes after taking off, both 'Pilot A' and 'Pilot B' were flying in a north-easterly direction back towards the take off area. They were in a group made up of approximately seven paragliders (see Photo 2, below).

Photo 2, showing position of Pilots A and B, 11 seconds prior to collision.

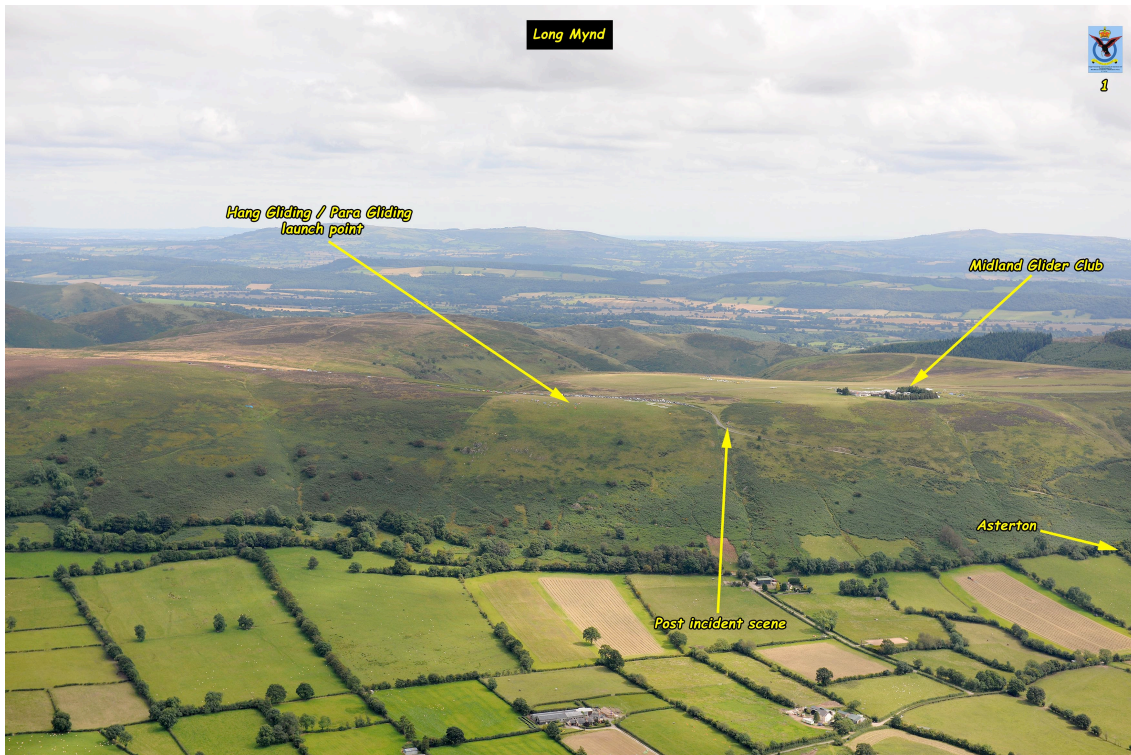
Photo 3, showing a section of the Long Mynd, take-off area and incident site.

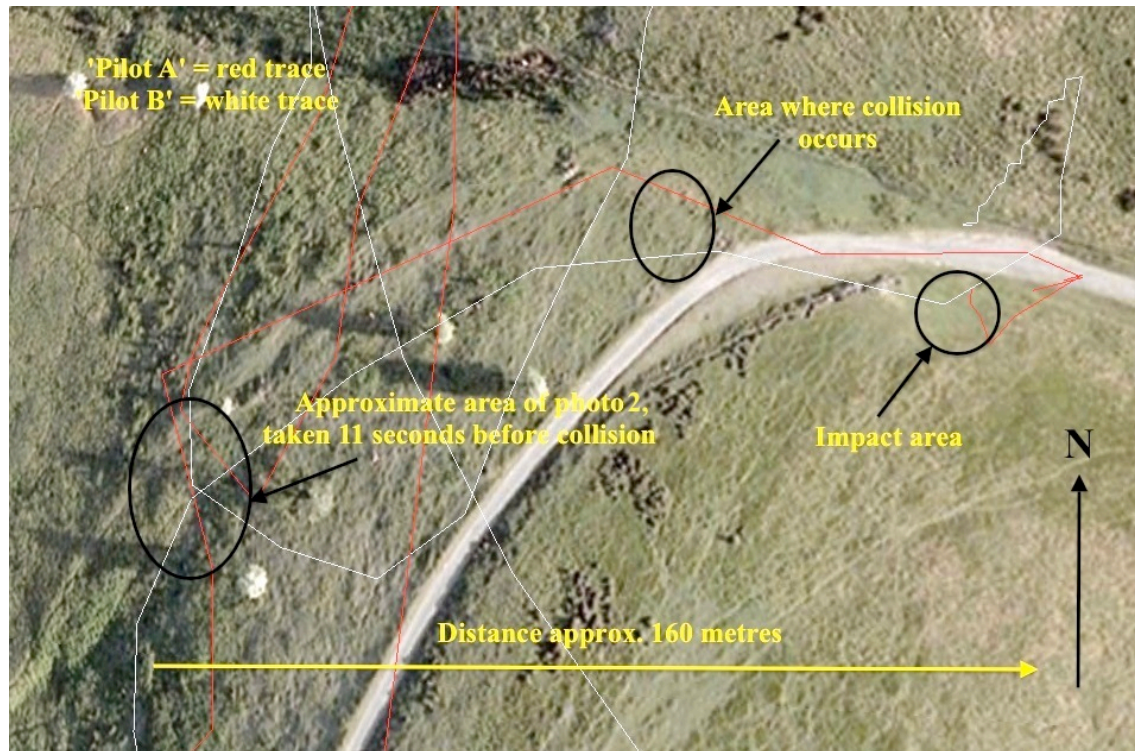
Photo 4, showing the collision and impact areas and also the approximate location of Photo 2.

The pilots impacted approximately 170m south of the take off area and adjacent to the access road that comes up and bisects the hill. This area is grassy and sloping, however, in this immediate area there is only a shallow layer of soil covering the underlying rock making it extremely hard. (See photos 1 and 4)
