British Hang Gliding and Paragliding Association

**Investigation of a Hang Gliding accident
which occurred at Teba near Algonodales, Spain,
on 21st March 2012
in which the student pilot suffered fatal injury.**

BHPA investigation serial number: IR 12/014

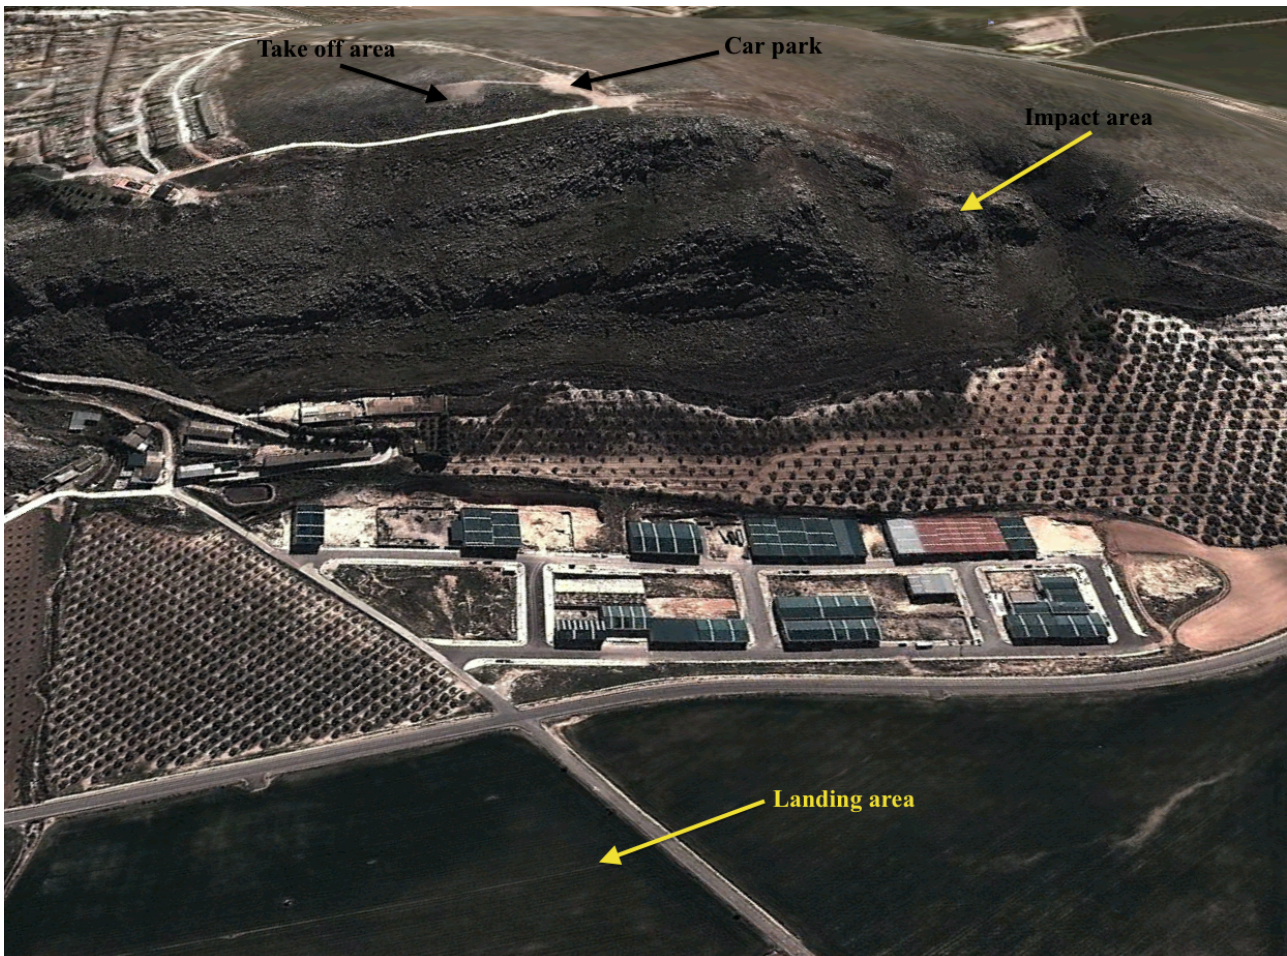
The diagram below shows the Teba northwest take off with the approximate crash site.

The pilot crashed amongst rocks on the side of the hill.
