REPORT

**Investigation of a hang gliding accident
which occurred at the Long Mynd, Nr Church Stretton
on 26th May 2013
which involved serious injury to the pilot.**

BHPA investigation serial number: IR13/062

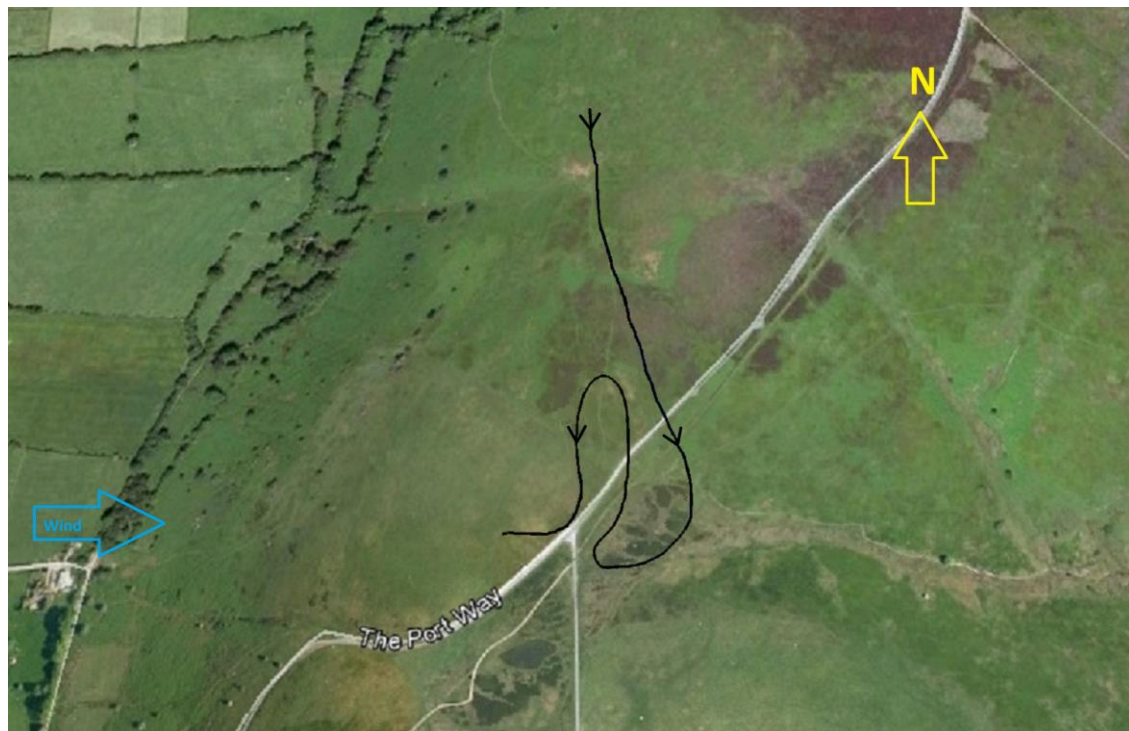
Picture 1: Pilot A's approximate landing circuit track

Pilot A made a second turn (to the left) outside the corner of the field at approximately 50 feet agl, then entered the field heading cross-wind, still in the left turn.

Pilot A reversed the turn as his final turn at about 20 feet agl. He rolled wings level out of the turn very low, in ground effect and flew into the back of a paraglider pilot who was packing his equipment in the field.

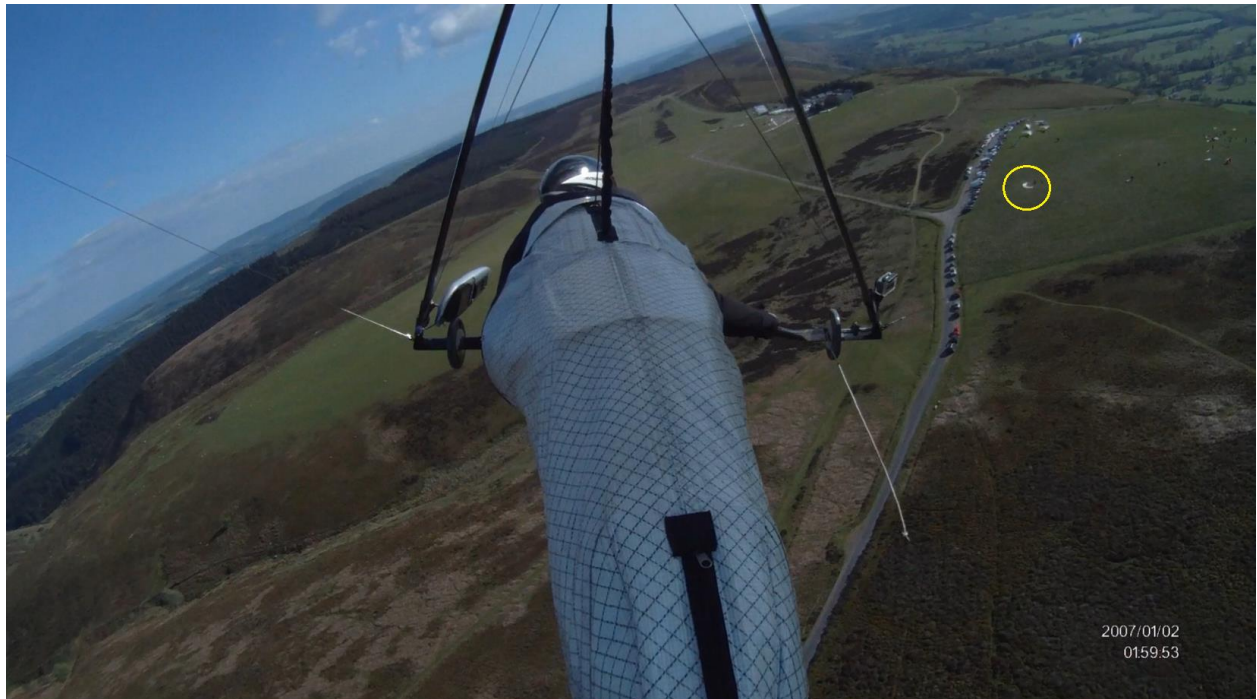
Picture 5: Pilot A. Reconnoitre from North. Paraglider pilot group ringed.

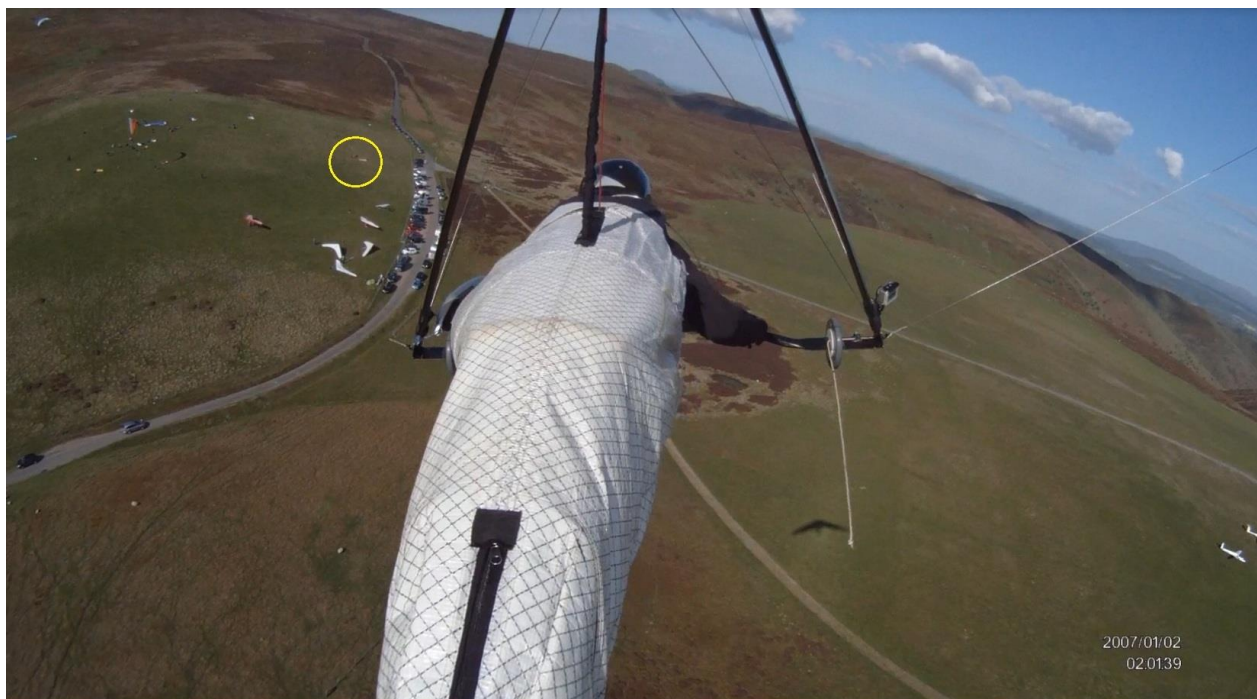
Picture 6: Pilot A. 360 to South of field. Paraglider pilot group ringed.

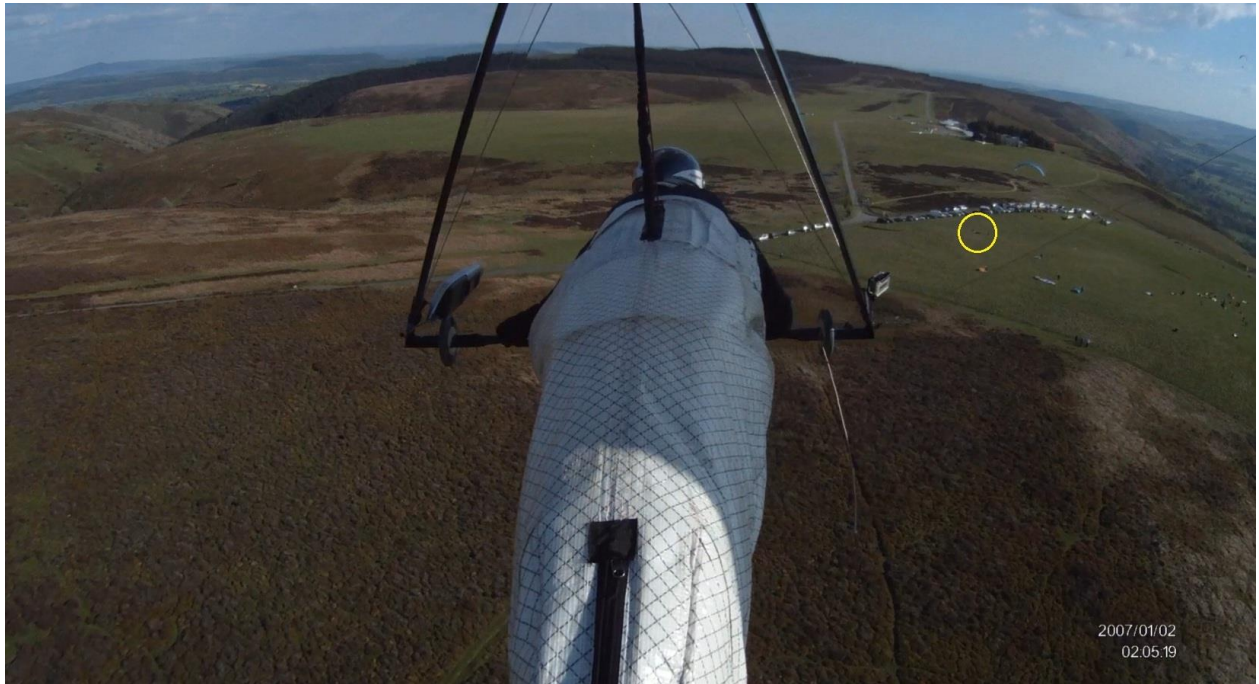
Picture 7: Pilot A. Flying to the back of the field from North West. Paraglider pilot group ringed.

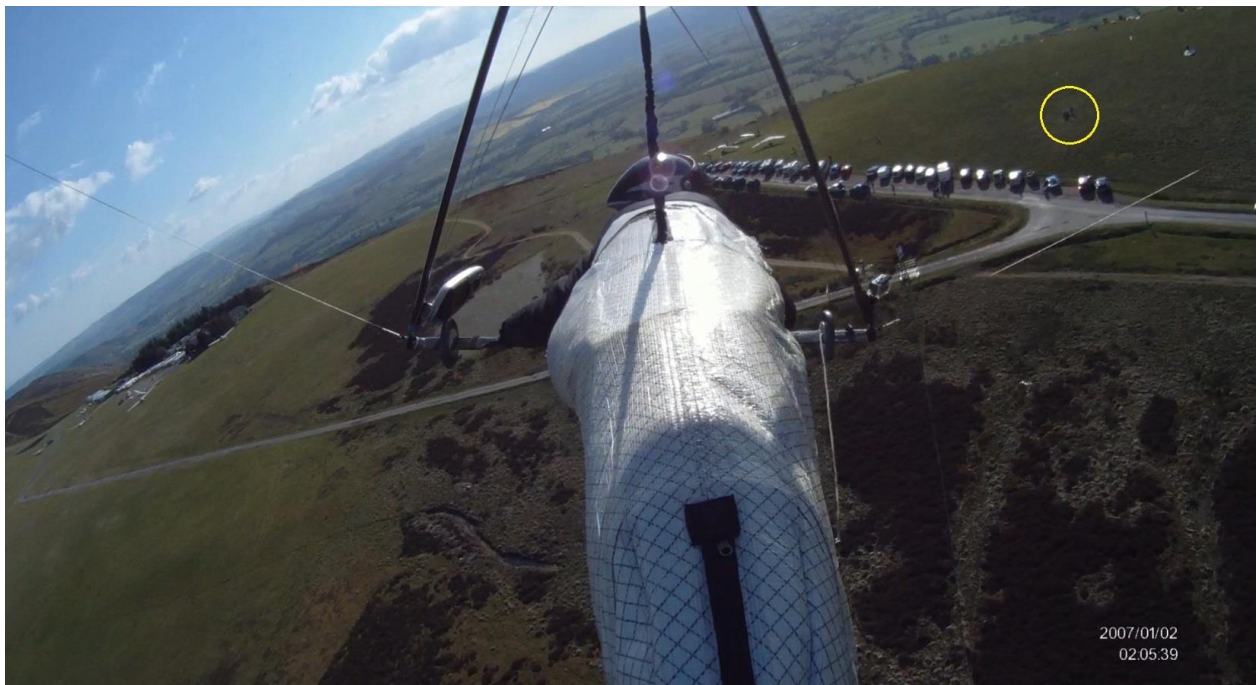
Picture 8: Pilot A. First turn behind the field. Paraglider pilot group ringed.

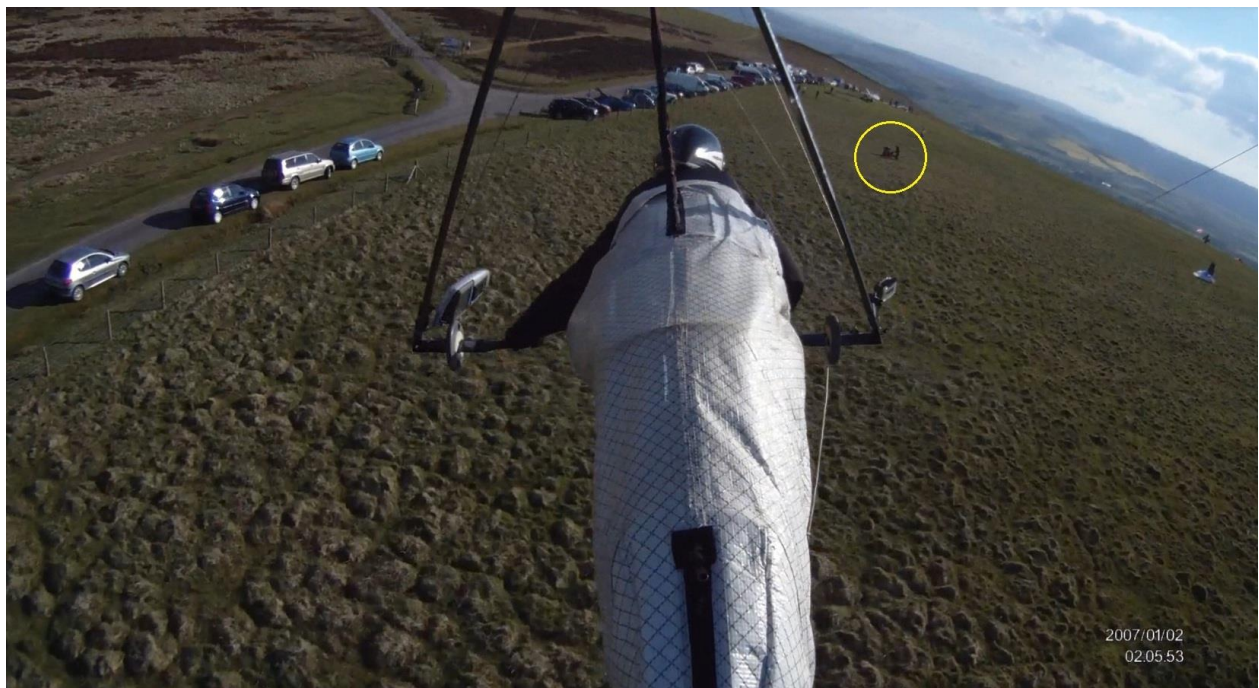
Picture 9: Pilot A. Base leg – crossing into the field. Paraglider pilot group ringed. (It was at about this time that Pilot A states that he shouted a warning.)

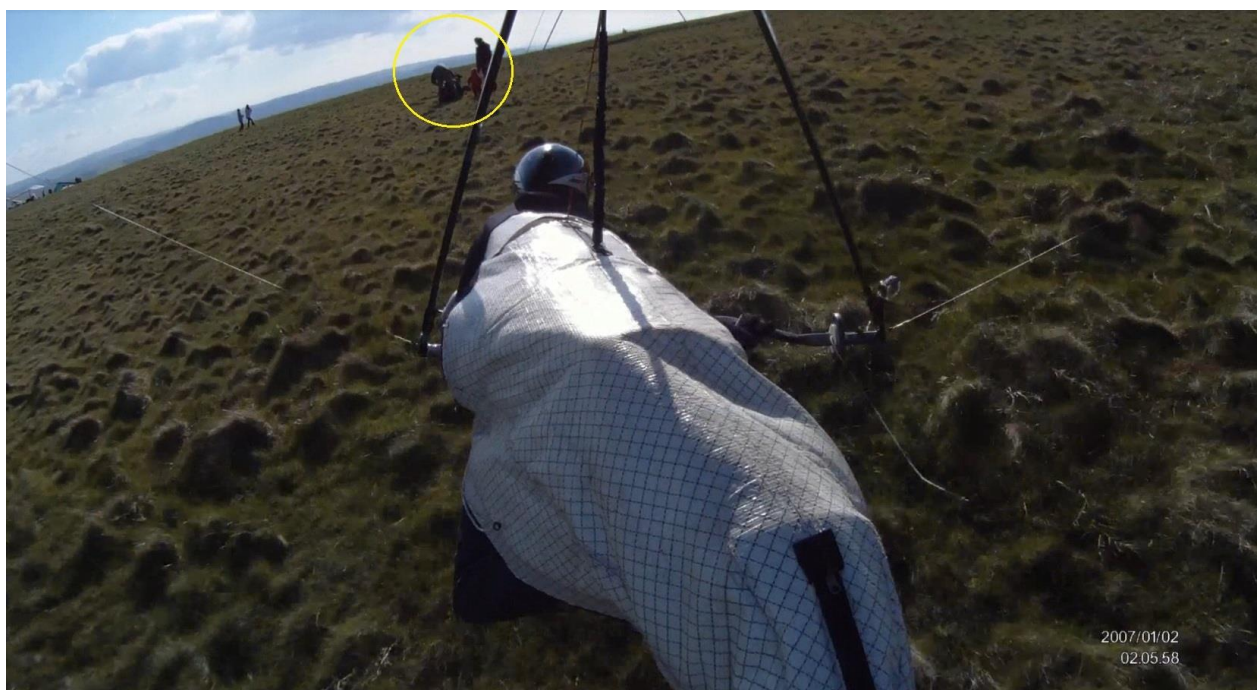
Picture 10: Pilot A. Completing final turn. Paraglider pilot group ringed.

Due to an unexpected loss of height the pilot completed his final turn at a height and position which lined him up precisely with the group of three people, and he had no time or space to manoeuvre on final approach to avoid the collision.

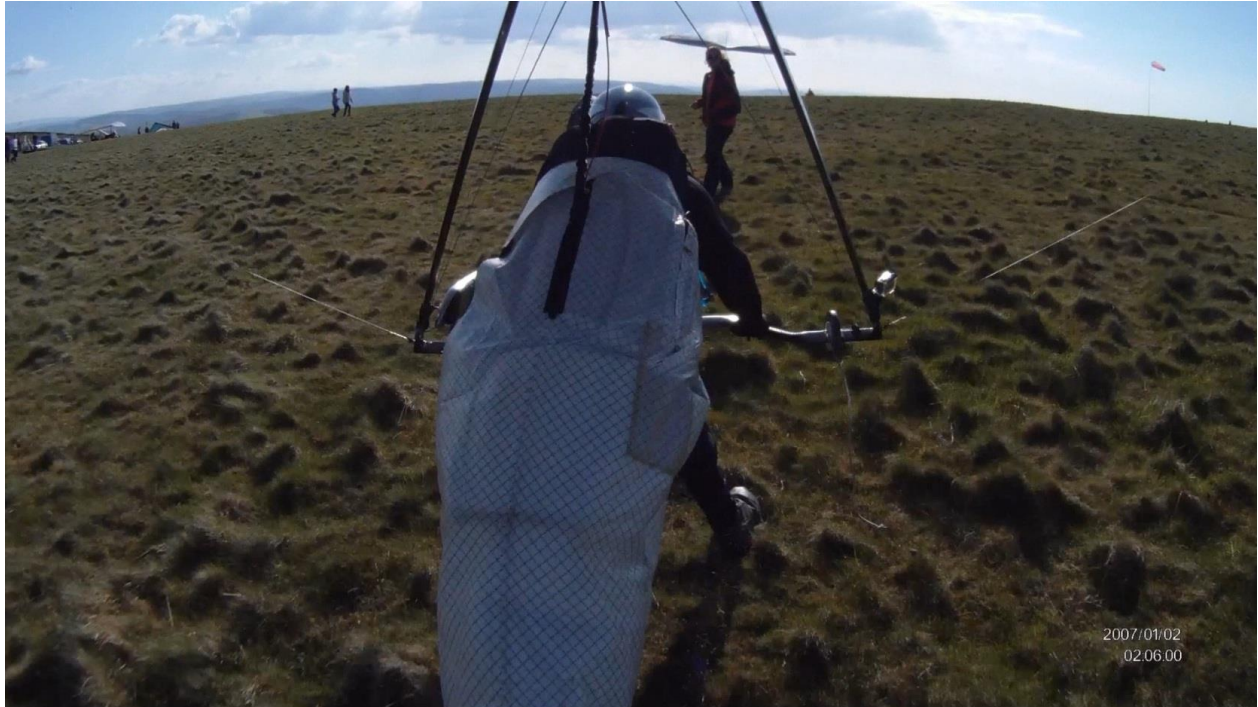
He stated. ‘As I straightened up from my final turn I saw that I was going to hit the group of people. I had to correct a slight yaw, and this had me aiming at the man on the left. I had the base bar a foot or so off the ground, and the Litespeed glides a long way in ground effect – probably 100metres. I thought about flaring over the group, but thought my base bar would hit the man in the head. I wanted to hold the

glider back, by jumping through the A frame, whilst knowing this was impossible. I got my feet down and wanted to slow the glider but it was still going quite fast.'

Picture 11: Pilot A. Attempting to slow the hang glider.

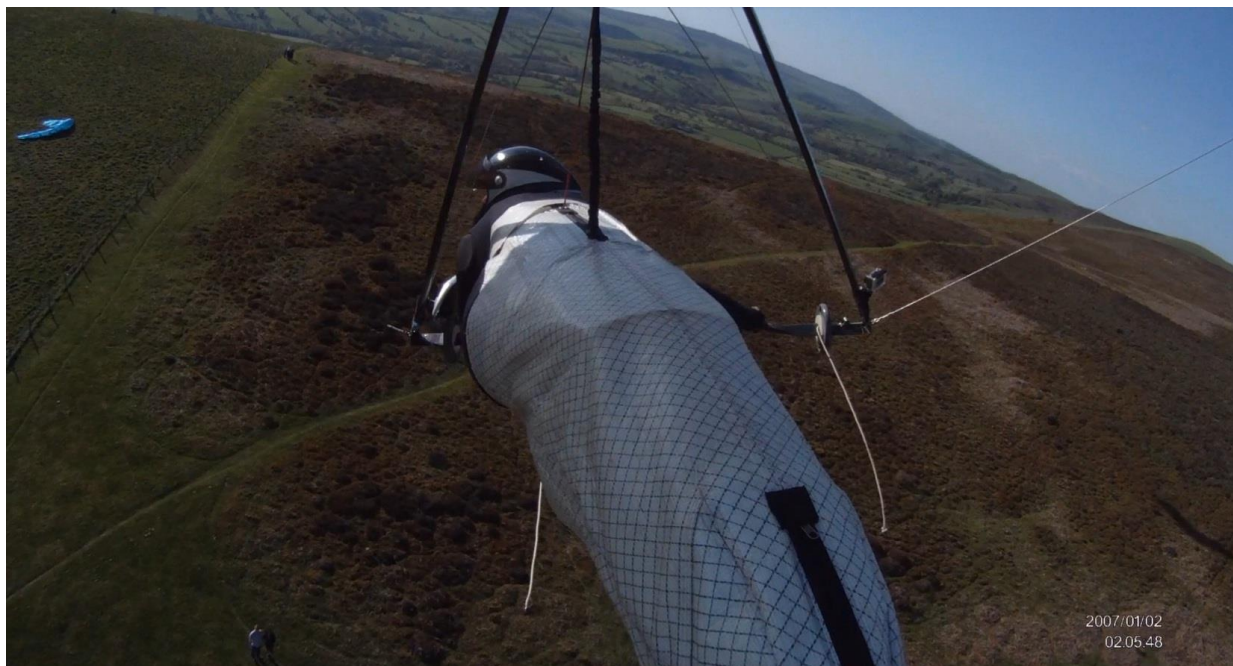
Picture 12: Pilot A. At this point the second glider flown by Pilot B was directly in front of and considerably higher than Pilot A. Pilot A's attention is focused across and down to his left.

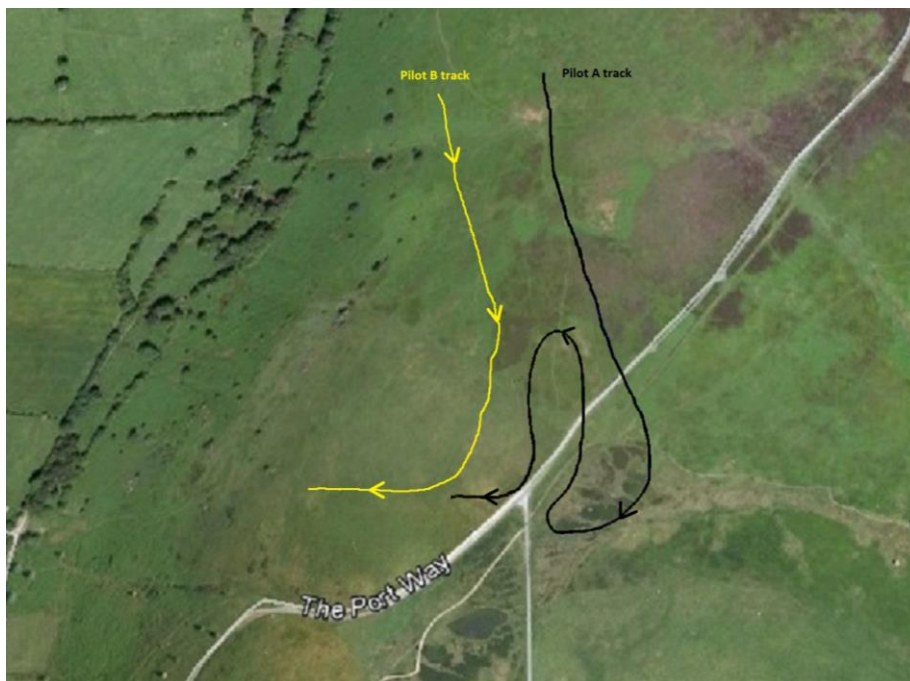
Picture 18: Pilot A's approximate landing circuit track in black. Pilot B's approximate landing circuit track in yellow.

Pilot B was performing a conventional top landing approach (as recommended). Pilot A was performing an S turn approach.

The S turn approach used by Pilot A also almost certainly produced a situation where Pilot A and Pilot B were flying towards each other just to the North of the field, as Pilot B headed SE on a curving downwind leg from the ridge, and Pilot A headed back NW from his first turn at the back of the field. Having aircraft flying in opposite directions in a landing circuit is undesirable. Pilot A believed that, as he was already involved in making his 'S' turn landing approach, it would be poor airmanship for any other glider to commence an approach. (Note. Whilst ideally only one hang glider would be on approach at any time, at most busy sites it is normal and necessary for several gliders to be able to approach at the same time. This is easily and safely accomplished if they all fly a predictable approach path in the same direction.)

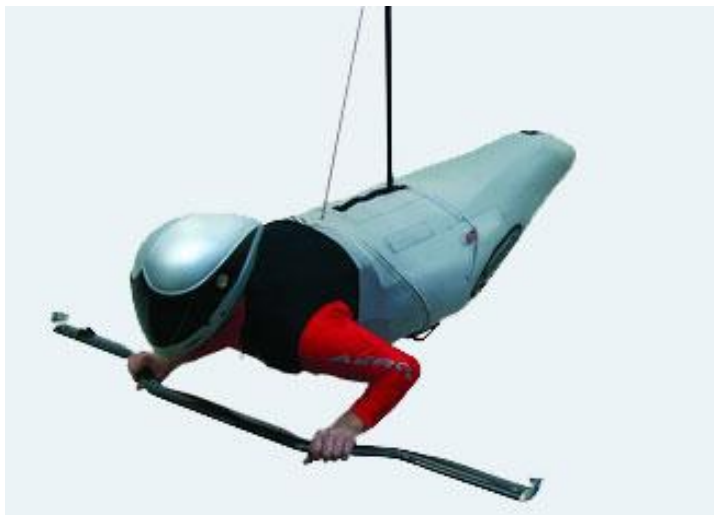
An additional possible factor is that these 'single strap' harnesses incorporate a tilt angle adjustment mechanism – in the case of the Aeros Viper harness this is activated with a 'butt lever'. A tilt limit cord is held in a cleat within the harness, behind the pilot's back. When the pilot raises his backside the 'butt lever' releases the cord and allows it to move, until the pilot lowers his backside, when it relocks. These tilt angle adjustment mechanisms are designed to handle the small loads involved in holding the tilt angle, and are known to slip when the components get worn. Under the 'g' loads involved in an accident such as this one, it is considered likely that the tilt angle adjustment cord would slip, allowing the pilot's head to move even further forward under the glider's nose.

Picture 19: Aeros Viper harness showing tilt angle adjustment cord.

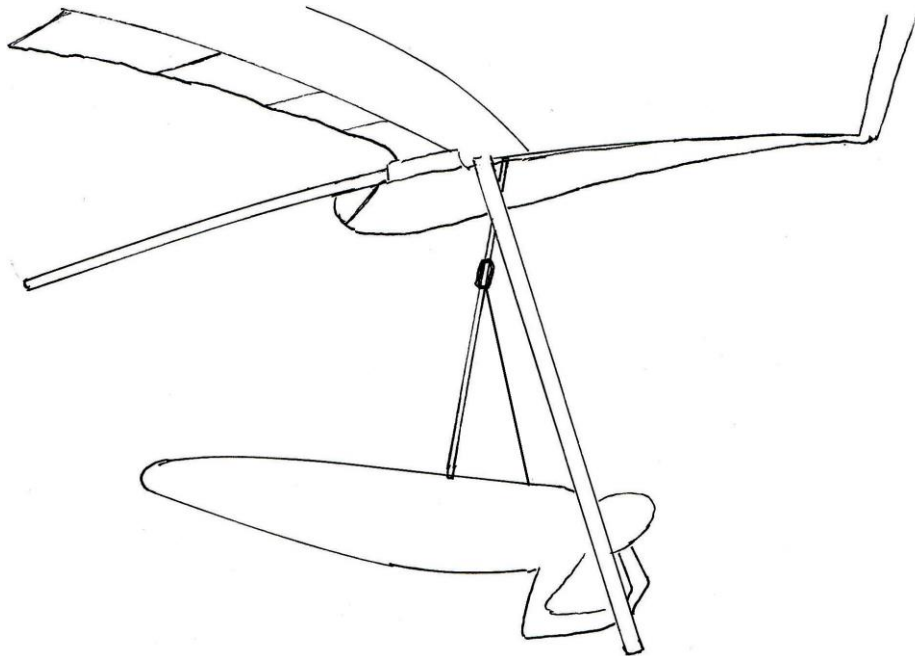
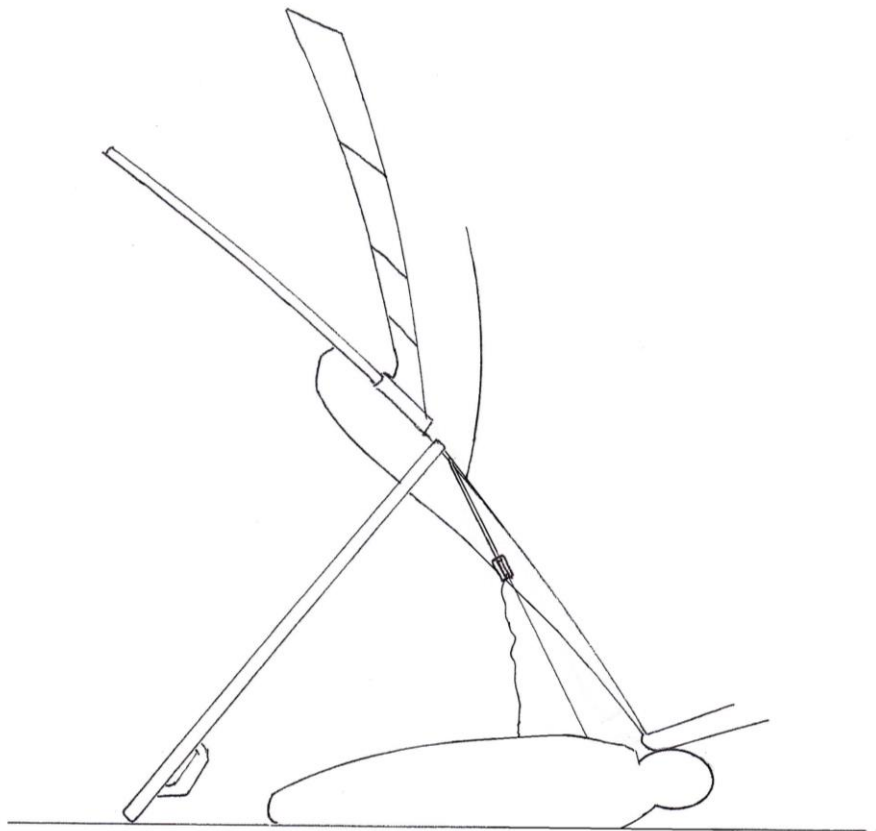
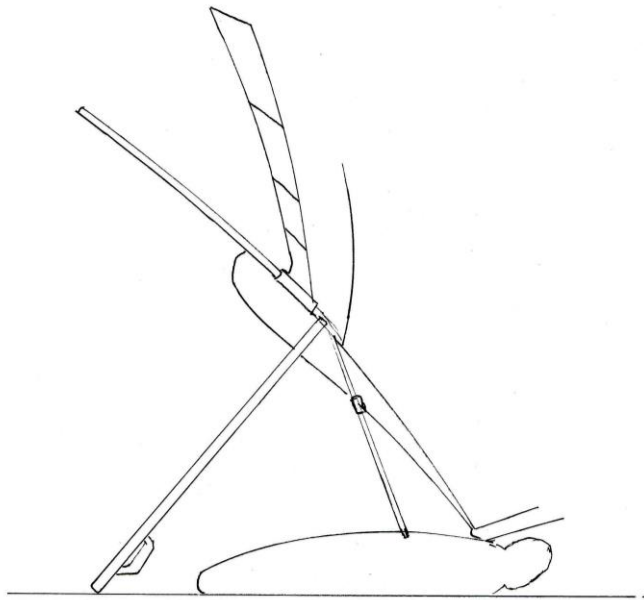
Attention then focussed on the harness design. This harness, like various other modern performance-orientated 'single hang strap' designs, was found to allow the pilot to get his head in front of the glider's nose in an accident.

Picture 20: Diagram illustrating the range of movement possible with this glider / hang strap / harness geometry. (Final picture show result if tilt angle cord slips under crash load.)

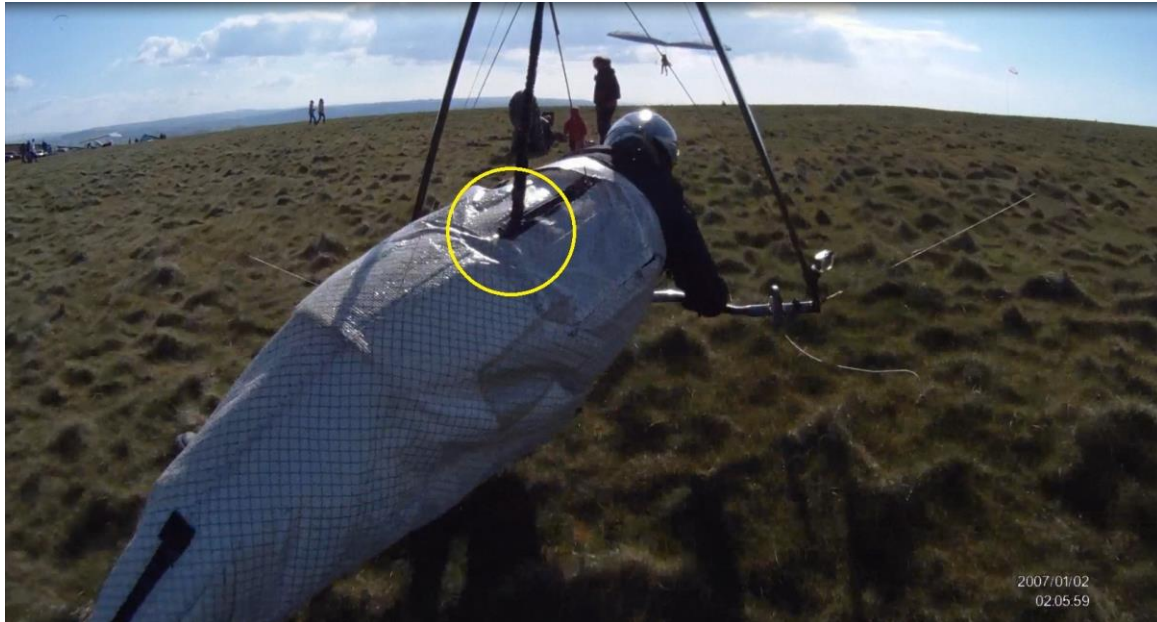
Picture 21: Pilot A: Slider fully back, hands on base bar

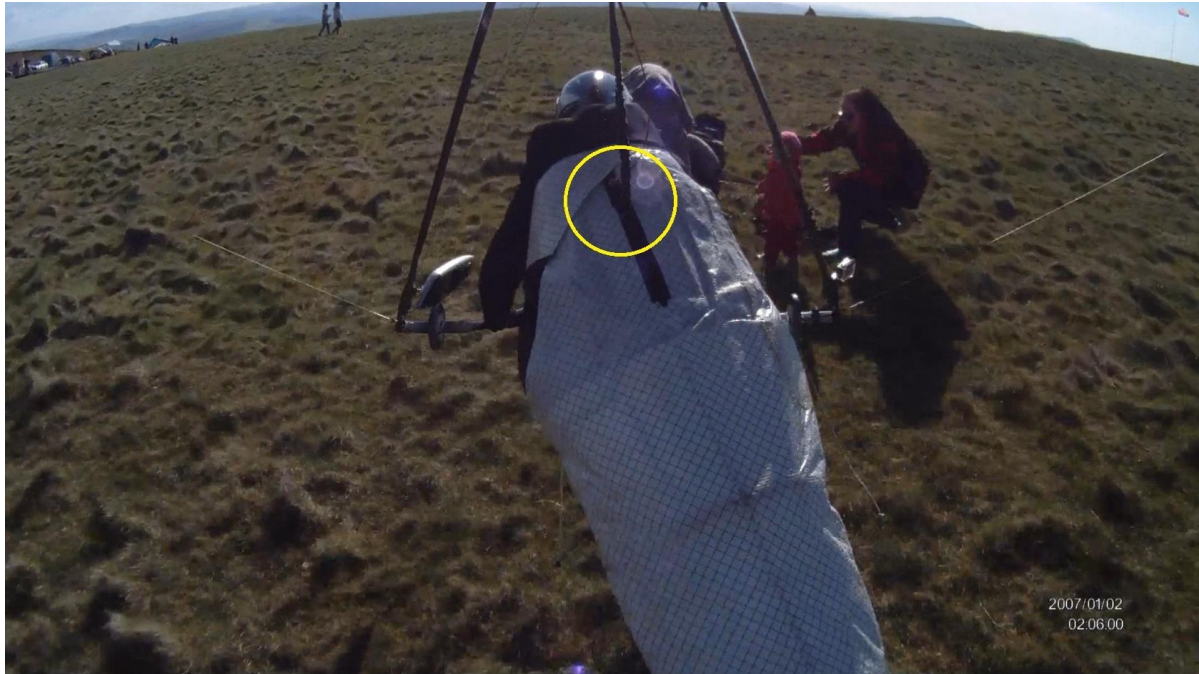
Picture 23: Pilot A: The moment the slider moves forward, shoulders up, hands still on base bar

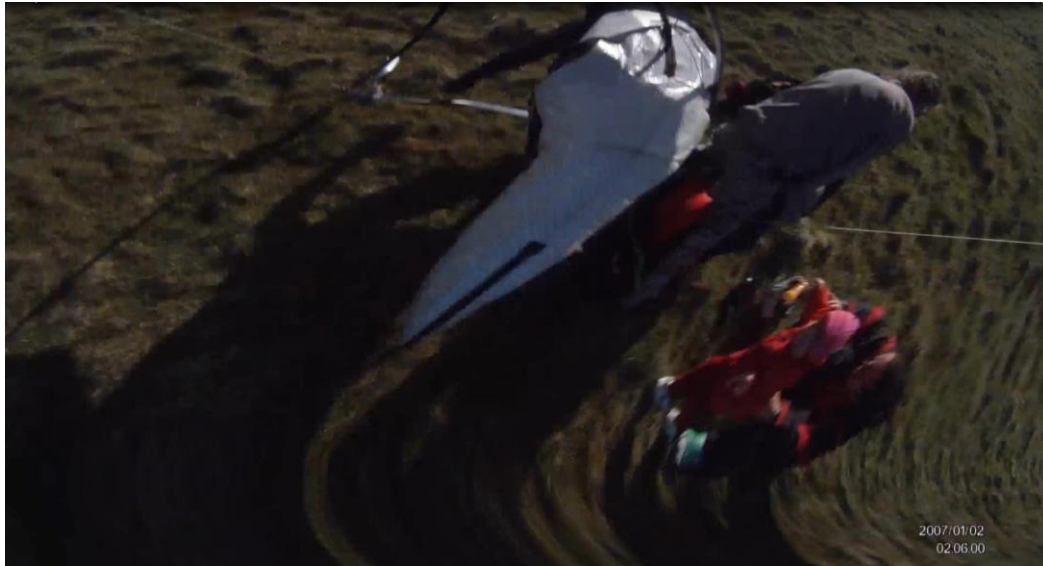
Picture 25: Pilot's hands on base bar during impact. (This image has been distorted by the speed of rotation of the camera.)

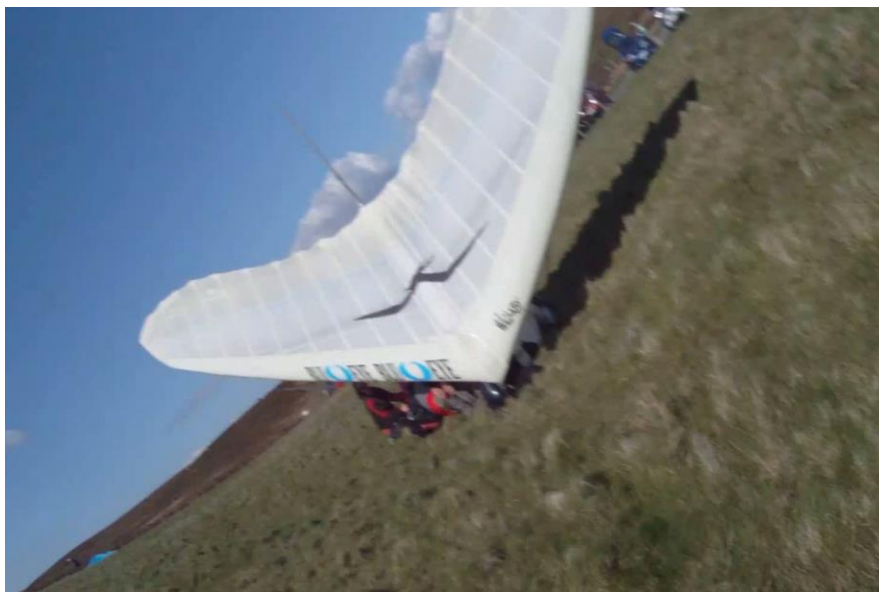
The puncturing of the nose cone indicates that the glider's nose came down with considerable force and hit the rear of the helmet. This may have driven the helmet tail into the vertebrae. Whether the glass-fibre helmet 'tail' would have spread, absorbed or concentrated this force is a matter of conjecture. Other possibilities are that the glider nose's impact with the helmet led to a twisting injury, or that the top edge of the carbon fibre back plate in the harness was driven into the area during the impact. Or that the damage was caused by the pilot's body continuing forward after the pilot's head had impacted the ground. However, the pilot clearly recalls feeling a sharp blow to the back of his head, and given that the video still clearly shows the glider's nose down in this area, the helmet tail being driven into the neck seems the most likely explanation.

Picture 26: Pilot A: Hang glider nose down behind pilot's head.

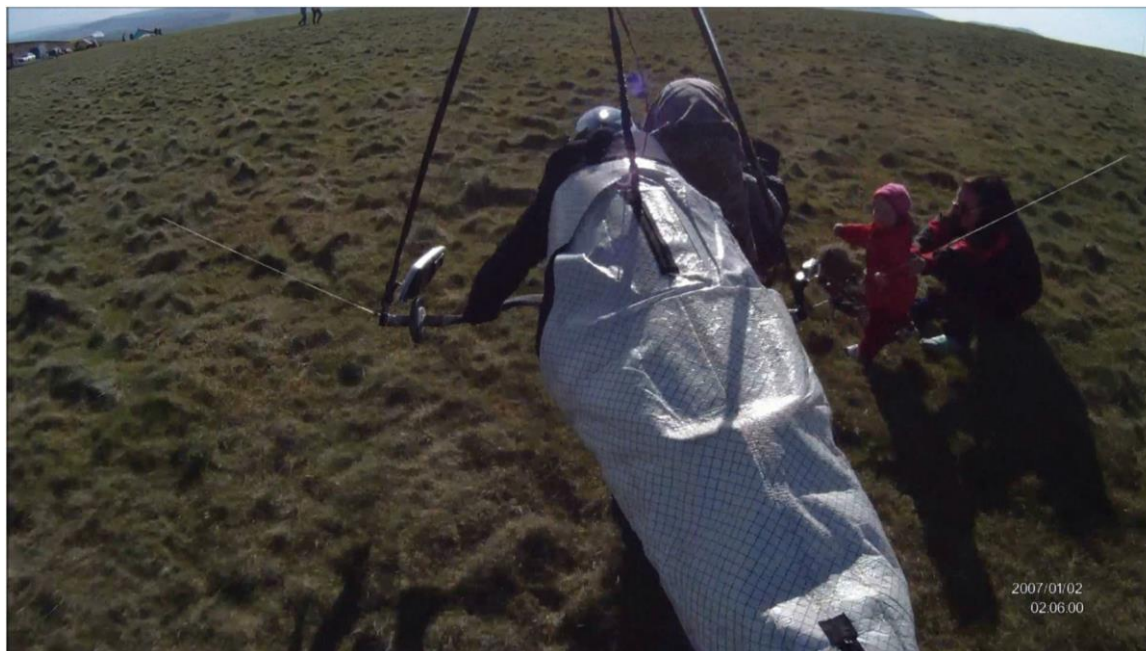
It is also clear from the footage from the onboard camera that a very different accident was narrowly avoided by the mother pulling her young child (toddler) back to safety. Even so, the corner of the glider's control frame passed in line vertically and approximately a metre horizontally away from the toddler's head, at flying speed.

Picture 29: Mother snatches toddler back.
