British Hang Gliding and Paragliding Association

REPORT

**Investigation of a paragliding incident
which occurred at Chetwynd airfield,
on 26th August 2013
in which the pilot suffered serious injury.**

BHPA investigation serial number: IR 13/123

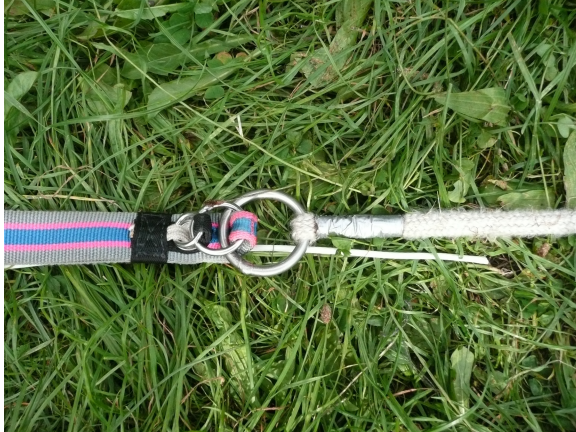
Photo 1. Showing Y bridle release system.

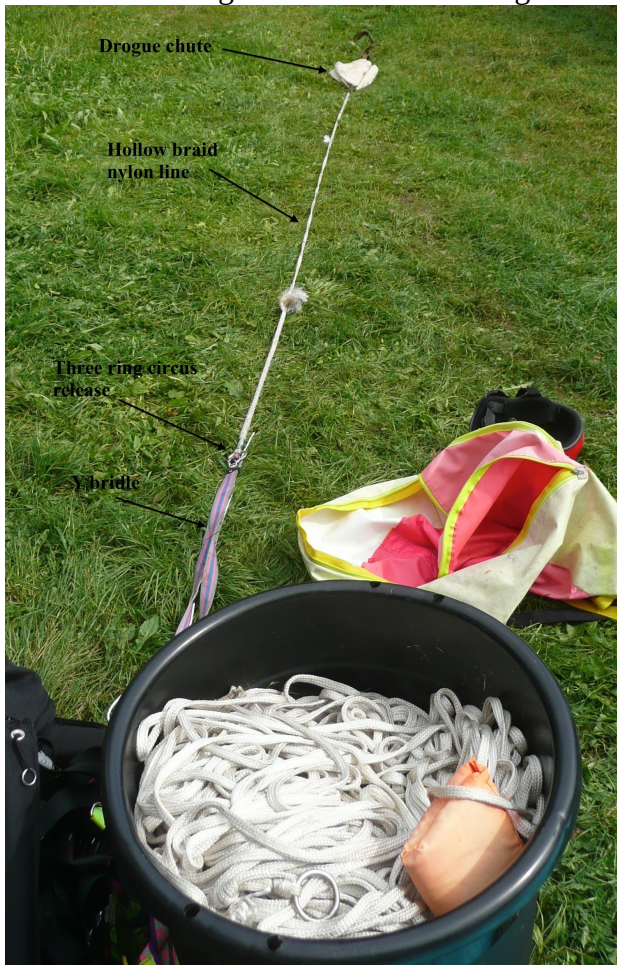
Photo 2. Showing bridle attached to drogue chute.

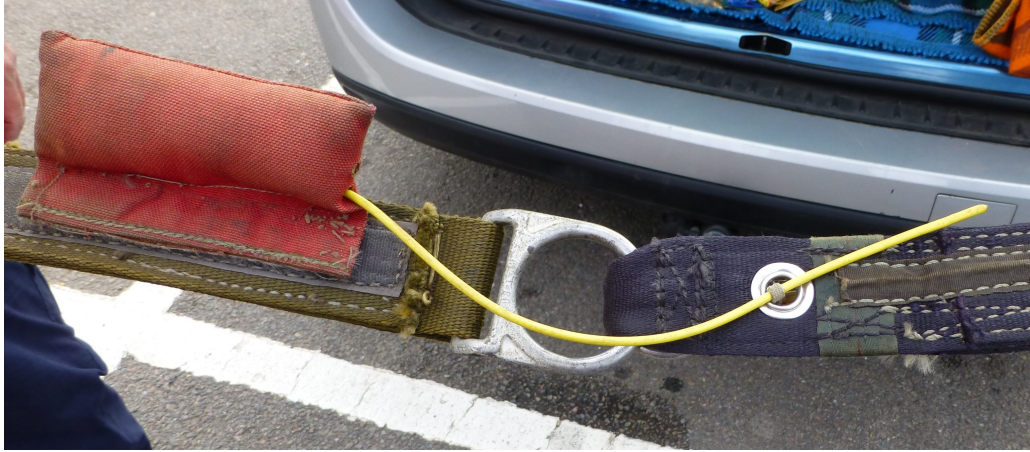
Photo 3. Showing 3 ring circus back-up release.

The CFI highlighted a problem with the Gibbs mechanism in that it failed to release when he realised there was a problem and attempted to release the tow line. This is discussed in more detail in the analysis section of the report.

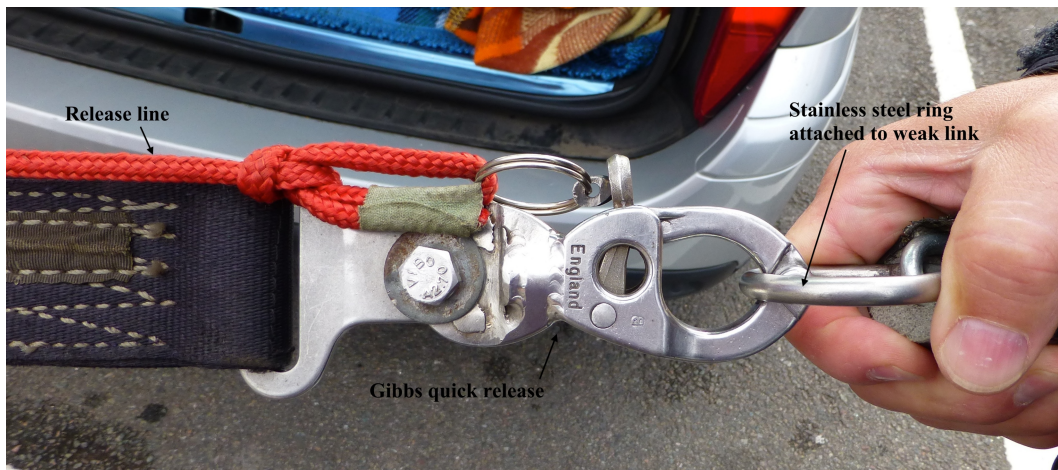
The Gibbs quick release failed to operate correctly when the CFI made the decision to cut the towline at the vehicle end and again when tested by BHPA investigators. A direct comparison test was subsequently made with an identical unit known to function correctly. Once again the incident Gibbs release failed to operate correctly whereas the unit used for comparison did. It proved impossible to visually identify the difference between the faulty Gibbs release and the release used for comparison. The unit has been sent for further testing.

Photo 4. Showing Gibbs release mechanism with towline attached via weak link.

The weak link used was a Tost green 300daN type. For the purposes of tow paragliding the BHPA Technical Manual states that;

With the ‘all up’ weight of Pilot A being approximately 110kg, the weak link should have had a value of 125daN or less. Given the tow tensions used (see below), a correctly calibrated weak link to the specified value of 125kg would have failed, thereby preventing the excessive tow force.
