# REPORT

**Investigation of a paragliding (mini-wing) accident  
which occurred at Pendle Hill, Nr Clitheroe  
on 4<sup>th</sup> December 2013  
which involved the death of the pilot.**

BHPA investigation serial number: IR 13/155

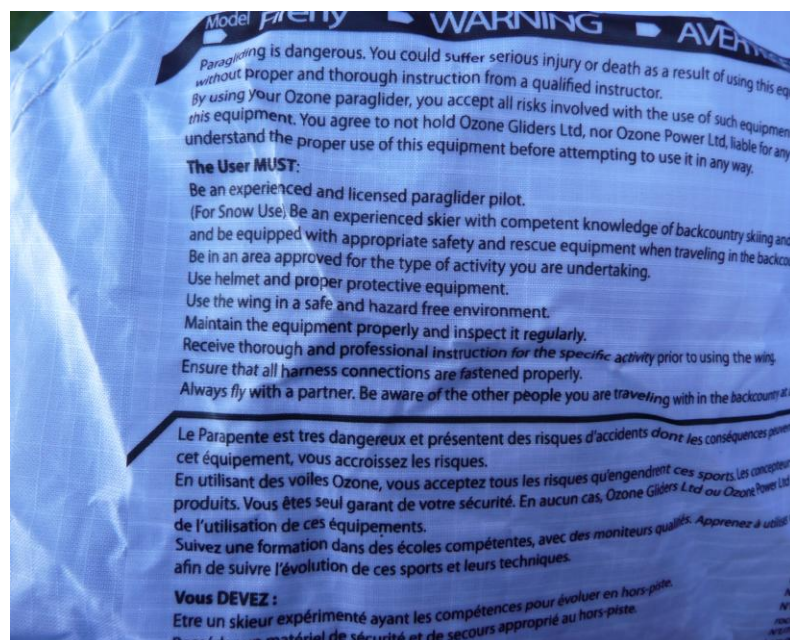
Fig 2: Warning label on Pilot A's canopy.

The glider had a warning placard attached, with information which was also included in the Owner's Handbook for the glider. This is reproduced below:

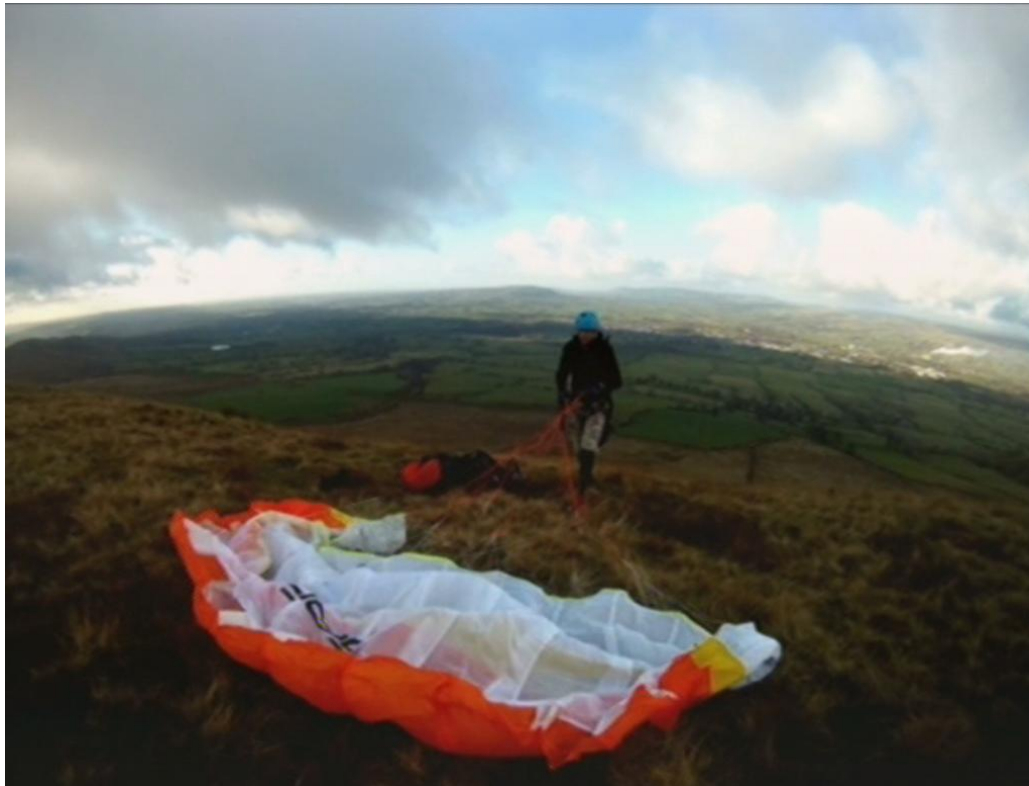
Fig 4: Weather conditions as Pilot B prepared for flight.

Pilot B has stated that the wind direction was WNW (West-North-West) and the wind speed estimated at 5-10mph on arrival at the launch point and 12-17mph at time of Pilot A's launch/accident. (The video evidence supports the 5 – 10mph initial wind strength estimate.) He noted that the wind was increasing in strength from the time of arrival at the hill top to the time of the accident.

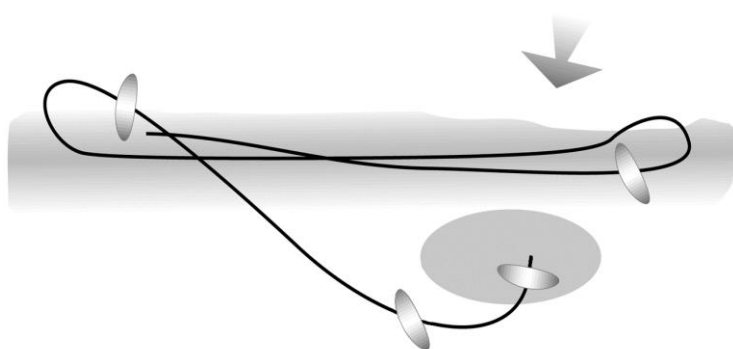
*Fig 5: The 'Crosswind Crabbing Approach'.*

Pilot B states that Pilot A had commenced what is believed to have been a landing approach by flying downwind from the ridge face. This would presumably have been followed by two left 90° turns to bring him back into wind for landing. This is the classic aircraft type landing circuit. (It is also possible that Pilot A was planning to make a single 180° turn back into wind.) Experience from over thirty years with hang gliders and paragliders has shown that the classic aircraft circuit type approach and the 180° turn variant are both totally unsuitable for top landings. They both involve the glider flying downwind, generally at very low altitude, and having to make significant steep turns whilst descending in wind gradient. Also, the vastly increased speed over the ground (in this case in the order of 50mph when flying downwind), and resulting space used when making a turn, leads to pilots making increased aggressive control inputs, which can in themselves lead to departures from controlled flight. Many accidents resulted from this in the early days of the sports. Trained paraglider pilots are taught a method of top landing that is called the 'crosswind crabbing approach'. At all stages during this type of approach the canopy is flying facing largely into wind. Only one very small turn is required.
