**British Hang Gliding and Paragliding Association**

# **REPORT**

**Investigation of a paragliding incident  
which occurred at Edge Top,  
on Friday 31<sup>st</sup> July 2015  
in which the pilot suffered fatal injury.**

BHPA investigation serial number: IR GBR-2015-2327

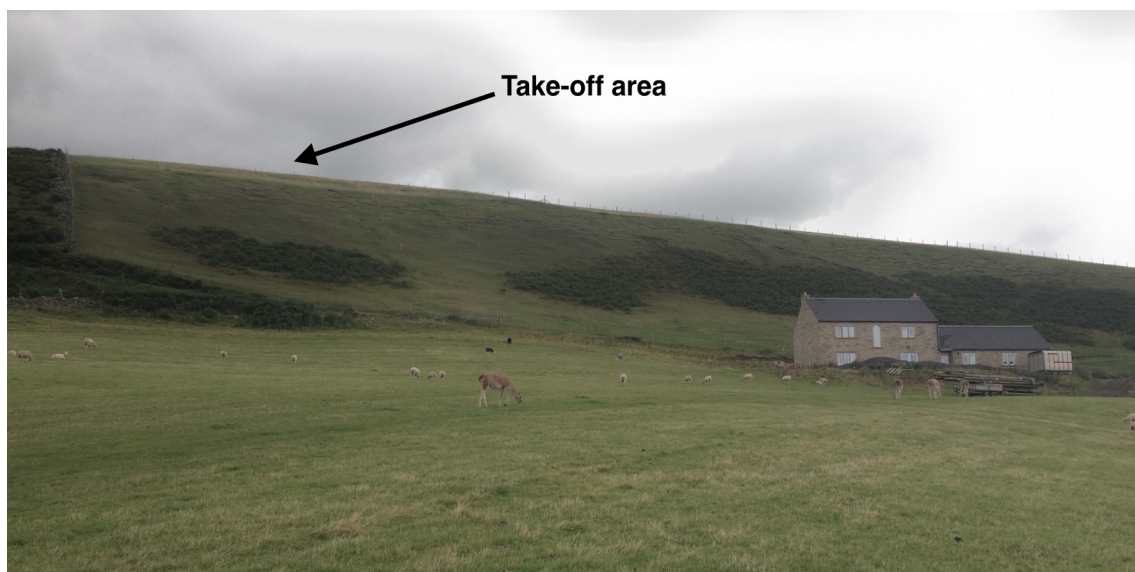
Photo 1.

The site, known locally as Edge Top, is situated approximately one mile southwest of Hollinsclough in the Peak District national park. OS Grid reference SK055657. The ridge is approximately 2km long and faces in a southwesterly direction. There is a slight shoulder a few hundred metres north west of the take-off area, beyond which the ridge faces west southwest. The high point of the ridge is 424m as marked at the trig point, situated behind the launch area. The landing area is some 40-60m below depending on the field chosen. There is a farmhouse and a number of barns and outbuildings at the foot of the hill in the area below take-off. The ridge forms one side of a valley, which is approximately 2km wide. The ridge on the opposite side is higher, being over 500m in places. Photo 1 shows the view looking back up towards take-off with the farmhouse in the foreground.

The site known as Edge Top was historically a hang gliding site. It was chosen predominantly as its location provided easy vehicular access to the take-off area. However, there are a number of hazards that make the site less than favourable from a paragliding point of view. The ridge is one side of a relatively narrow valley. The opposite side of the valley is significantly higher and the terrain between is undulating. In stronger winds this will inevitably result in terrain induced turbulence. There is also a large farmhouse with a number of large barns situated at the foot of the slope, adding to the probability of turbulent airflow. The site is known to be thermic in sunny conditions and also to be affected by wave in stronger winds. Under the “Hazards” section of the Peak Soaring Association sites guide it is noted that, “The site becomes extremely bumpy at wind speeds above 20mph”. This is certainly the case, however, the description was written long before the buildings at the base of the hill were constructed and with hang gliders in mind. Given the factors mentioned, it is likely that flying at Edge Top could be potentially turbulent and therefore dangerous to paragliders with wind speeds well below 20mph.

The investigation recommends the Peak Soaring Association reviews and where necessary, updates its sites guide.

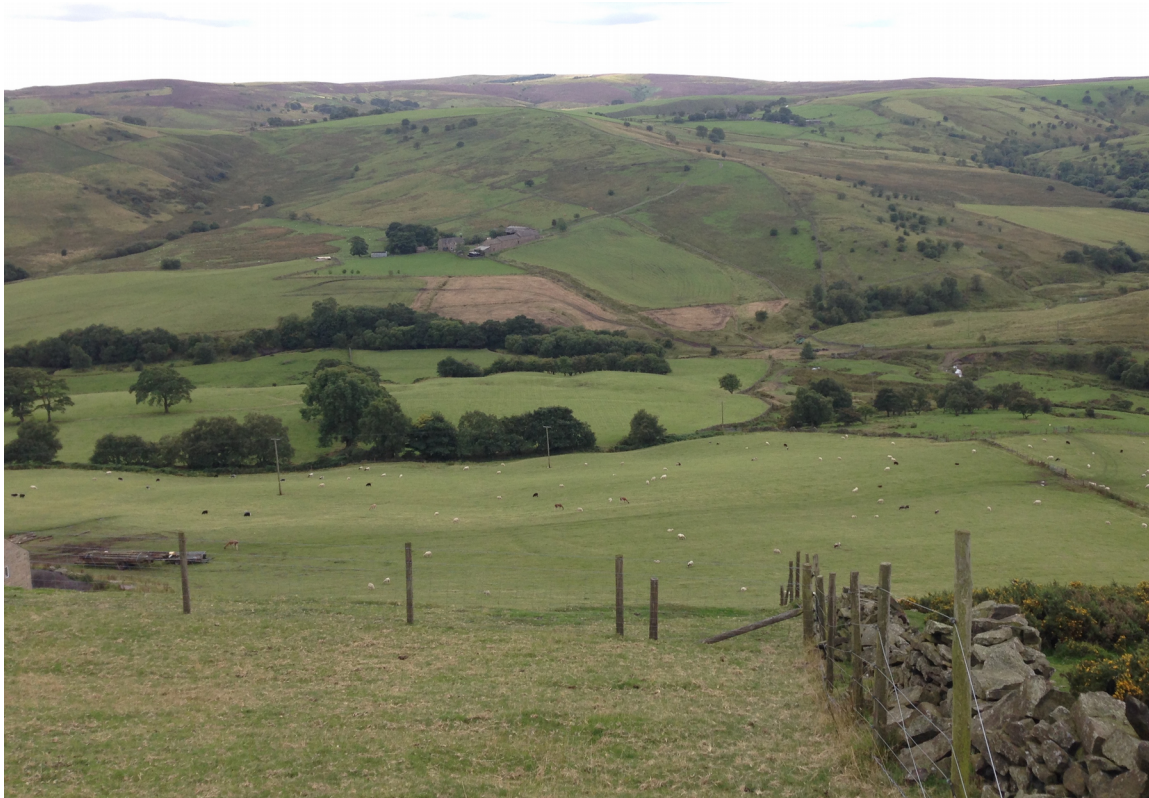
Photo 2. shows the view in a south-westerly direction, looking out from the area to the west of launch, close to where Pilot A hit the ground.
