British Hang Gliding and Paragliding Association

FORMAL REPORT

Investigation of a hang gliding incident, which occurred at Chabre Mountain, Laragne, France, on 22nd June 2016

BHPA Investigation serial number: IR GBR-2016-3434 Ratified 15th February 2017.

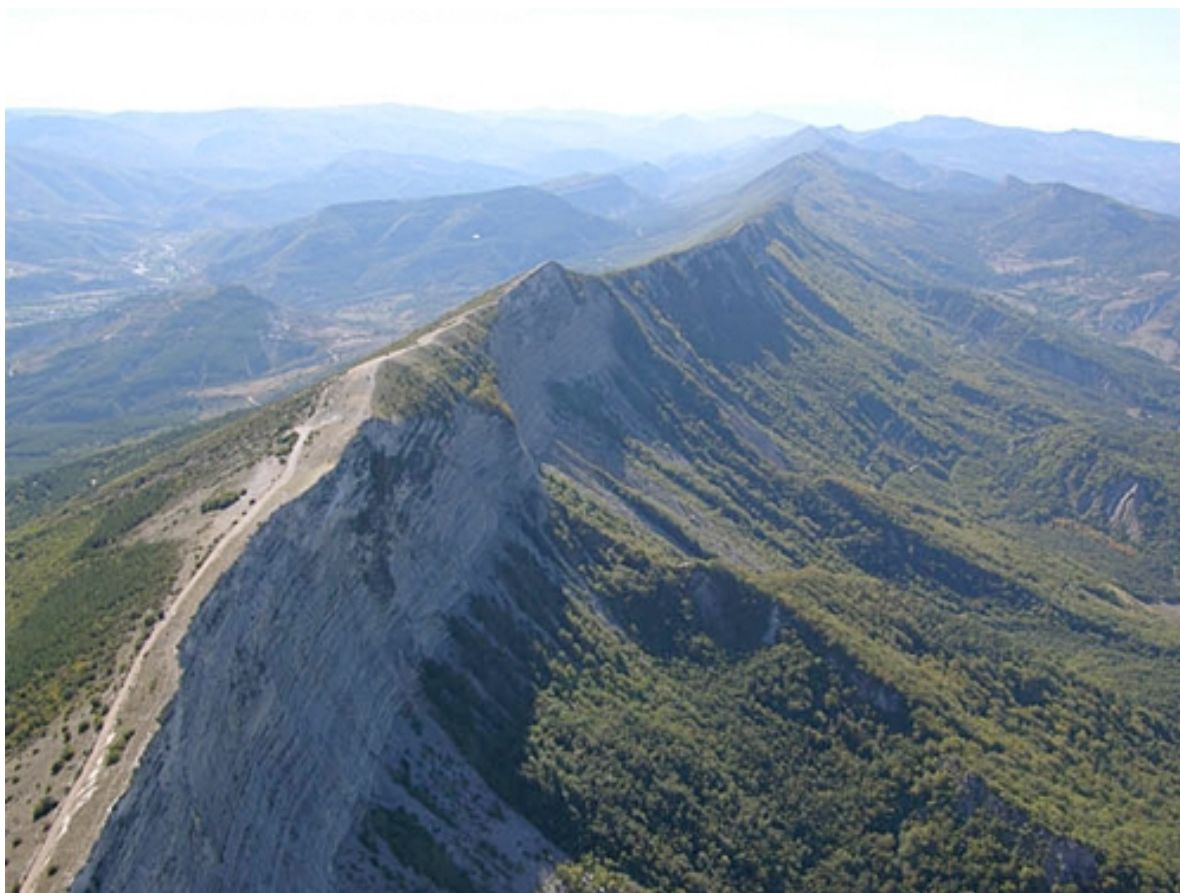
The site has a “spine back” with the northerly side comprising a steep wooded slope with a 200m (650ft) near-vertical cliff face at the top and a steep scree slope at the foot of the cliff (see Photo A).

Photo A. Chabre ridge. From the north side looking west.

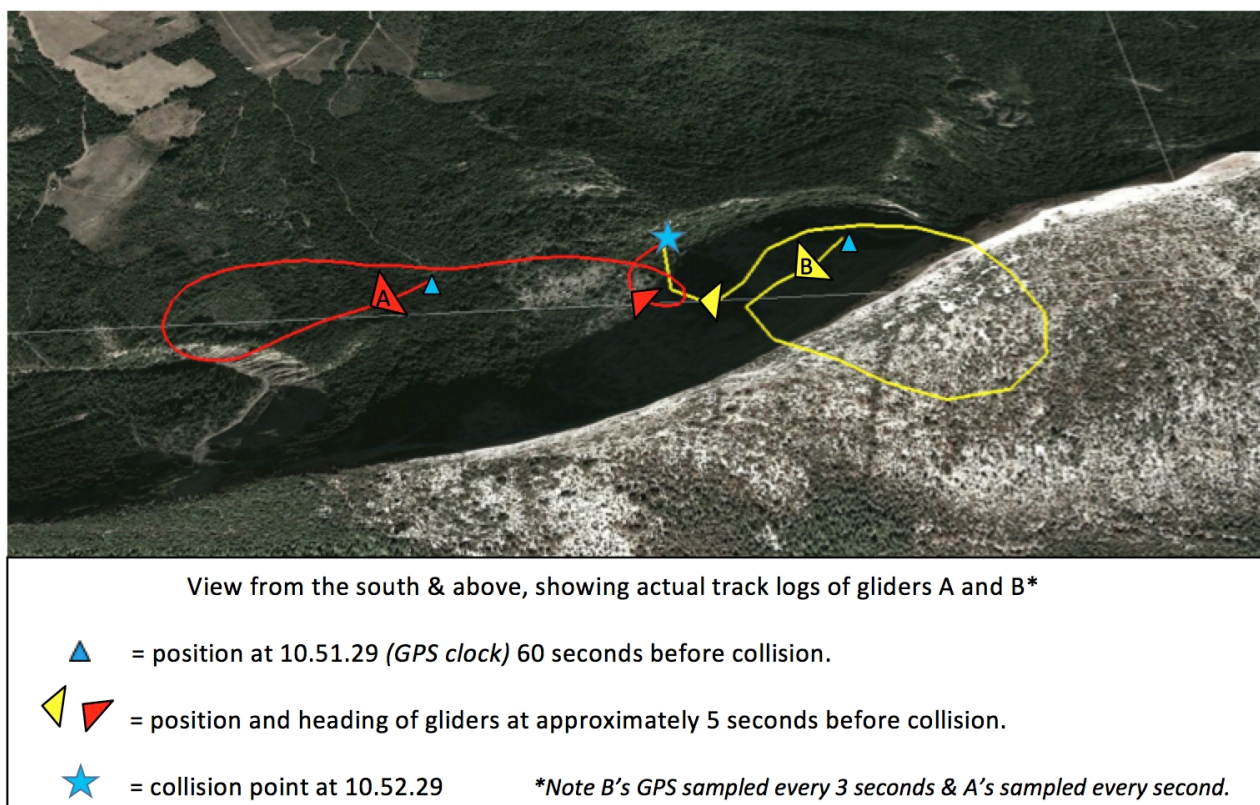
- 2.4.3** At the same time Pilot A was flying along the ridge in a westerly direction. Pilot A then turned back along the ridge and proceeded to track on an easterly path above the ridge for approximately 30 seconds. During this easterly track Pilot B was within his field of vision and slightly to his right. Refer to Figure 1 (below).

Figure 1. Visualisation of the tracks of both aircraft during the minute before the collision.

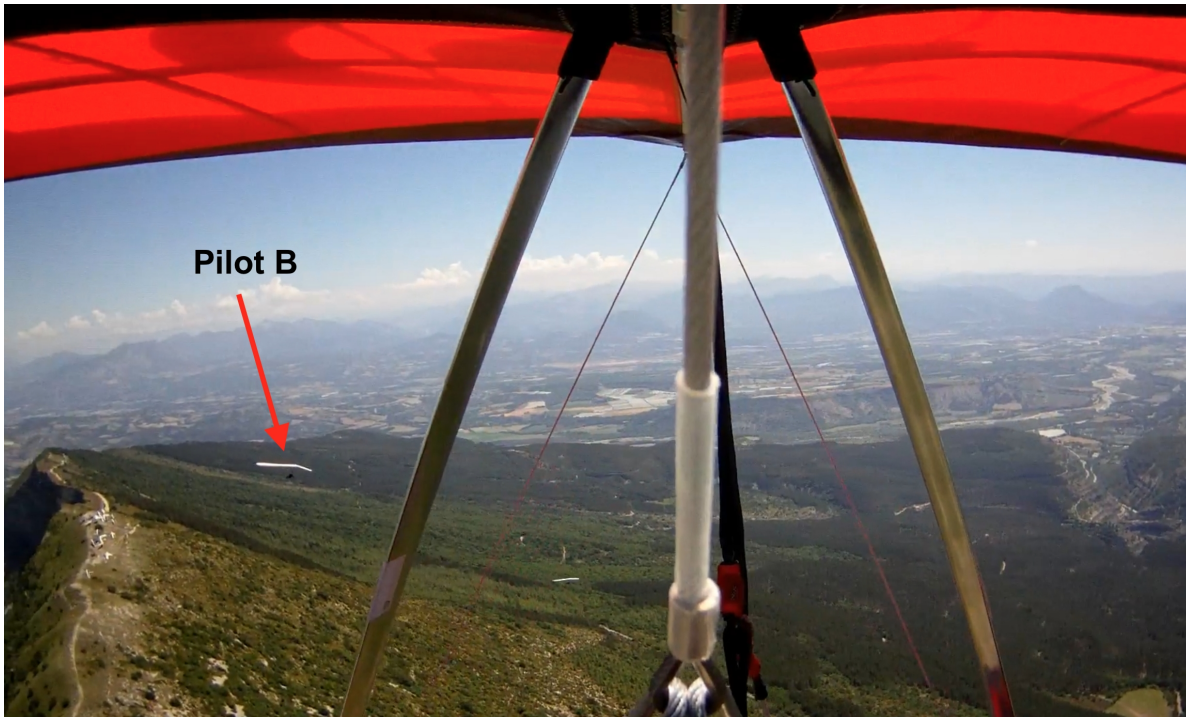
Photo B. Still shot taken from camera on Pilot A's glider approximately 15 seconds before collision. (Pilot B has been highlighted)

2.4.5 At this point both pilots should be aware of the other and should be considering the other pilot's position and track before committing to a manoeuvre. Once committed, they should also be monitoring the whereabouts of the other pilot in order to maintain a safe clearance and thereby reduce the risk of a collision. (Refer to Photo B above).

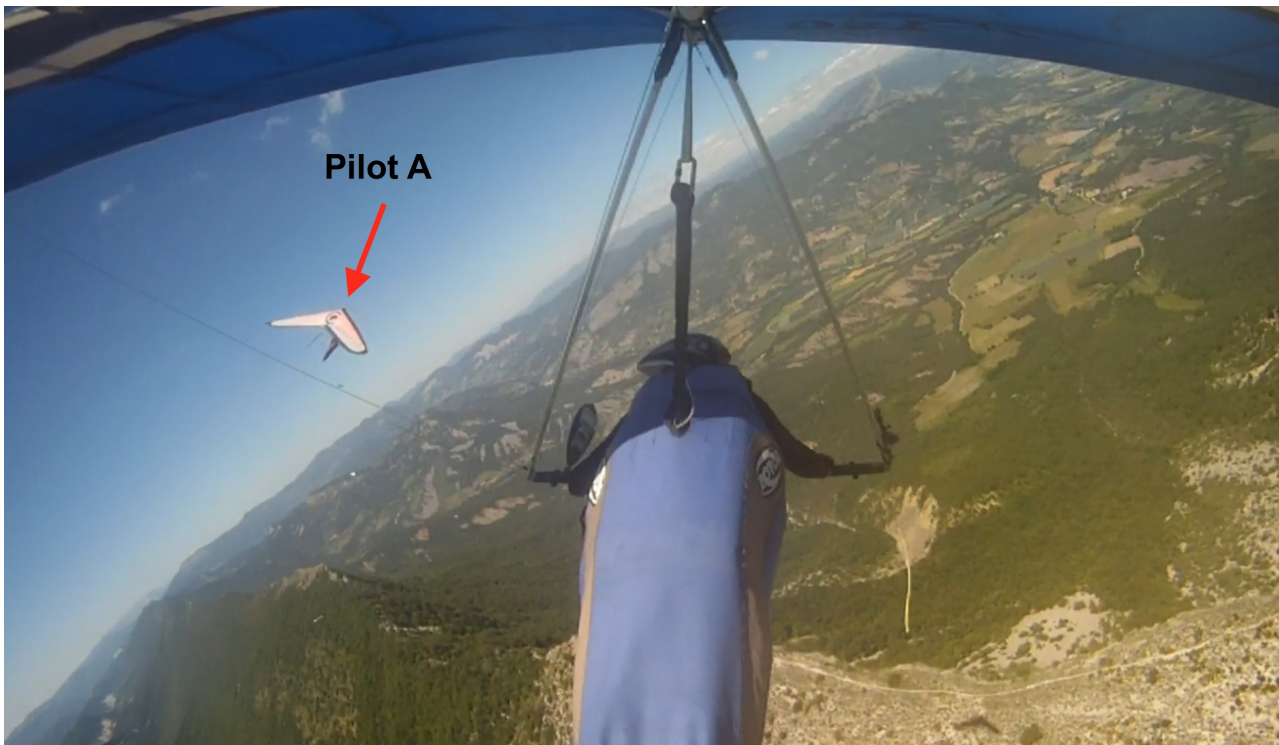
2.4.7 When Pilot A started his turn, Pilot B was in front of him and in his field of vision. As Pilot A continued his turn round in a westerly direction, Pilot B was then to his rear and therefore no longer visible to him. As Pilot A continued his turn round to the north he would have had the opportunity to see Pilot B to his right over his right shoulder had he maintained a lookout and checked the airspace in which he was turning was clear. At approximately 4 seconds prior to the impact, there was a period of 2 seconds where Pilot A's banked right wing obscured his view of the section of sky containing Pilot B. (Refer to Photo C below).

Photo C. Still from Glider B approximately 2-3 seconds prior to the collision. Pilot A can be seen on the left, with the position of Glider A's wing obscuring Pilot A's view of Glider B.
