# British Hang Gliding and Paragliding Association

## REPORT

Investigation of a paragliding incident, which occurred at Jhatingri Pass, Pradesh,  
India on 14th October 2016  
In which one pilot was involved and suffered fatal injuries.

BHPA investigation serial number: GBR-2016-4096

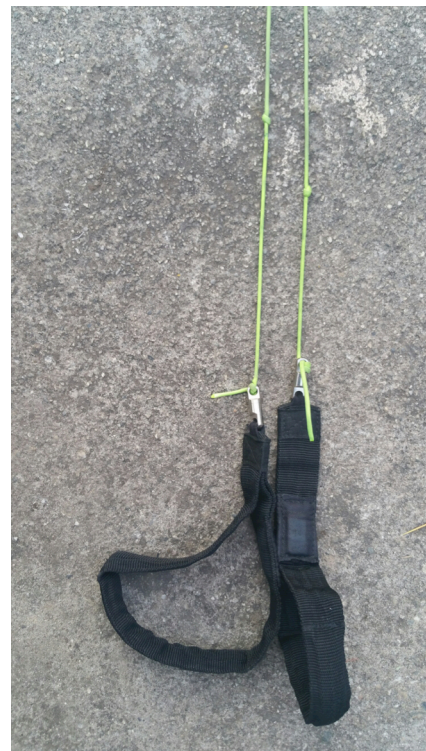
2.3 The investigation considered state of trim of the BDG Tala paraglider. During a subsequent inspection carried out by Aerofix, (an independent inspection and servicing company), it was found that the “C” lines, especially C 3 (the outer C’s) were significantly shorter than the manufacturers specification. In addition the investigation noted that witnesses stated that the control lines were also significantly longer than specified. These were photographed and measured by Pilots B and C after the incident and reported to be 140mm and 105mm longer than specified. After the incident Pilot B had re-set the control lines, so the investigation was unable to re-check these figures. There is no information on when, if ever the glider had last been checked.

*Photo B. The control lines of Glider A photographed after the accident. The knots (made by the pilot) reportedly indicate the correct length specified by the manufacturer.*

Pilot B states that he believes that Pilot A had his control lines wrapped around his hands at the time of the incident and did often fly with this configuration.

Pilot B and pilot C both note that it appeared that the glider could not recover properly as it was in the state known as “deep stall”. This is usually only possible when the pilot is over-controlling with too much input, or the glider is incorrectly trimmed.

The investigation considers that as pilot A was probably flying with wrapped control lines, and the reduced C line measurement places the glider out of trim, that these factors may

possibly have affected his ability to regain control, shortened C lines have the effect of increasing the gliders trimmed angle of attack and may have been a contributory factor to the gliders' failure to recover from its deep-stalled state.

4.1 The investigation recommends that through the medium of the national association's magazine, pilots be reminded of the hazards of out of trim gliders, or modifying the control line lengths of paragliders, and that altering any dimension places the glider outside its tested and certified configuration.
