# **British Hang Gliding and Paragliding Association**

## **REPORT**

### **Investigation of a Powered Paraglider incident which occurred at Stanton under Bardon, Leicestershire, on 19<sup>th</sup> February 2017 in which a pilot was fatally injured.**

BHPA investigation serial number: GBR-2017-4254

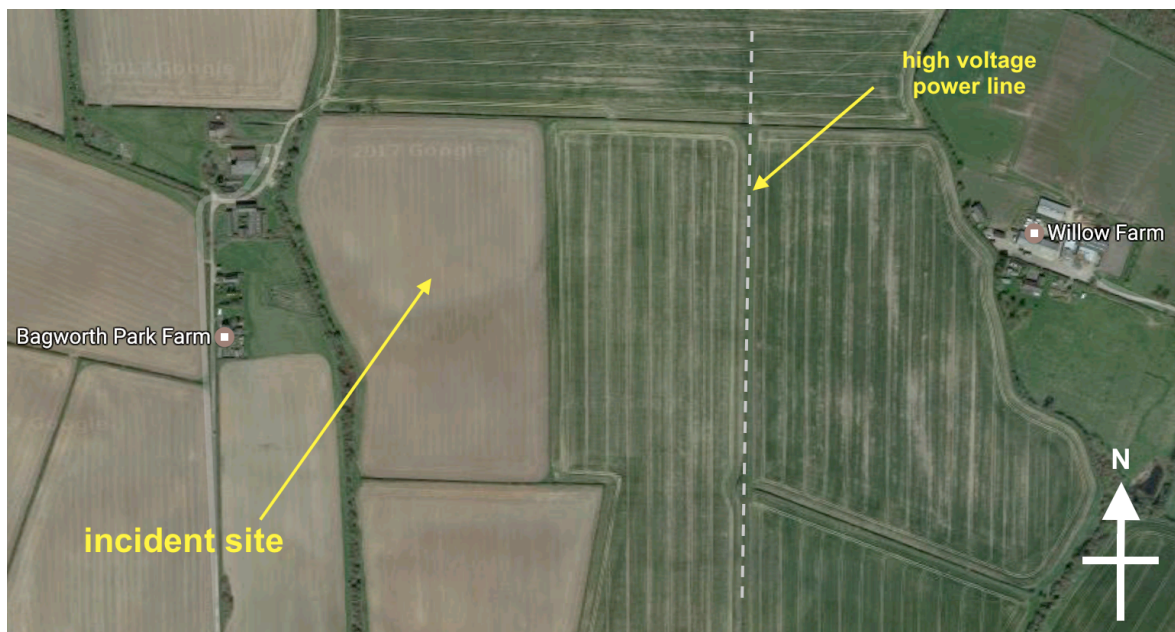
Figure 1

The incident site (see Figure 1, below) is a gently sloping field approximately 1.5km southwest of the village of Stanton under Bardon. It is surrounded by flat or gently sloping farmland. Apart from a line of high voltage power cables running approximately north-south at the far edge of the adjacent field, there are very few obstacles.
