BHPA Incident Report: GBR-2017-4623

INCIDENT

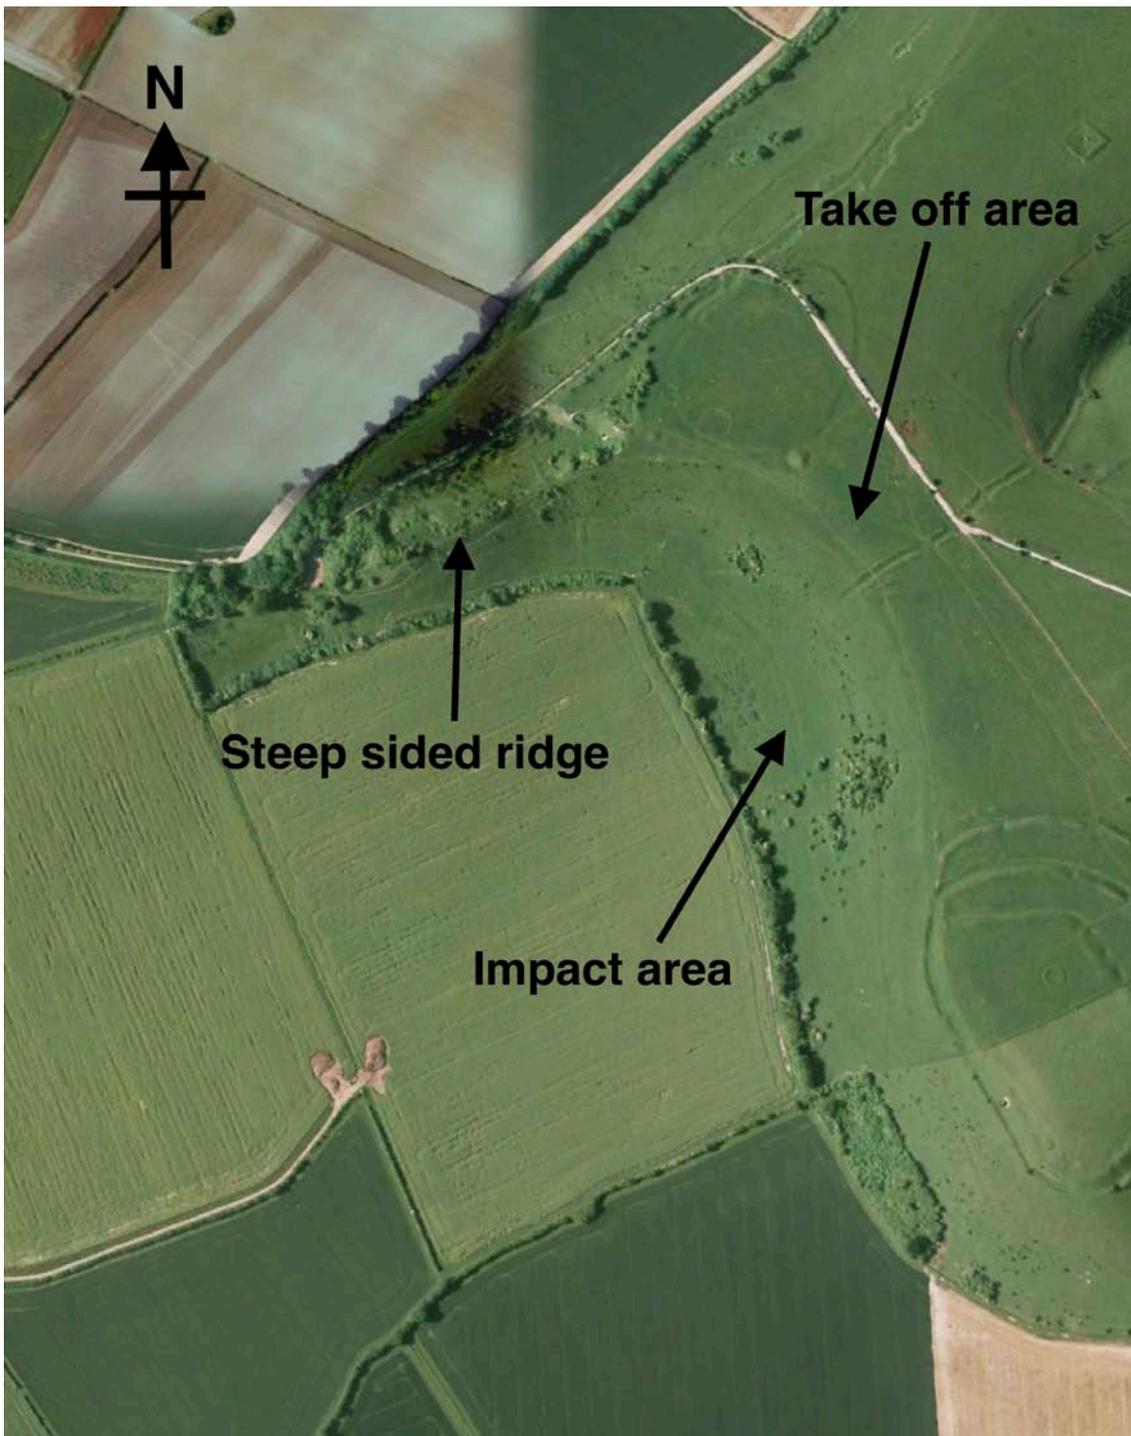
The bowl at White Sheet Hill faces in a southwesterly direction. See Photo below.

When the wind comes from the west, or north of west, it has to flow over the steep sided ridge shown on the left of the photo. This will give rise to extremely turbulent air in the area of the bowl.

The Investigation found that the incident occurred as a result of Pilot A taking off into turbulent air, in the lee of the ridge at the northern end of Spencer's Bowl, and losing control of his paraglider at a height from which recovery was unlikely.

The Investigation recommends that the Avon Hang Gliding and Paragliding Club review the entry in the site guide for Spencer's Bowl, placing particular emphasis on the potential severity of the turbulence when the wind is off to the north, and on the importance of clarifying the true wind direction before flying.
