British Hang Gliding and Paragliding Association

REPORT

Investigation of a paragliding incident which occurred at Gyrn Moelfre, Powys, on 14th June 2017 in which a pilot under training was fatally injured.

BHPA investigation serial number: GBR-2017-5189

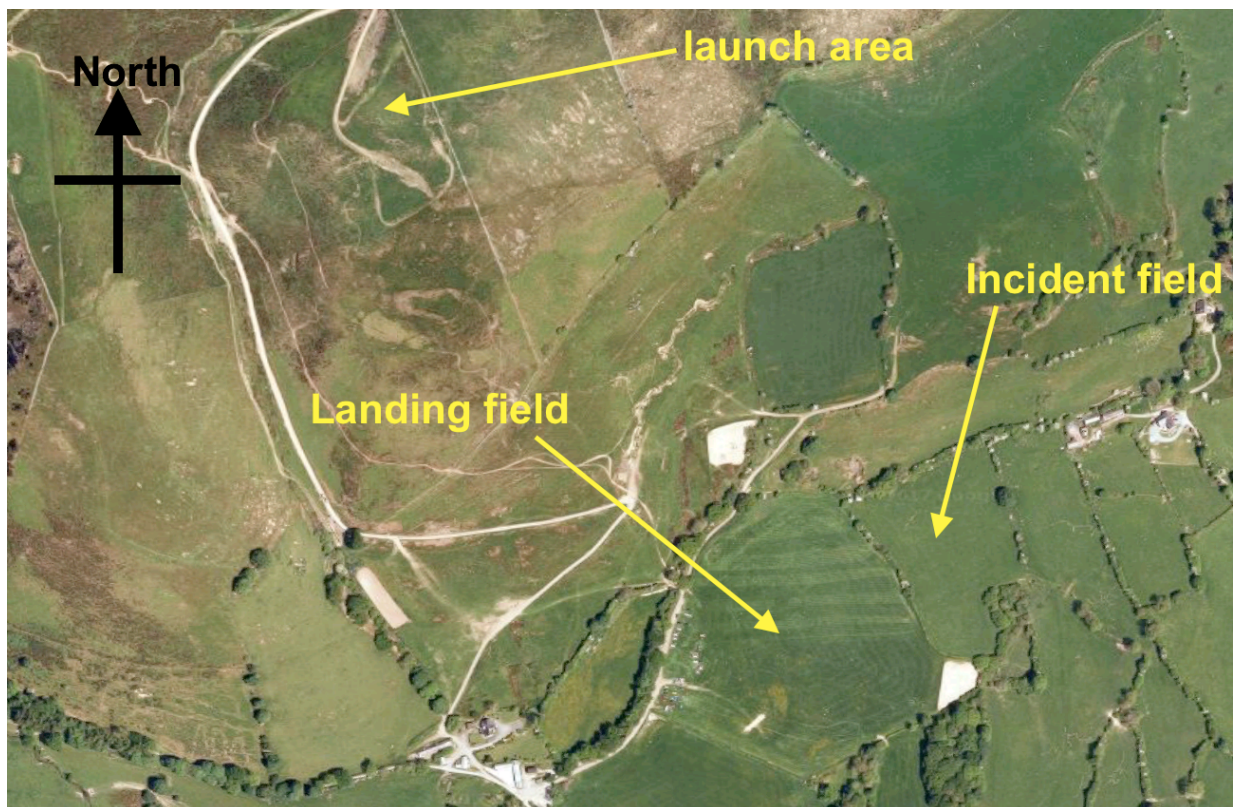
The landing field is a field at the foot of the hill that slopes gently downwards in a south-southeasterly direction. It is bounded by a line of trees at its northwesterly and southeasterly ends, and established hedges to the fields on its southwesterly and northeasterly sides (the latter field being the incident field), shown in Figure 1, below.

Fig. 1 (above) showing launching and landing areas, and the incident field.
