BHPA Incident Report: GBR-2018-8069

INCIDENT	Paragliding tandem incident.
Aircraft Type:	Niviuk Takoo 4, size 44 tandem paraglider fitted with Charly Quick-Out quick release karabiners. Niviuk Transat tandem pilot harness. Gin Safari-Passenger harness.
Certification:	EN-B
Manufacture Date:	April 2018. 20 hours.
Location:	Parlick Hill near Chipping in Lancs.
Date and Time:	11 th August 2018, 14:00.
Type of Flight:	Ridge soaring tandem flight.
Persons Involved:	Tandem Pilot, Pilot A. Passenger, Pilot B.
Injuries:	Pilot A suffered damage to his arm and shoulder. Pilot B suffered damage to her hands, arms and shoulder as well as significant spinal damage.
Nature of Damage:	No other damage.
Pilot's Rating/Licence:	Pilot A holds a BHPA Advanced Pilot rating and tandem licence. Pilot B holds a BHPA Pilot rating.
Pilot's Age:	Pilot A - 43. Pilot B - 42.
Pilot's Experience:	Pilot A gained his BHPA Club Pilot rating in September 2007. He gained his Pilot rating in January 2008 and his Advanced Pilot rating in June 2014 with an exam score of 94%. Pilot A gained his BHPA Tandem licence in July 2014. Pilot A is a registered Club Coach with the Pennine Soaring Club. Pilot A states that he has a

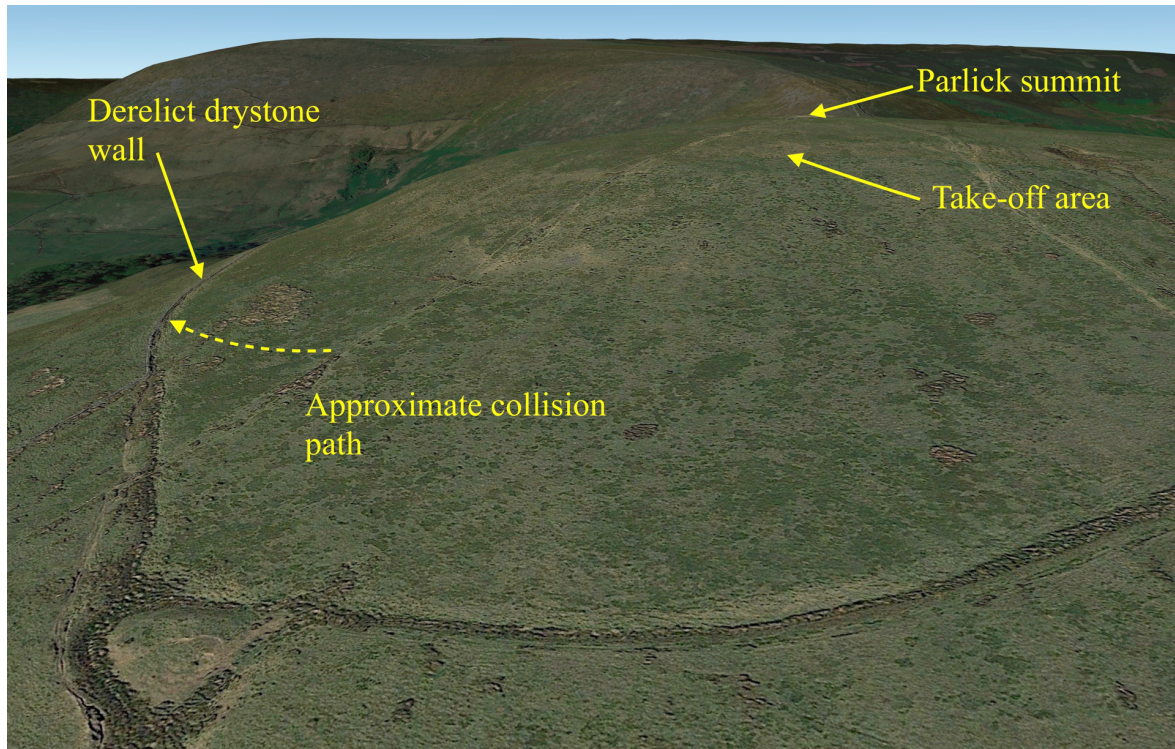
Parlick Hill south face

The following diagram shows a Google Earth image of the south face of Parlick Hill with the take-off and incident sites noted.

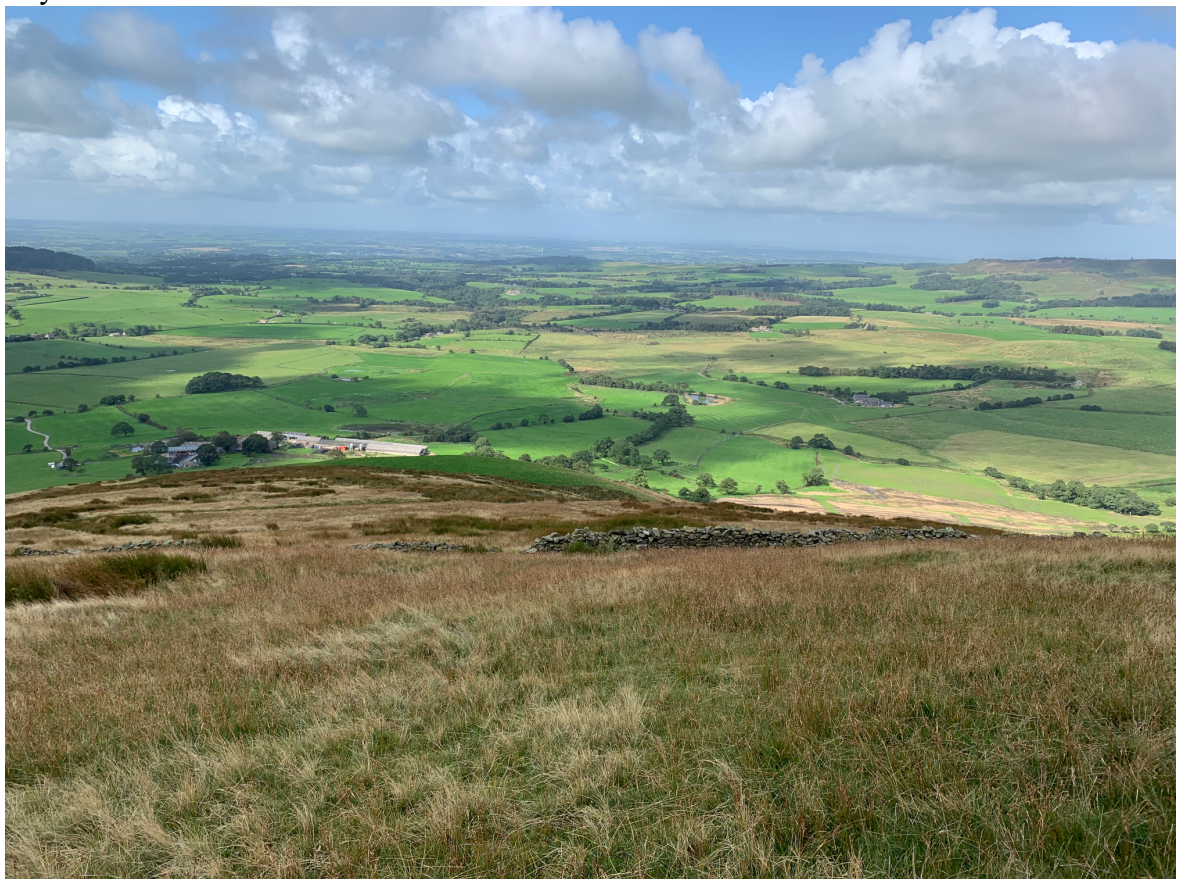
Parlick hill is a large landmass in the northwest of England. It has an east facing slope running south from Wolf Fell, a south facing slope at the southerly end of Parlick hill and a west facing slope running north from Parlick up to Fair Snape Fell. Parlick sits at a height above sea level of 432m giving a top to bottom of just under 200m. The hill is predominantly covered by moorland scrub with clumps of tussocky grass and is cut into large areas by fencing and drystone walls. To the southernmost end of the westerly face is a derelict remnant of a drystone wall. It is situated approximately two thirds of the way up the slope, running in a north south direction for approximately 200m. It is this wall into which Pilot A and pilot B collided.

Drystone wall as viewed from above.

The Investigation found that the incident occurred as a result of Pilot A losing control of the tandem paraglider and being unable to regain control before colliding with a derelict drystone wall. The Investigation considered that the loss of control was a direct result of Pilot A being caught out by a gust of wind, while kiting the glider back up the southwest face of the hill, which was considerably stronger than the prevailing wind conditions.

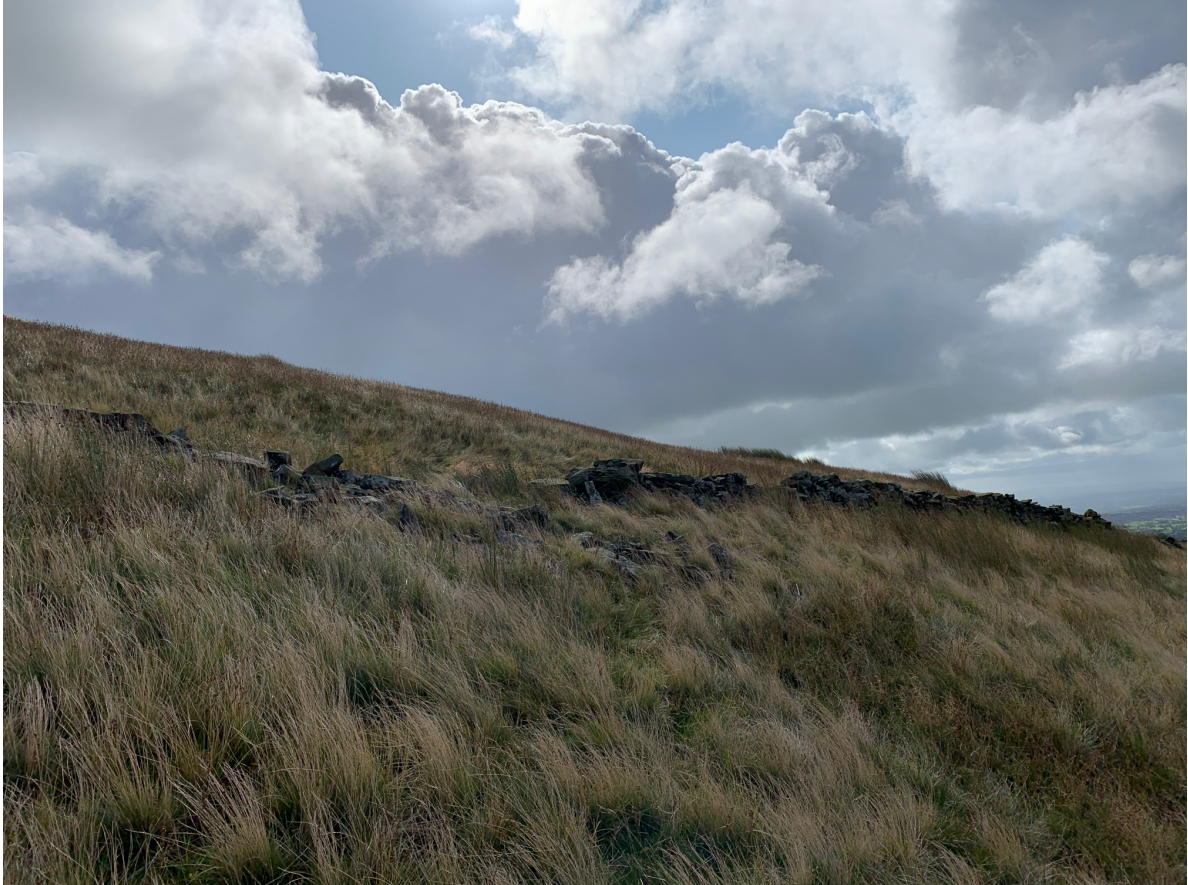
Drystone wall viewed from below.
