BHPA Incident Report: GBR-2022-22803

1.0 Synopsis

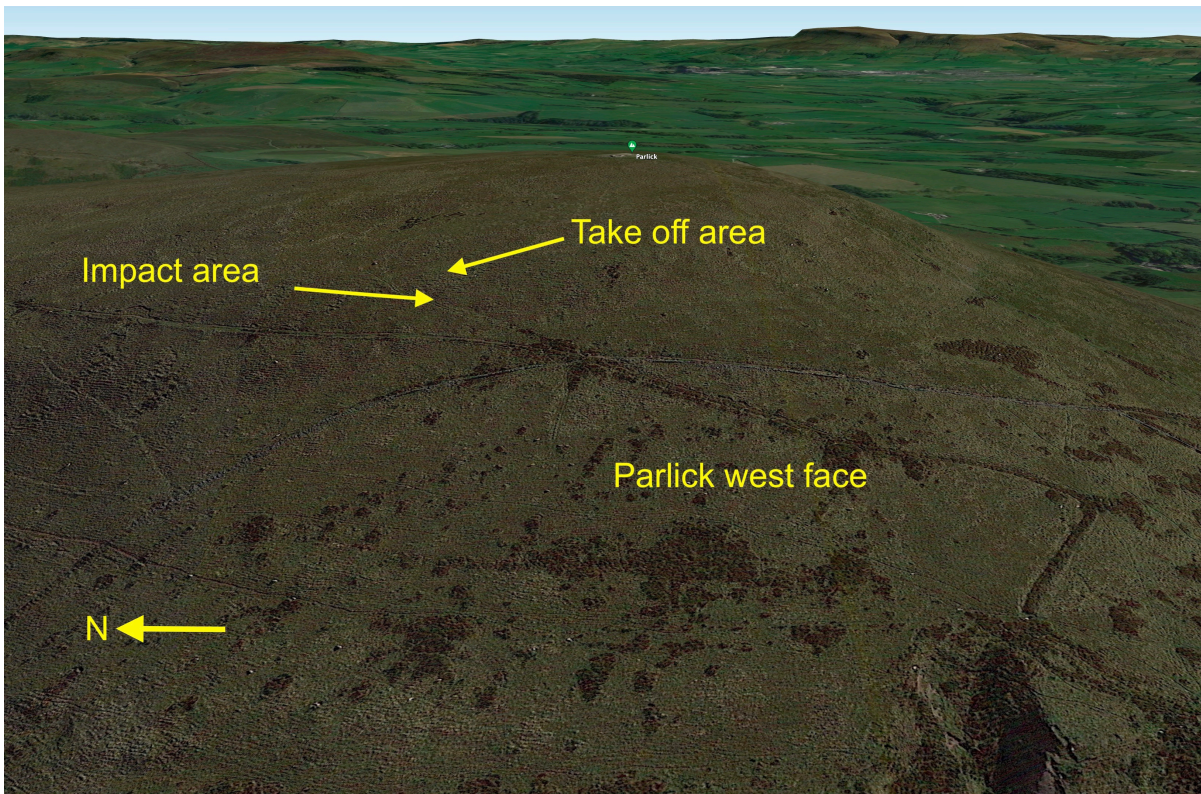
Parlick west face with take off and impact sites.

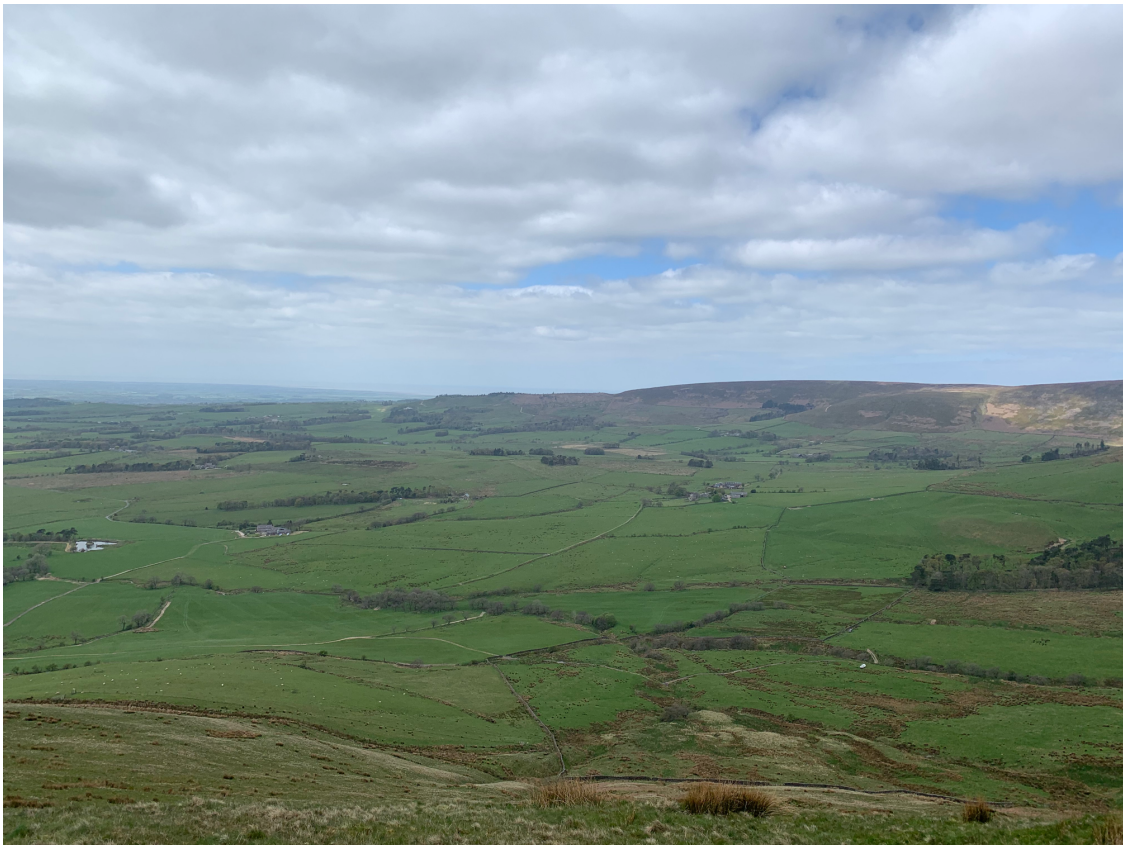
View from Pilot A's take off area looking to the west.

Though the ground is undulating with numerous small gullies, there is little of substance to cause any significant mechanical turbulence.

The Investigation did not consider the site to have been a factor in this incident.
