## **BHPA Incident Report: GBR-2022-24615**

### **INCIDENT**

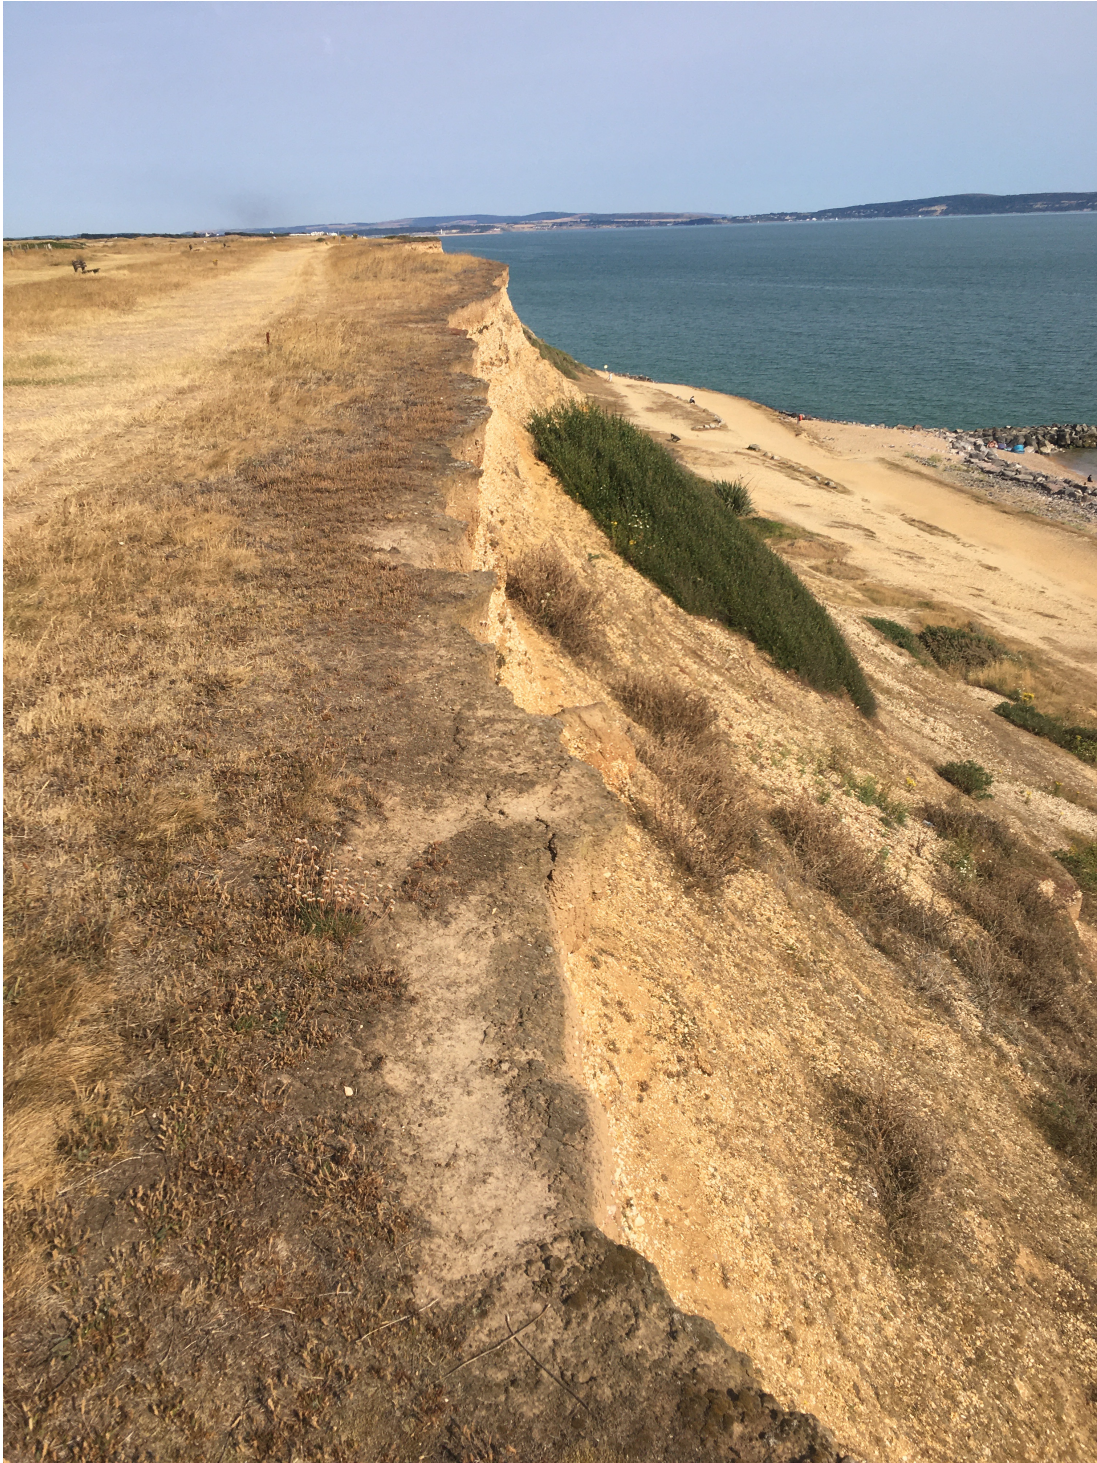
Photo 1, looking east from incident site.

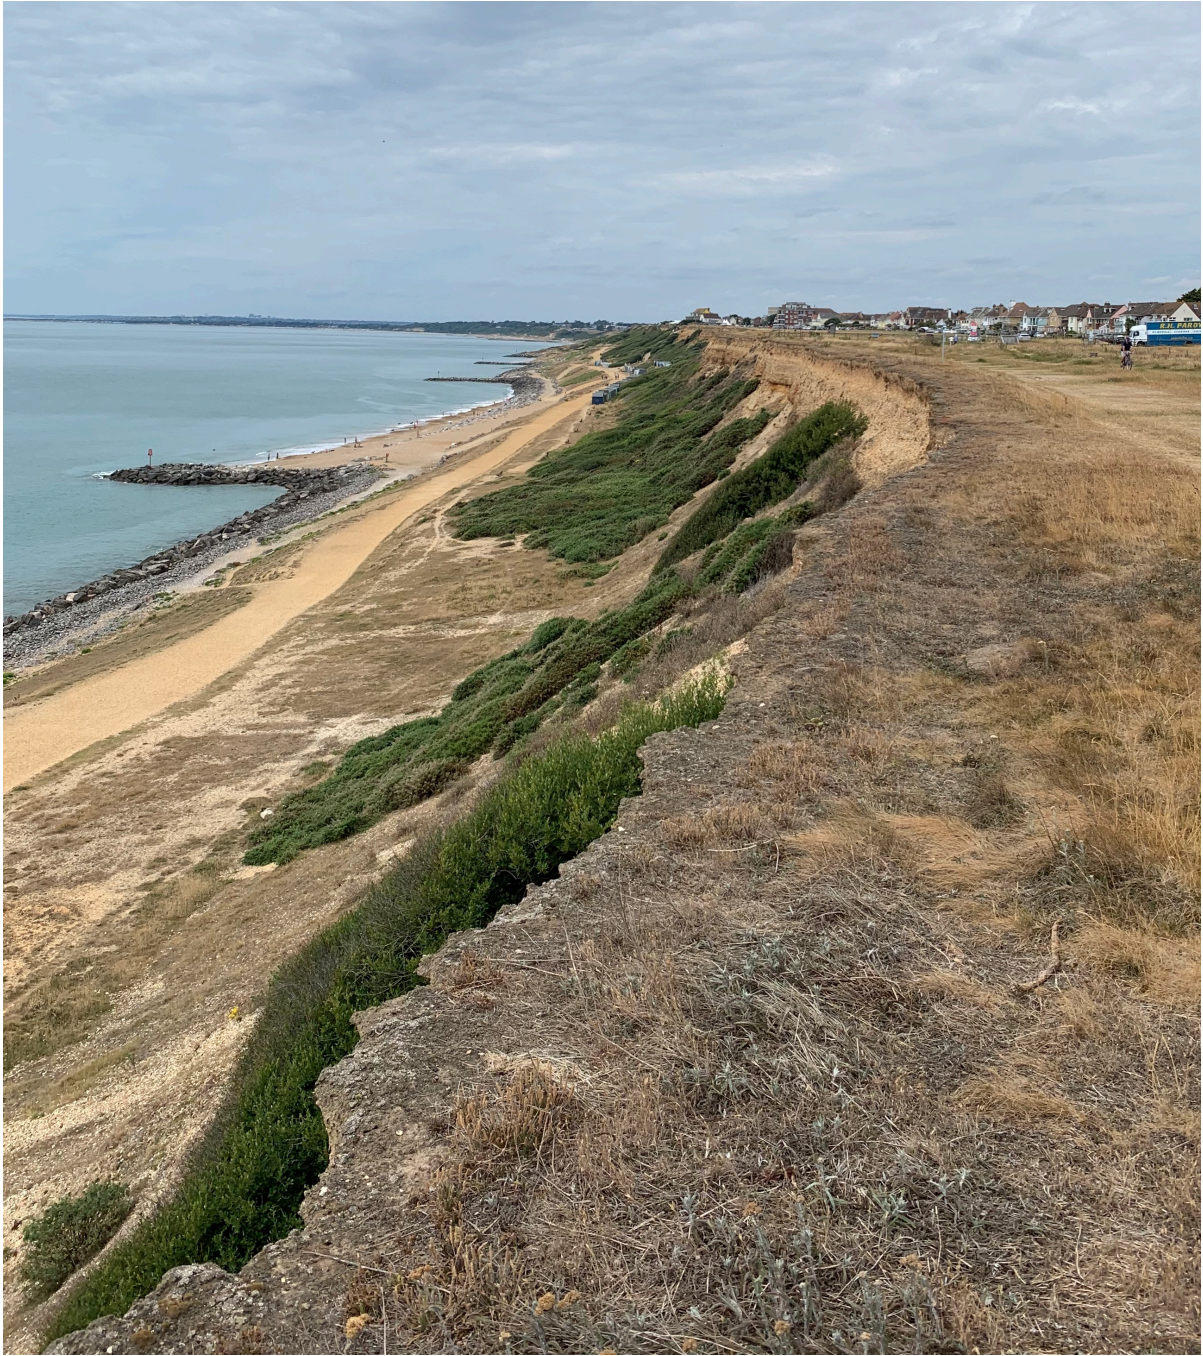
Photo 2, looking west from incident site.

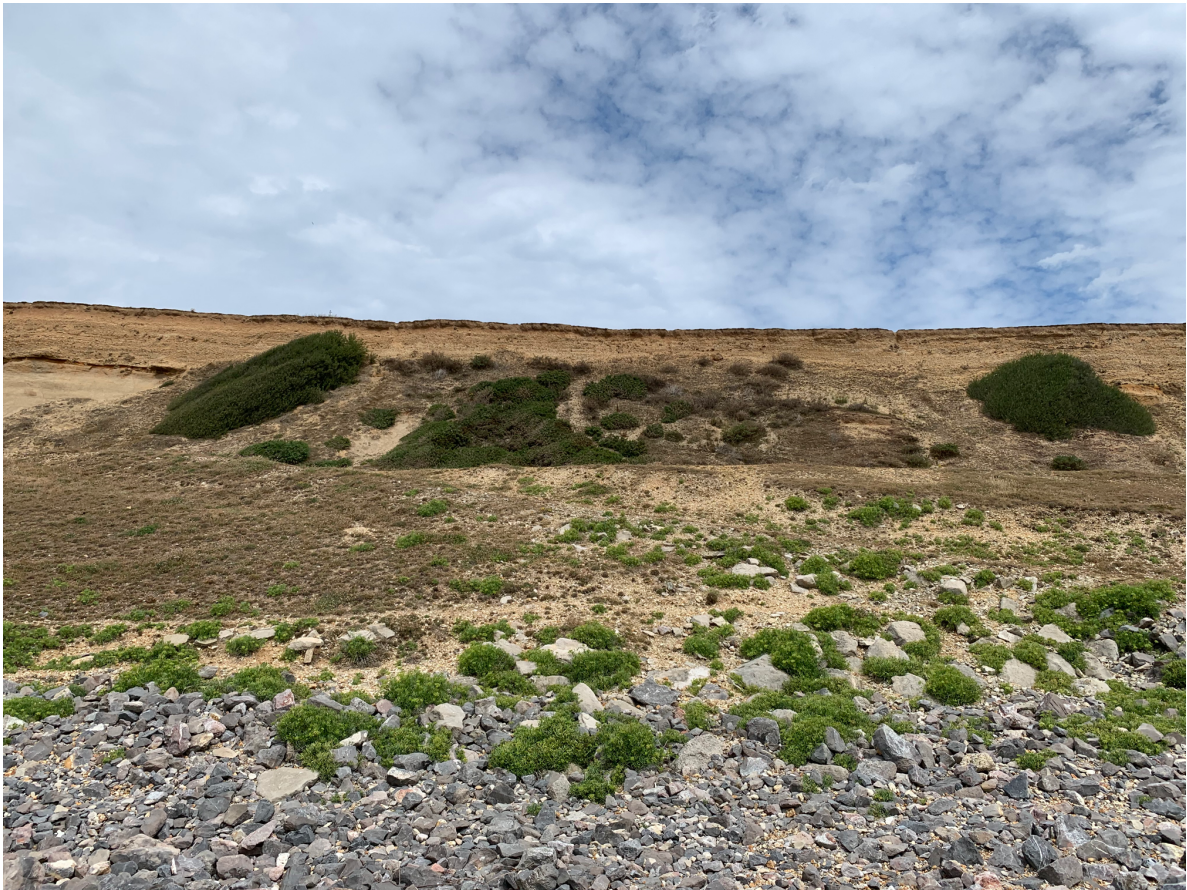
Photo 3, looking up at the incident site from the beach.

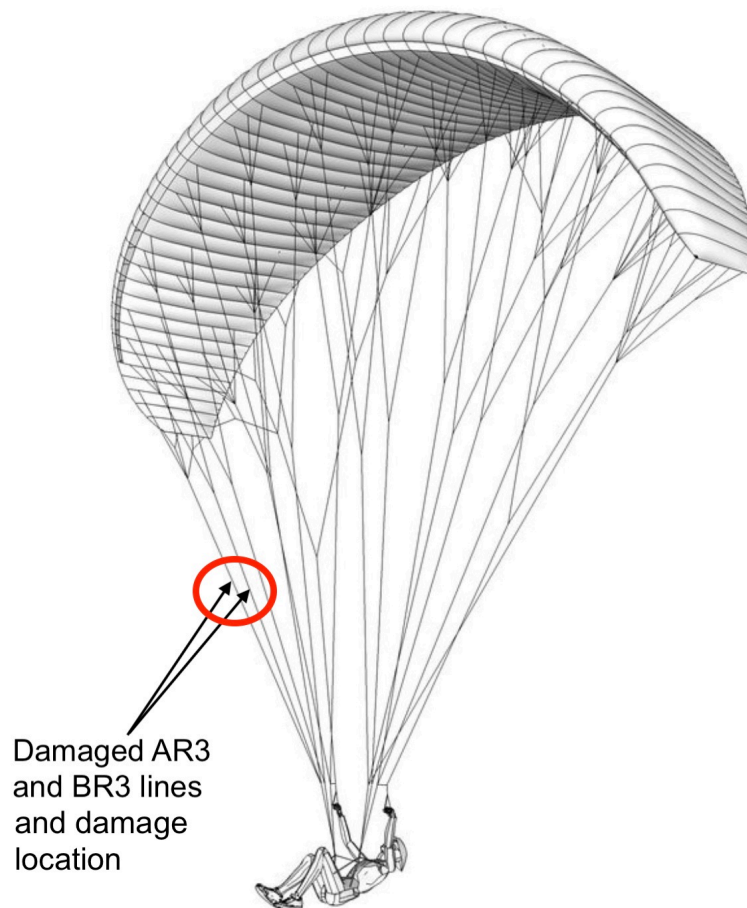
Diagram of basic paraglider showing area of line damage.

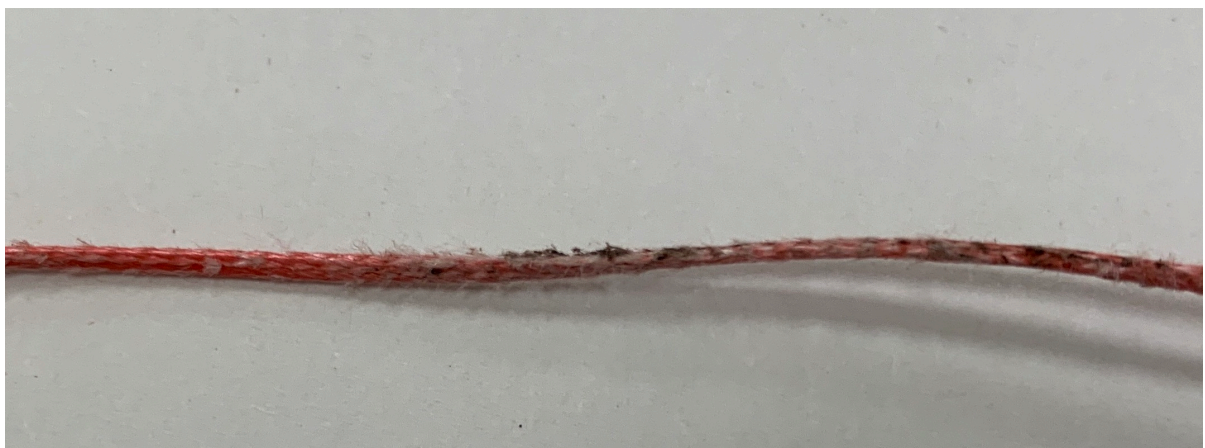
Photo showing damage to AR3 line.

The photo clearly shows the area of wear and debris, which is consistent with contact with the rough ground. It is possible that the damage was already there prior to the incident, but the Investigation found this highly unlikely, given Pilot A's experience. Pilot A would have known that such damage would render the glider unsafe and require immediate repair. It is therefore most likely that the damage was not there before the incident. It is possible that the damage was sustained as the glider was dragged up and over the cliff top. However, the

evidence suggests that it was caused due to contact with the cliff while the glider was still flying. The precise area of damage, the extent of the damage and the fact that just the outermost A and B lines were damaged is consistent with the glider having caught the cliff while still in flight. The position of the damage is also in line with the witness statement where Witness B described Pilot A as having been "...very close to the cliffs and was dipping down below the edge."

Pilot A's rapid turn into the cliff would also indicate that the glider outer lines on the right-hand side had caught on the cliff edge whilst in flight, causing the glider to turn quickly and dynamically into the cliff. In the light winds present it is highly unlikely that the rapid turn was the result of a departure from normal flight caused by turbulent air.

The investigation recommends that the BHPA FSC should remind pilots, through their magazine Skywings, that if they find themselves scratching close to a steep slope or cliff face, they must be alert to the possibility of a wing tip or suspension line contacting the ground and, even if the air appears smooth, leave a significant margin for the unexpected.
