## **BHPA Incident Report: GBR-2022-27371**

<b>Aircraft Type:</b>	Powered paraglider. Paraglider wing: BGD Luna 2, size 23 (serial number (BG0920021A). Paramotor: Vittorazi Moster 185 engine with an E-Prop carbon fibre propeller and right-hand mounted hand throttle, fitted to Condor XS 93 frame by Hs COM; an Apco harness including a harness mounted Apco Mayday emergency parachute.
<b>Certification:</b>	DGAC. Not certified to EN 926-2.
<b>Location:</b>	Field belonging to New Church Farm, Tong Lane, Bradford.
<b>Date and Time:</b>	9 <sup>th</sup> August 2022, approximately 18:00 UTC.
<b>Type of Flight:</b>	Local flight.
<b>Persons Involved:</b>	Pilot A
<b>Injuries:</b>	Cause of death listed as multiple injuries.
<b>Nature of Damage:</b>	Damage to the paraglider. Substantial damage to the paramotor.
<b>Pilot's Rating/Licence:</b>	None.
<b>Pilot's Age:</b>	54
<b>Pilot's Experience:</b>	No logbook available.
<b>Information Source:</b>	Police Witness Statements from Pilots B and C, Witnesses D, E, and H. A report and diagrams from Pilot B; reports from Witnesses F and G, a photo provided by Witness G; paraglider inspection report from an independent service centre; a Met Office aftercas

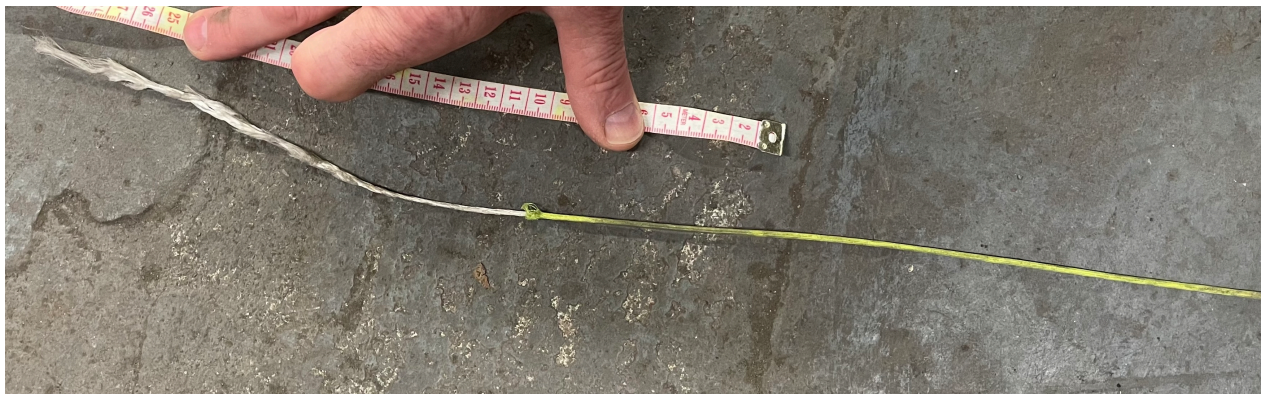
The left-hand control line was severed. The line had a different break type from the cleanly cut suspension lines. This line is shown in Fig. 2. The cut had occurred approximately 89 cm from the control handle. Fraying of the sheath (fluorescent yellow) and structural core (white) can be clearly seen. This suggests a different mechanism of damage from the cutting that had been performed to sever the suspension lines. The Investigation determined that the damage to the left-hand control line of the paraglider was consistent with contact with a rotating propeller.

*Fig. 2: left hand control line cut, approximately 89 cm from the control handle.*

From this evidence the Investigation determined that the left-hand control line came into contact with an uneven and previously repaired section of the propeller. The propeller was turning under power at the time, causing the line to be entrapped and eventually severed.

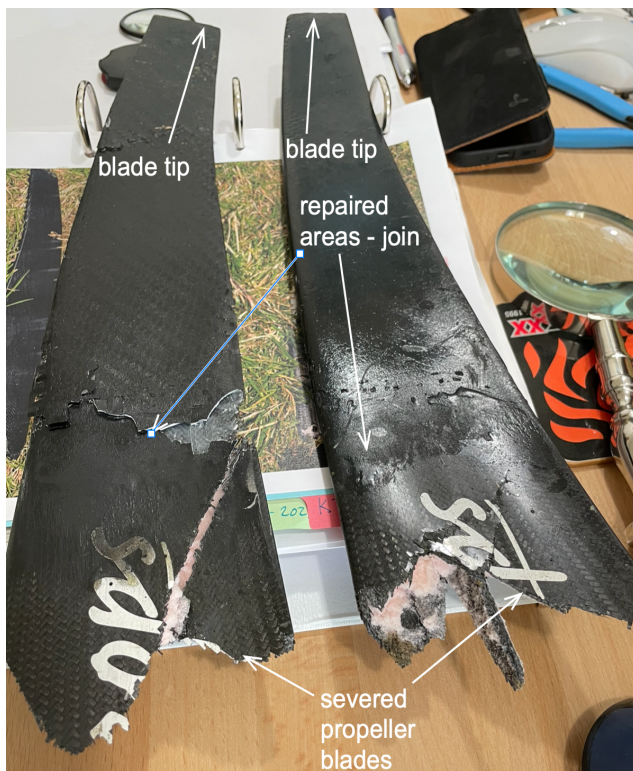
The Investigation noted that both blades of the propeller showed signs of a repair having previously been made, following damage evidently across the full width of both blades. This is illustrated on Fig. 3. A fibre mat had been used to re-join the broken blade sections. It is not known whether the repair was made following the incident described by Pilot C (see 3.3.4), or was made after another incident. Given the nature of the damage that the repair endeavoured to make good, it is apparent that in this previous incident the blades had been severed half way along their length, and had incurred considerable damage.

*Fig. 3. Broken propeller blades and previously repaired areas.*

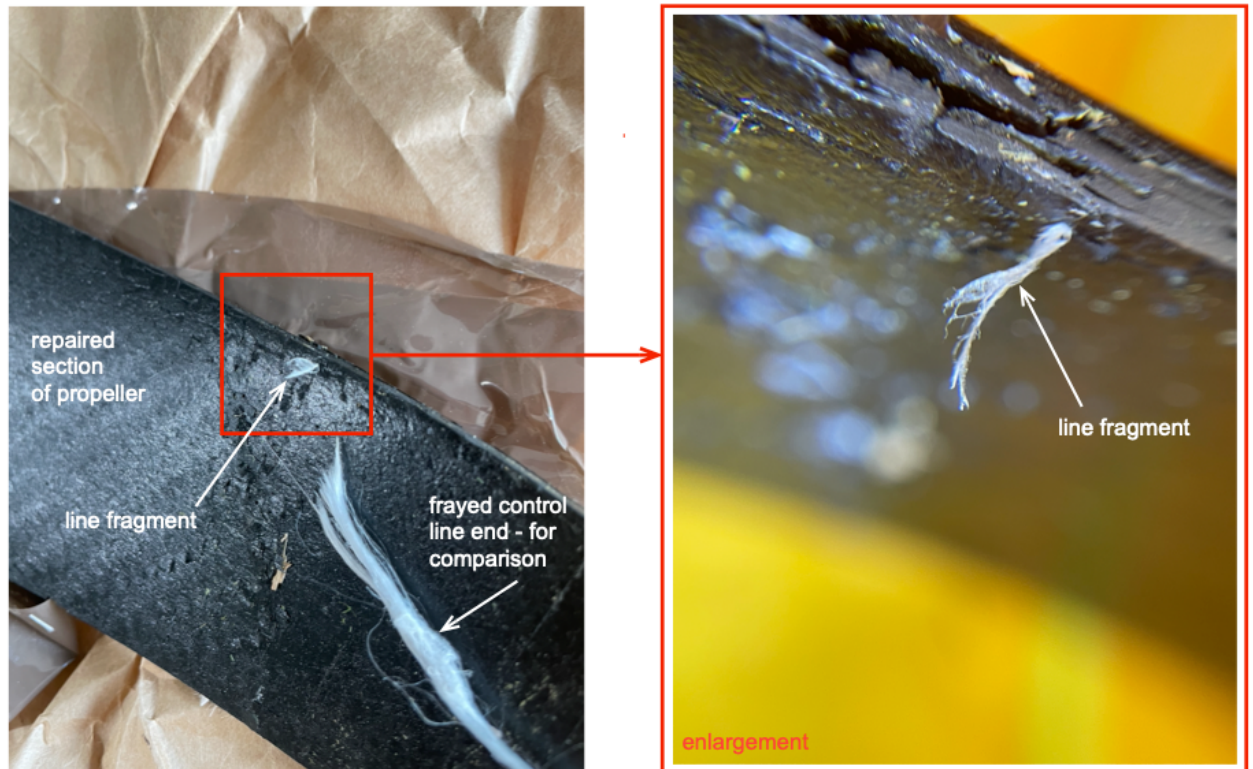
The repair to both propellers was uneven and had areas of sharp edges, rough and uneven surfaces, and surface crevices. On close inspection, strands of paraglider line core material (white in colour) could be seen embedded in a repaired section of the blade's leading edge, within a crevice formed by a repair. This can be seen on Fig. 4.

*Fig. 4. The repaired section of propeller blade, and an enlargement of one area of propeller leading edge, with embedded control line fragment.*

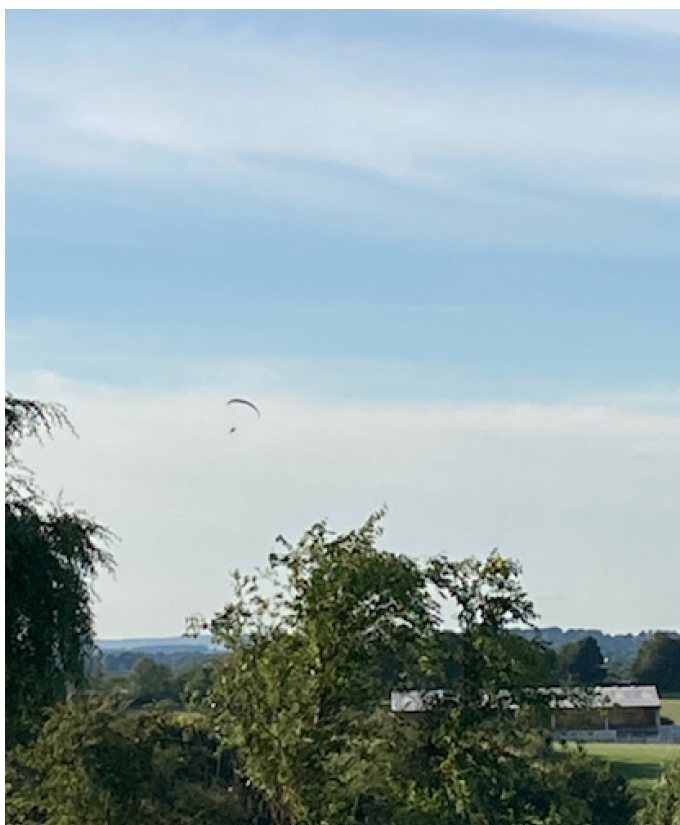
*Fig. 5*

- 3.4.5 The photograph in Fig. 5 was provided by Witness G, situated on the golf course approximately 750m to the south of the incident location. They stated that “Shortly after the photo was taken at 7:01pm we noticed the motor noise cut out” and seconds later the paraglider “then started spiralling”. Witness F stated they saw Pilot A “swaying” after the engine cut out. They did not see any “spiralling...or any sense of an emergency” before “the machine dipped out of sight and a second or so later we heard a ‘crumping’ sound”, evidently the noise of the impact.
