Ozone BV1 Important Notice

IMPORTANT SAFETY NOTICE

Concerning the Ozone BV1 harnesses produced before November 2022.

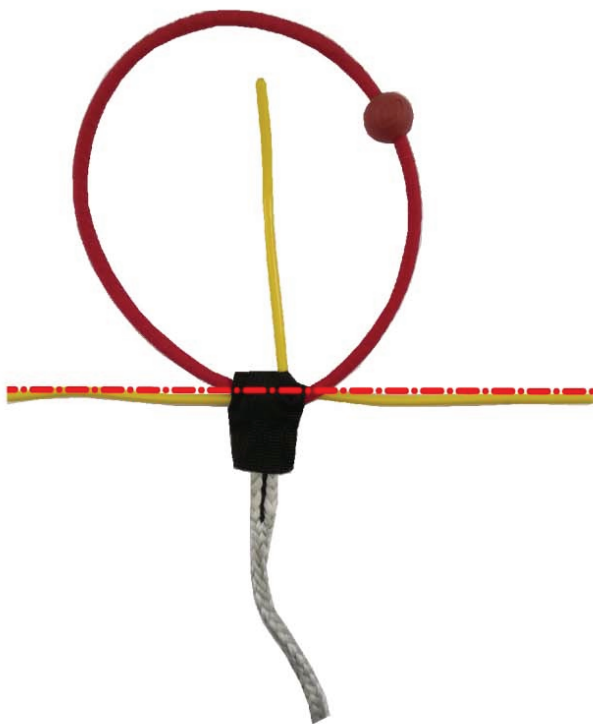
Original Spec

The parachute handle extraction of the BV1 is certified and effective. However we have found that in certain circumstances that it is possible for the extraction force to be excessive. The process can be improved by 1, modifying the plastic pins; 2, NOT routing the pins through the red loops and 3, NOT securing the handle under the lower pin.

1. Remove the handle from the harness so the pins are extracted from the loops. Bend the horizontal pins to downwards by approximately 30 degrees. No tools are required, the modification is easily made by hand using gentle pressure.
