Nov 0017 Importer's Safety Notice

AIR Atos – all models

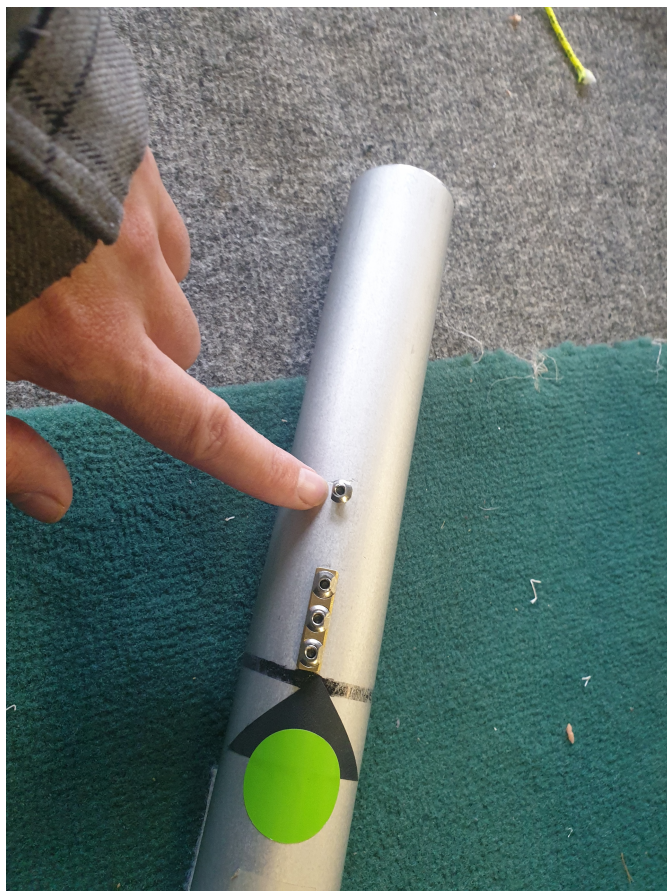
Inspection revealed that the outer leading edges of the Atos had been inserted on the wrong sides. The leading edge junctions of all Atos gliders are colour coded and should be fitted green to green and red to red. In addition, a small screw on one leading edge (pictured) should conflict with a rivet to prevent the wrong outer section being inserted; however if either is incorrectly fitted or worn they may not prevent mis-rigging.

Incorrect insertion will lead to dramatically-altered washout and potentially dangerous behaviour in flight, yet without close inspection it's not apparent that the glider is mis-rigged. Before their next flight, all Atos pilots are recommended to:

- Check that it is impossible to put the leading edge outer in the wrong side.
- During your pre-flight check, always include a green-to-green, red-to-red check.

If, in flight, the glider feels dangerous in pitch, deploy the flaps to regain control. If necessary, seek modification to your glider at Avian.
