SAFETY ADVISORY

Issued by: **Angus Pinkerton – Chairman of the Flying & Safety Committee. 11 September 2024**

Woody Valley Hang Gliding Harnesses: Tenax 3 with "Inside Trim" system and Tenax 4.

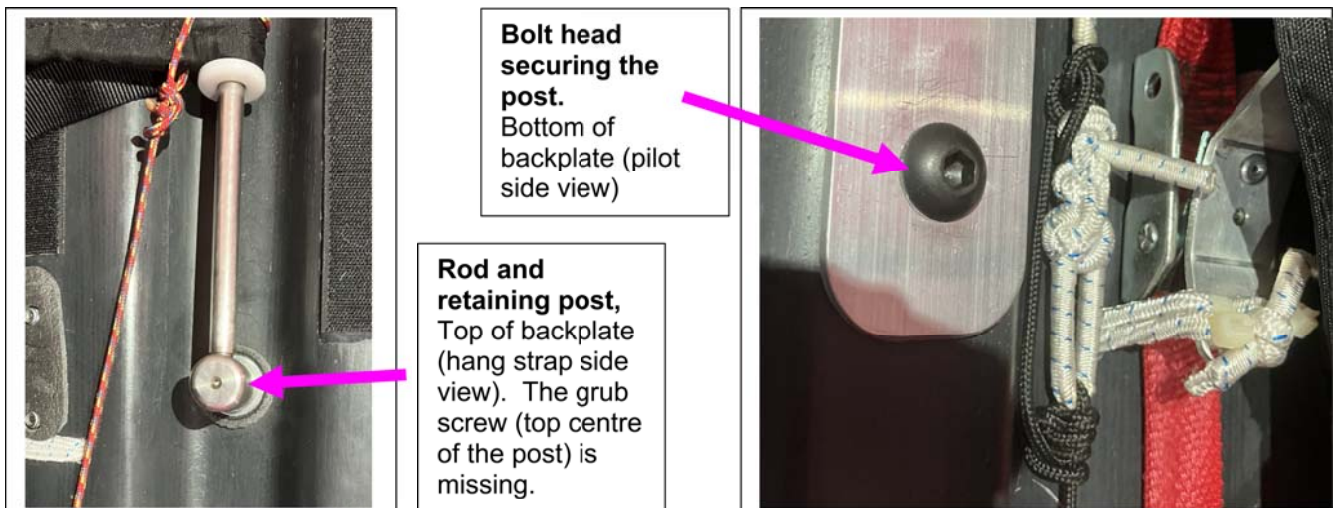
In a Woody Valley Tenax 3 hang gliding harness with the "Inside Trim" system, the hang strap is connected to a slider on a steel bar on the outside of the load spreading backplate. This bar allows the hang strap to slide backwards and forwards to enable the pilot to adjust their position for flying and landing. The bar is retained by two "posts" that are fixed to the backplate by bolts. (The Tenax 4 model uses a similar method of attachment.)

During a recent inspection of the inside trim system on a Woody Valley Tenax 3 hang-gliding harness, it was discovered that one of the bolts that attach the posts to the backplate had become loose by some 4 turns (rotations) allowing considerable movement of the post. By experiment, a further loosening of 2 more turns allowed sufficient movement of the post to allow the rod to detach completely. It was also noted that the grub screw that is threaded into the post to lock the rod to the post was missing.

The hang strap itself is also attached to the harness via a maillon, which serves as a back-up to the primary slider / rod hang system. However, were the rod to detach from the post during flight, the pilot could experience a sudden drop of approximately 30cm (~12") before the back-up strap / maillon engaged. This is connected well forward of the normal hang-point position, and there would be a resultant head up movement as the secondary system takes the load of the pilot and harness. Such a sudden drop and change of attitude could momentarily or permanently affect the pilots' ability to control the glider, with potentially serious consequences.

Pilots who fly using either a Woody Valley Tenax 3 (with Inside Trim), or a Tenax 4, harness should not fly with them until they have inspected their harness to ensure that the post mounting bolts are tight, and the grub screws are present and secure, at both ends of the rod attached to the back plate.

These bolts and grub screws should be regularly checked.
