## **BHPA Incident Report: GBR-2019-10927**

### **INCIDENT**

### **1.0 Synopsis**

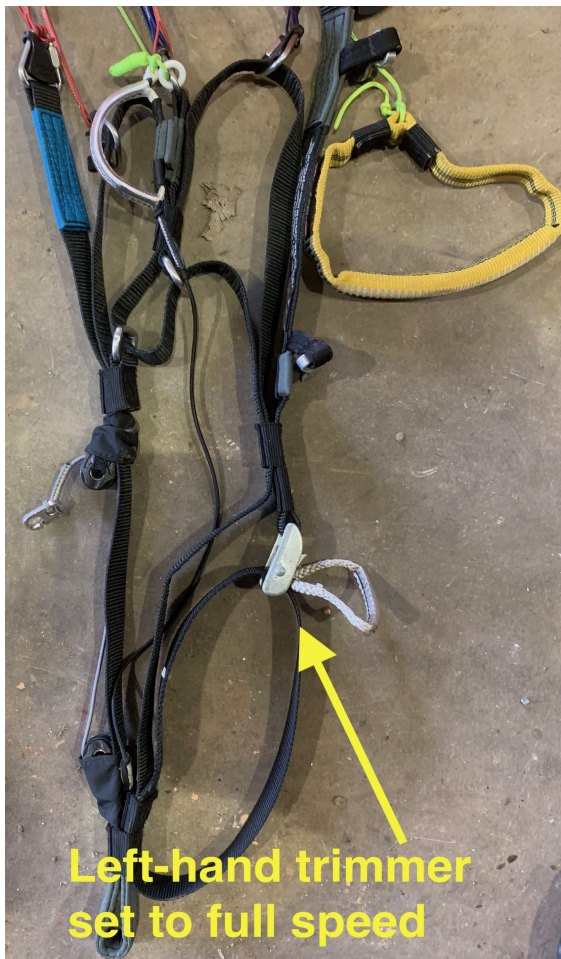
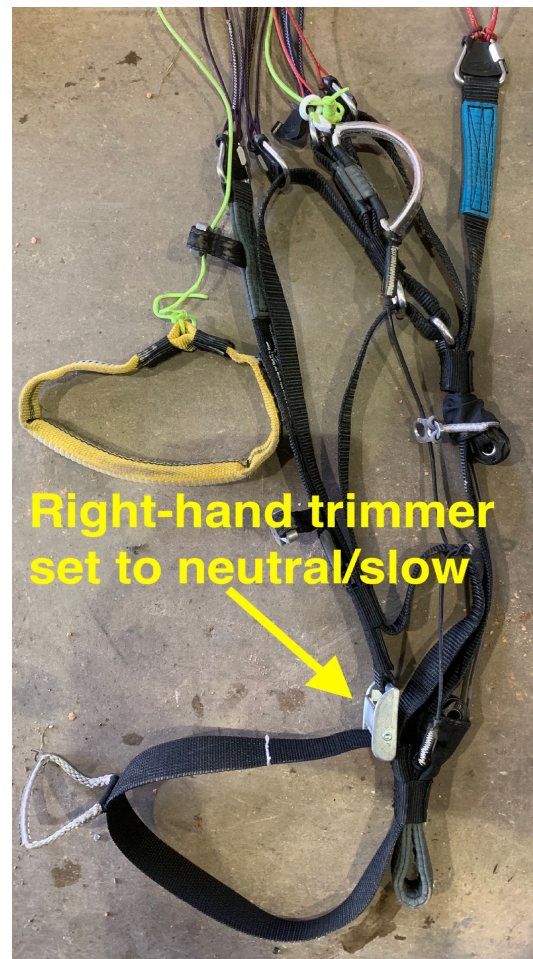
Inspection of the glider showed that the trim system on the risers was set asymmetrically. The following photos show the risers as they were found:

The right-hand trimmer is set at what Ozone call the “neutral” position, which is the position to which the trimmers are set for EN certification and is the slowest setting. The left-hand trimmer was set at full speed. It is highly unlikely that Pilot A set the trimmers like this on purpose as it would have resulted in the glider being placed in a constant righthand turn. Equally, it is unlikely that this configuration was set accidentally as the resulting turn would have been noticeable. The most likely explanation is that Pilot A was in the act of re-trimming the risers when the incident occurred, in preparation for landing. In the user manual, Ozone recommend that the Roadster 2 is returned to the neutral trim position for landing. It is impossible to say what effect the asymmetric trimming of the risers had on the glider once it had departed from normal flight. The Investigation considered that, given the height at which the incident occurred, the asymmetric trimming of the risers would not have had a significant impact on the overall outcome.

The Investigation considered that the paraglider, paramotor and parachute were of a suitable type and size for Pilot A. The Investigation considered that the asymmetric trimming of the risers may have been a contributory factor in this incident.

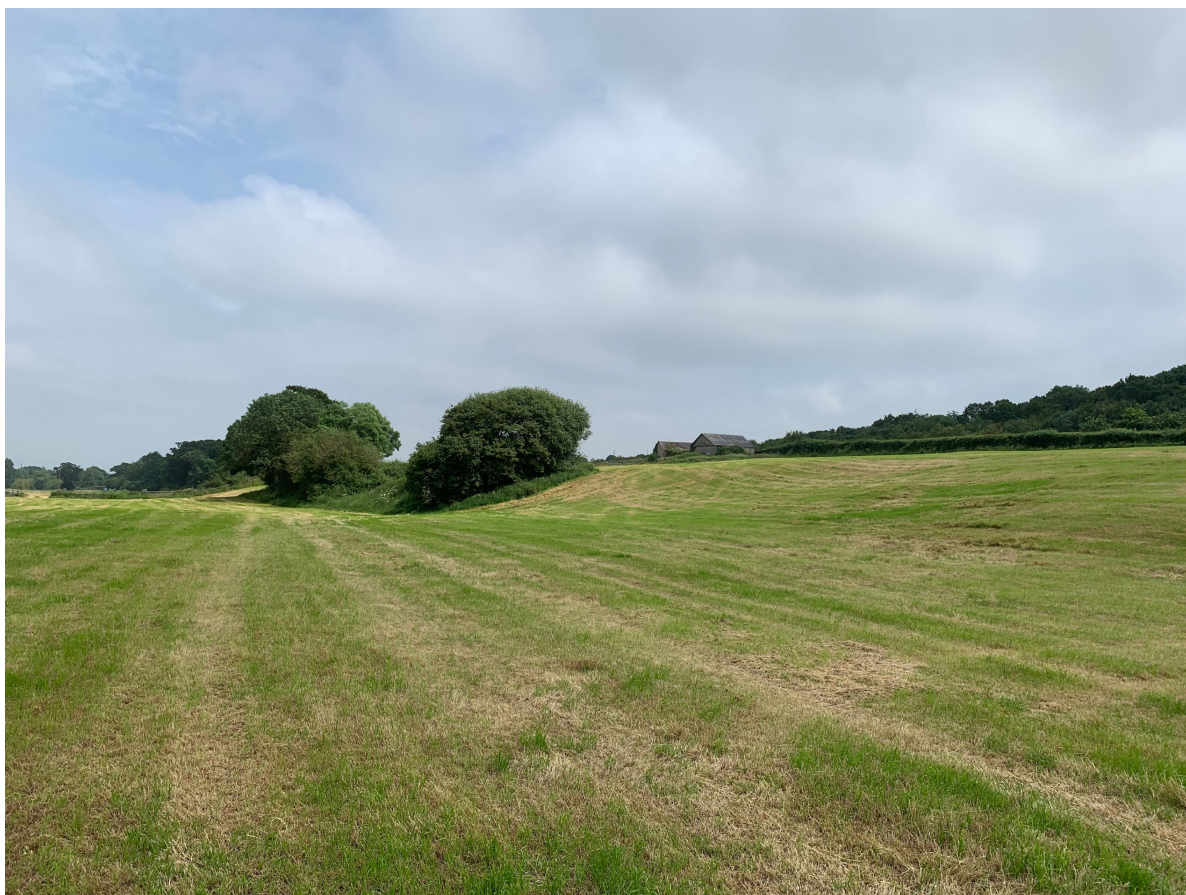
The field at Colhayes Farm is approximately 1000m long, running east to west, and 250m wide. The field has a line of mature trees running from the northeast corner down towards the southwest, that follow a step in the field. On the southern edge of the field there are two large barns that are approximately 75m upwind of the incident site. The following photo, looking in an easterly direction, shows the step in the field, the line of trees and the barns.

Looking at the field from above it would be obvious to a qualified pilot that both the trees and the barns were a source of potential turbulence in the conditions that were apparent on the day. The prevailing wind would have been coming directly over the barns and also over the trees at their eastern most edge. Pilot A had a good view of the field and would have had an unrestricted view of any potential hazards.

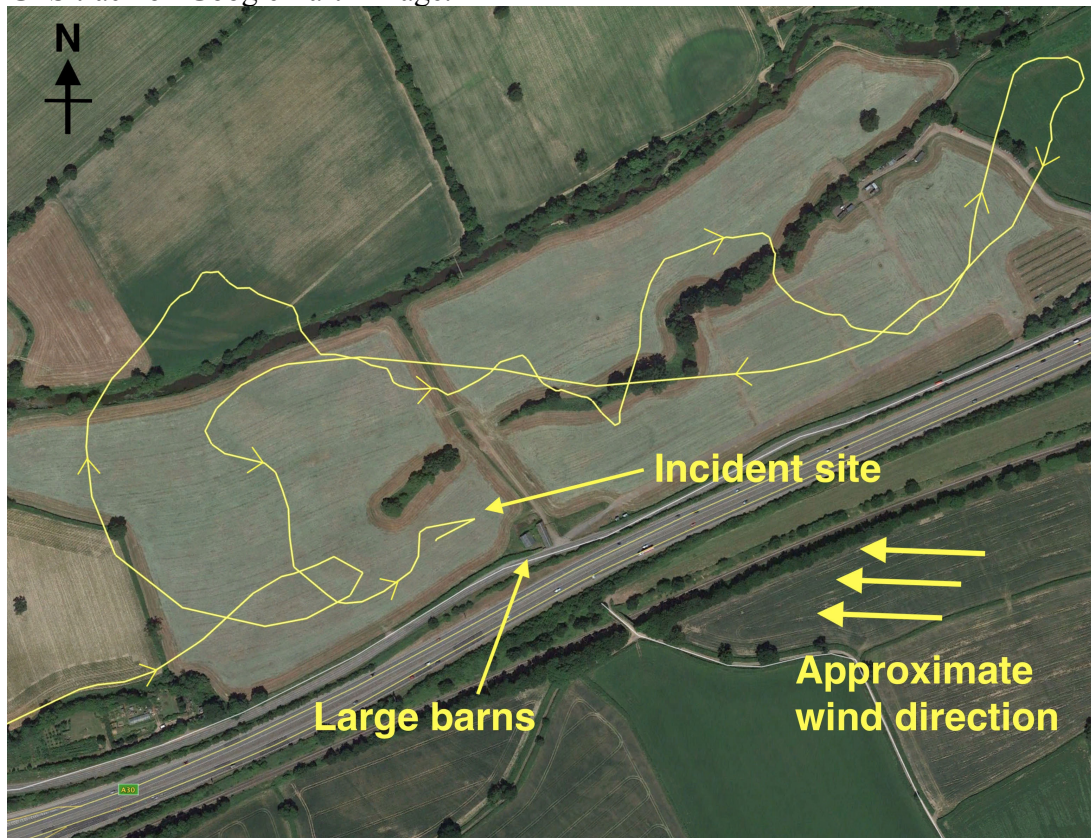
GPS track on Google Earth image.

The Garmin Etrex GPS data shows that Pilot A flew the length of the field before circling back, gradually descending from a height of approximately 100m above the ground to approximately 30m above the ground, presumably with the intention of making a landing in order to refuel. The route planned by Pilot A on the Garmin GPS unit shows the local Honiton Tesco, a further 2.5km up the A30 to the east, pinpointed as a petrol station for the purpose of refuelling.

Analysis of the video footage immediately before the crash shows the glider being pitched backwards by the turbulent airflow. GPS data puts Pilot A at a height above the ground of approximately 20-25m at this point. While in the back pitch the glider suffered a 50% asymmetric collapse on the right-hand side causing it to rotate first right then left, as it recovered and the pilot swung back underneath. As the glider began to pitch forward and recover airspeed, Pilot A applied a large amount of brake to both sides of the wing. This caused the wing to stall and rotate 180 degrees before diving forwards into the ground. The incident, from the point where the glider was initially pitched back, to the point where Pilot A hit the ground, took a total of seven seconds.

The Investigation found that the turbulent leeside conditions into which Pilot A flew were a significant factor in this incident. The Investigation also considered the incorrect application of the brakes by Pilot A to have been a significant contributing factor.
