British Hang Gliding and Paragliding Association

REPORT

Investigation of a paragliding incident which occurred at Sierra del Buey, Murcia, Spain, on 10th October 2019 in which the pilot suffered fatal injuries.

BHPA investigation serial number: GBR-2019-12343

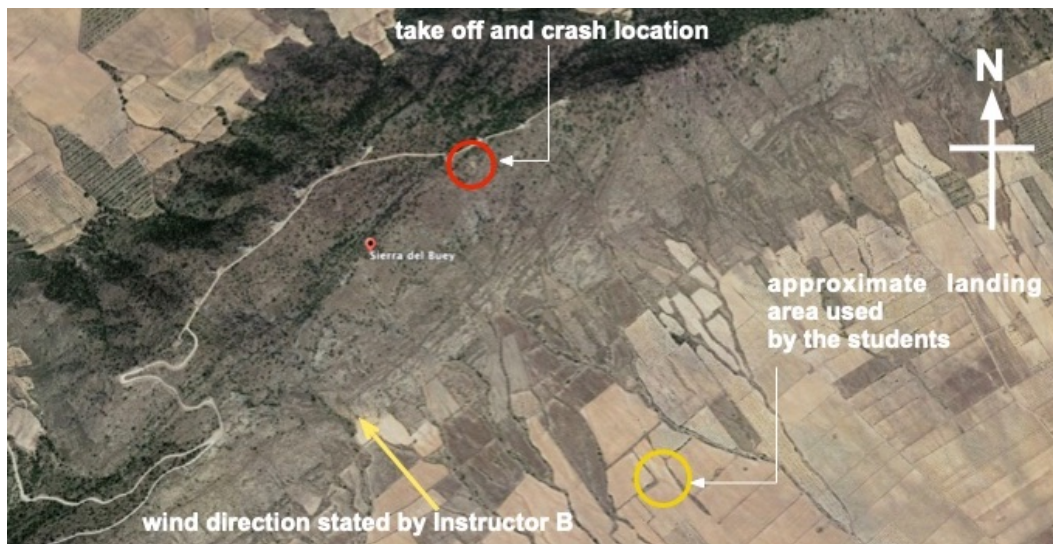
Fig. 1 (above): Site photograph (source: Google Maps).

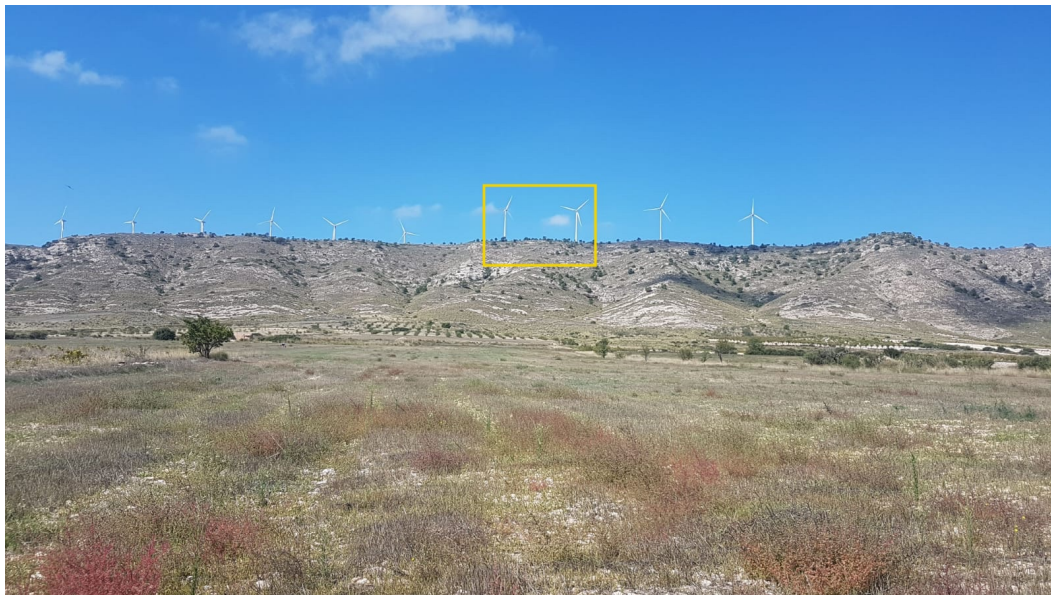
Fig. 2 (above): Site photograph. Yellow box indicates approximate location for Fig. 3.

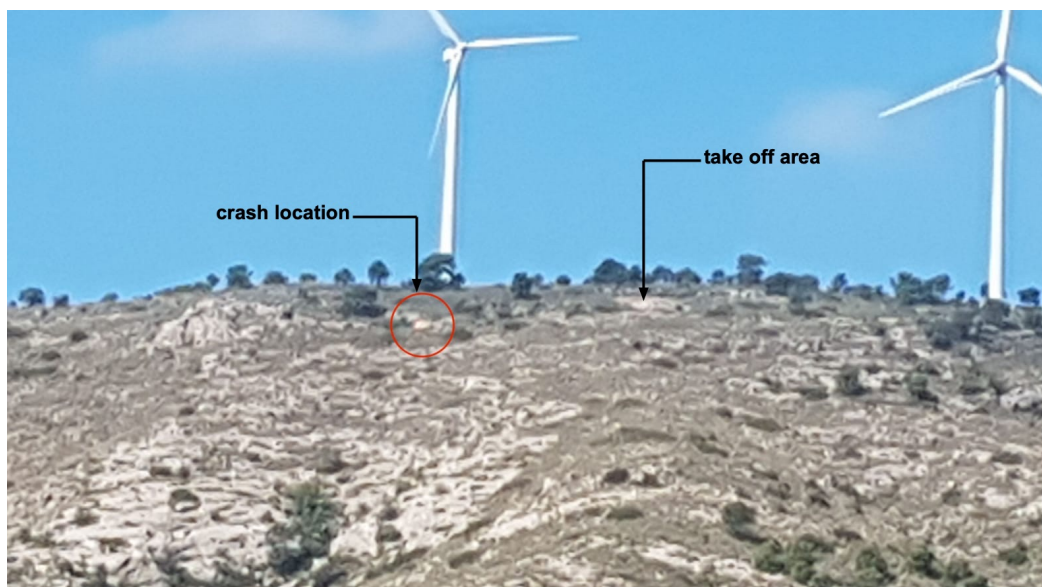
Fig. 3 (above): Take off and approximate incident location shown.

Pilot D lost altitude and was directed to the landing field, where he landed. Instructor B stated that Pilot A was losing height and was on his final beat before he would radio him to head to the landing field. As he approached the launch point Instructor B noted he was “approx. 60 feet high”. His wing suffered an asymmetric collapse on the left-hand side that Instructor B noted was “approx. 40 percent of the wing nearest the hill”, and he was seen to apply the left-hand control hard. Instructor B gave him an instruction over the radio to counter the turn, but the paraglider accelerated into the hillside and Pilot A struck the ground feet first.

The Investigation determined that Pilot A’s wing encountered turbulent air that brought about an asymmetric collapse and led to his wing turning towards the hill. Pilot A did not apply the correct action in response. His control input increased the rate of turn and his proximity to the ground led to his impact, where he sustained fatal injuries.
