BHPA Incident Report: GBR-2020-16524

Aircraft Type:	Paraglider: Air Design Rama Flex size M (serial number XPMP132009AC). Paramotor unit: "Flat Top" with Vittorazi Moster Classic engine and 1.3m carbon propeller).
Certification:	Paraglider not certified under EN 926-2.
Location:	A hillside adjacent to Gryfe Neuk Nursery, near Kilmacolm, Renfrewshire.
Date and Time:	2 nd June 2020, approximately 11:00 UTC.
Type of Flight:	Local flight.
Persons Involved:	Pilot A.
Injuries:	Cause of death listed as multiple injuries, due to fall from a height whilst paramotoring.
Nature of Damage:	Damage to the suspension lines of the paraglider. Damage to the paramotor.
Pilot's Rating/Licence:	None / unknown (not a BHPA member).
Pilot's Age:	77
Pilot's Experience:	Approximately 300 hours powered paraglider (paramotor) airtime logged since 2001.
Information Sources:	Statements from Witnesses B and C. Data from Pilot A's flight logbook. Wing inspection report from an independent expert. Aftercast information from the Met Office. Soaring weather aftercast provided by the UK RASP voluntary open weather service (www.stratus.org.uk). Static and video camera footage from Scottish Police.

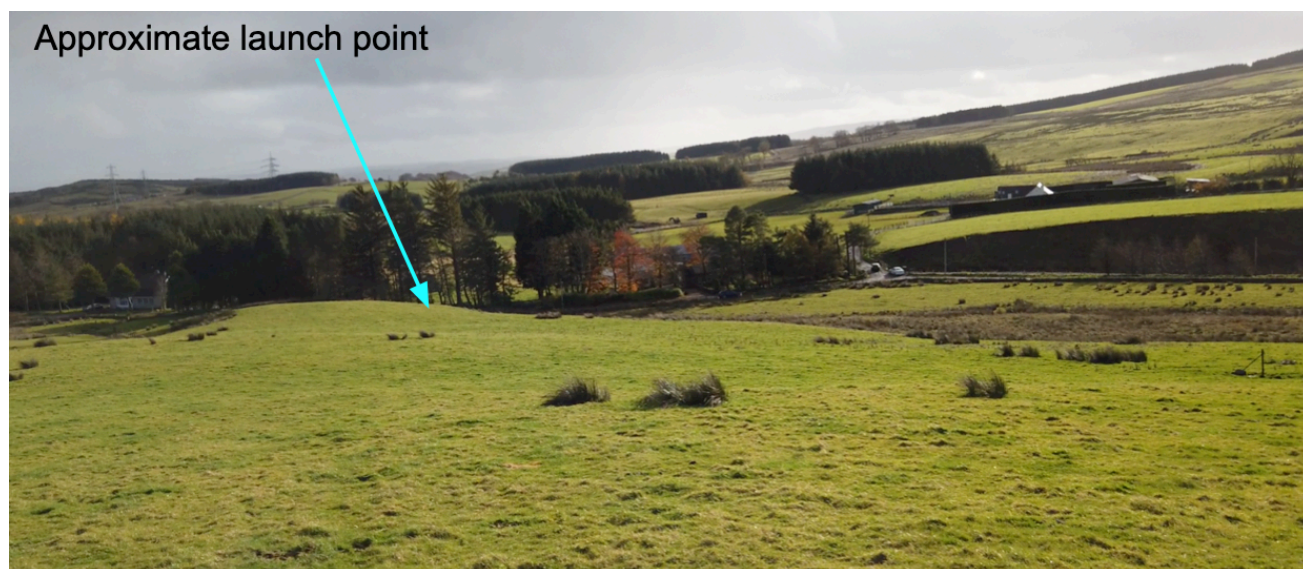
From their position at the roadway, Witness B observed Pilot A launch from an area of hillside within 20m of the road and access gate (the approximate launch location is shown on Figure 1).

Fig. 1 (above). View from the approximate impact area looking south-southeast towards the launch point and road.

Pilot A’s selected set up and launch area for the incident flight was in the lee of the copse of trees, and therefore sheltered from exposure to the airflow and meteorological conditions. The Investigation determined that once Pilot A was airborne and away from shelter of the trees, he encountered thermic activity and associated turbulent air which led to a departure from normal flight. His proximity to the hillside was such that he was unable to regain control before impacting the hill.

Pilots should be reminded through the BHPA’s “SkyWings” magazine not to let their choice of take-off location be determined by convenience or any factor other than suitability in the prevailing weather.

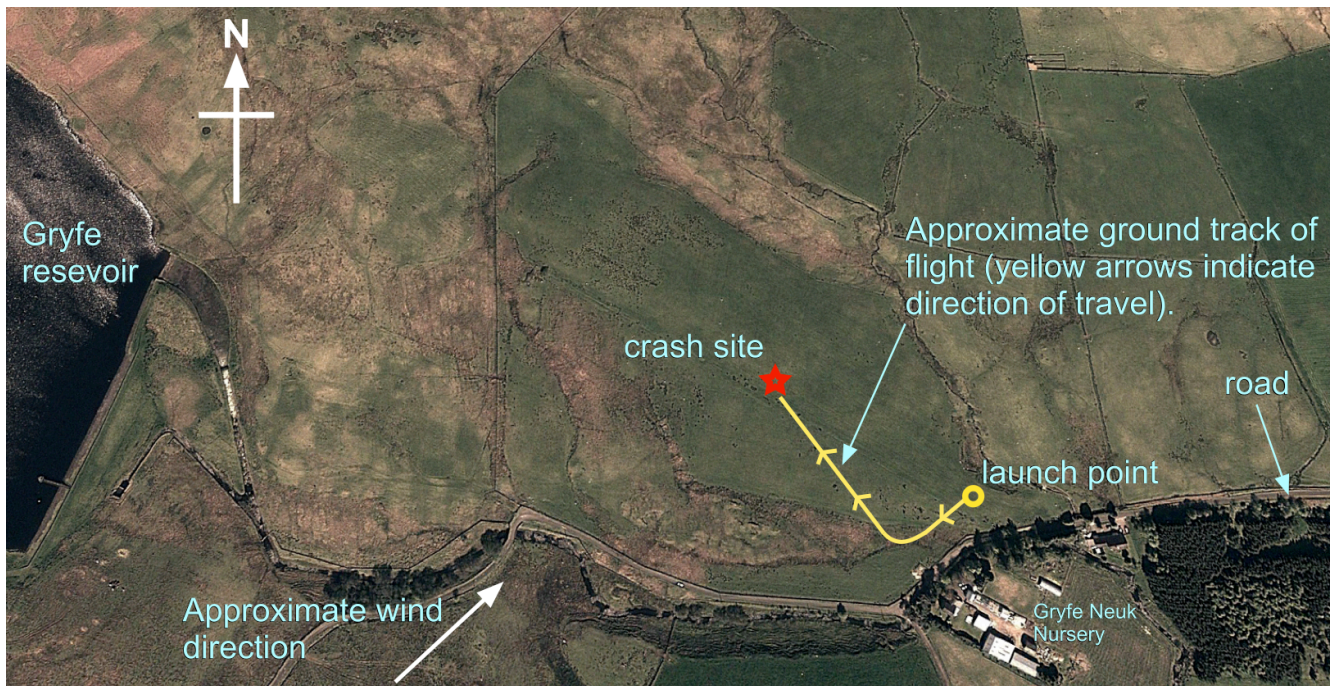
Fig. 2 (above). Background image source - Google Earth (imagery date 27th April 2011).

Witness B observed the flight from the time when Pilot A was running under his wing to get airborne. They reported that they had no concerns during the initial take-off and that the engine was on “full” during the flight. They described the track that Pilot A made, which is illustrated in Fig. 2 (below).

Witness B saw Pilot A “going up sideways” and described Pilot A’s paraglider as facing into wind throughout the flight but being carried up the slope instead of making forward progress into wind. They noted that the wing was rolling from side to side and could see that Pilot A was making control inputs in what they described as an attempt to correct the rolling movement of the wing. Witness C (from their position on the road to the east) observed the wing oscillating before it dropped out of view. It is evident that Pilot A’s wing had encountered an area of turbulent air.
