British Hang Gliding and Paragliding Association

REPORT

Investigation of a paragliding incident which occurred at City Airport, Barton, Manchester, on 27th September 2020 in which the student pilot suffered serious injury.

BHPA investigation serial number: GBR-2020-16106.

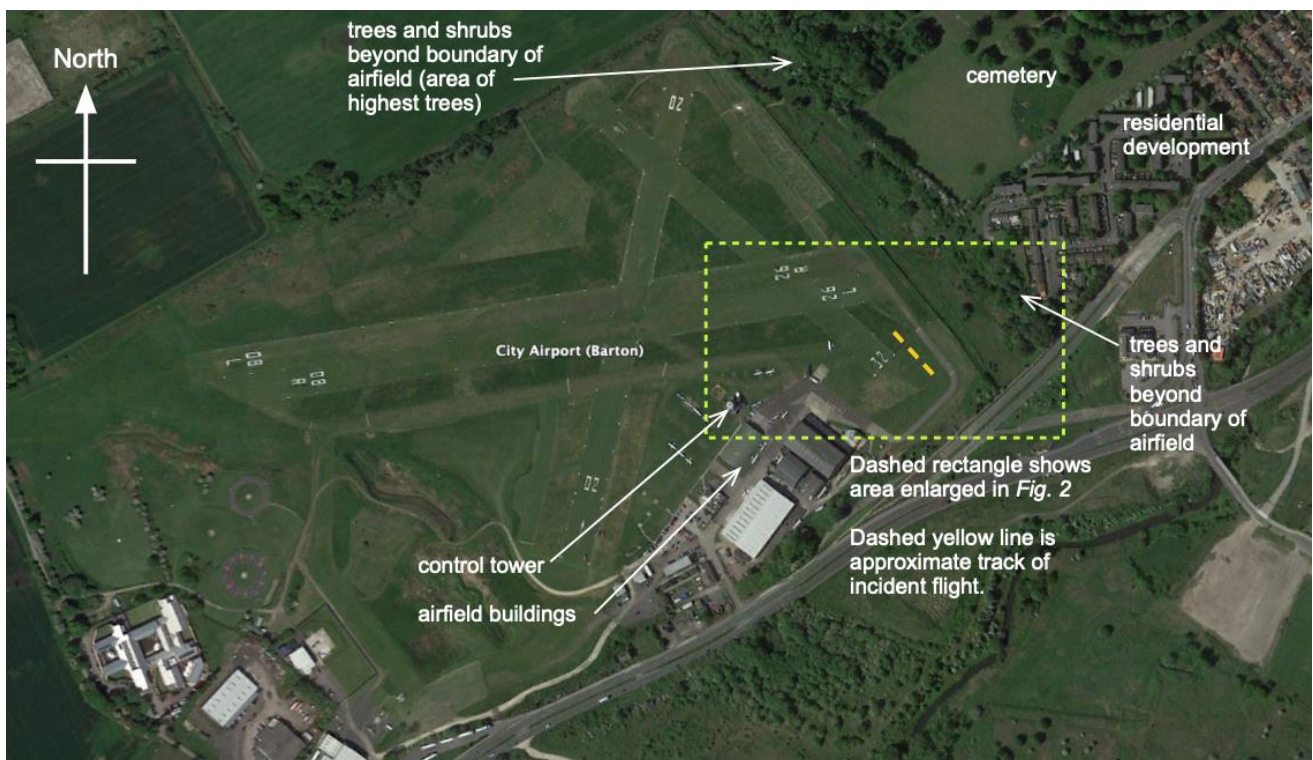
Fig. 1. Airfield layout and approximate incident location. Source of background map: Google Earth (2019).

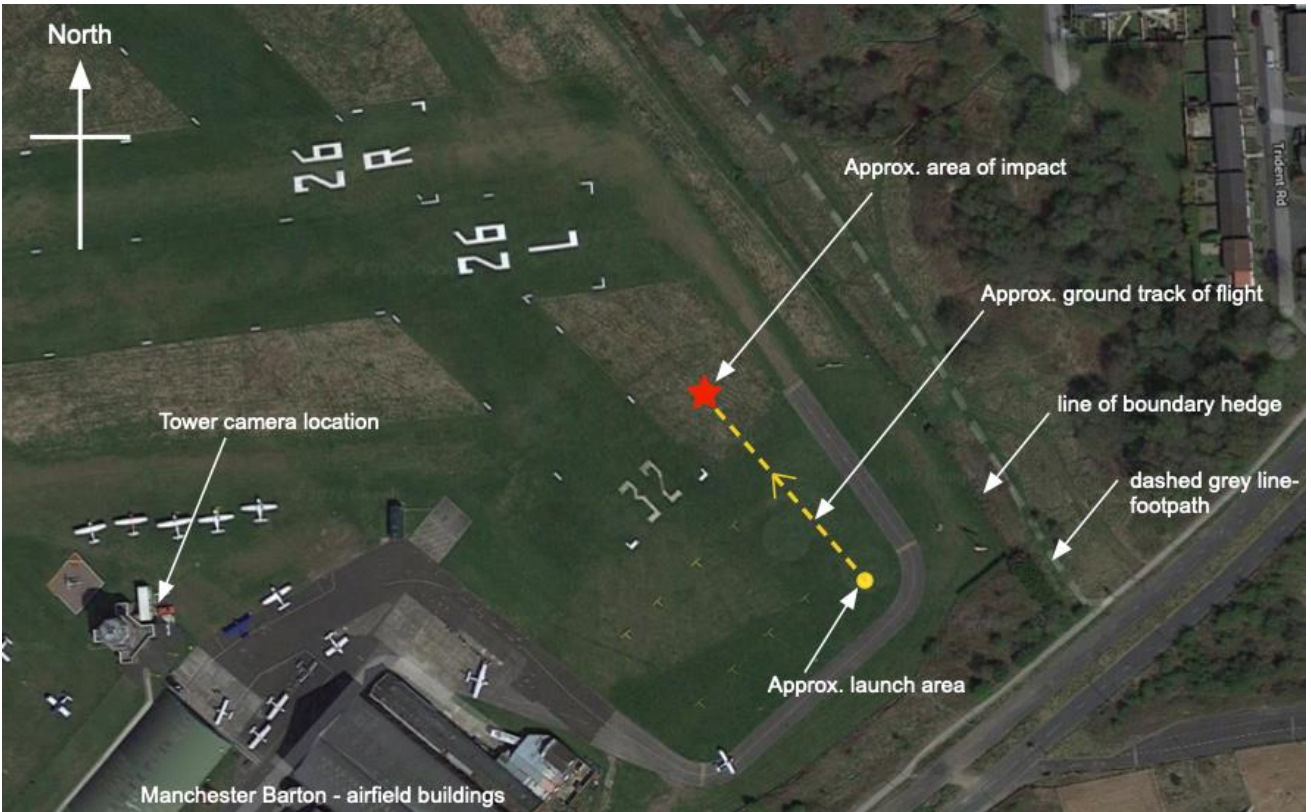
Fig. 2. Incident flight approximate ground track and impact location superimposed onto aerial view of site. Source of background map: Google Maps.

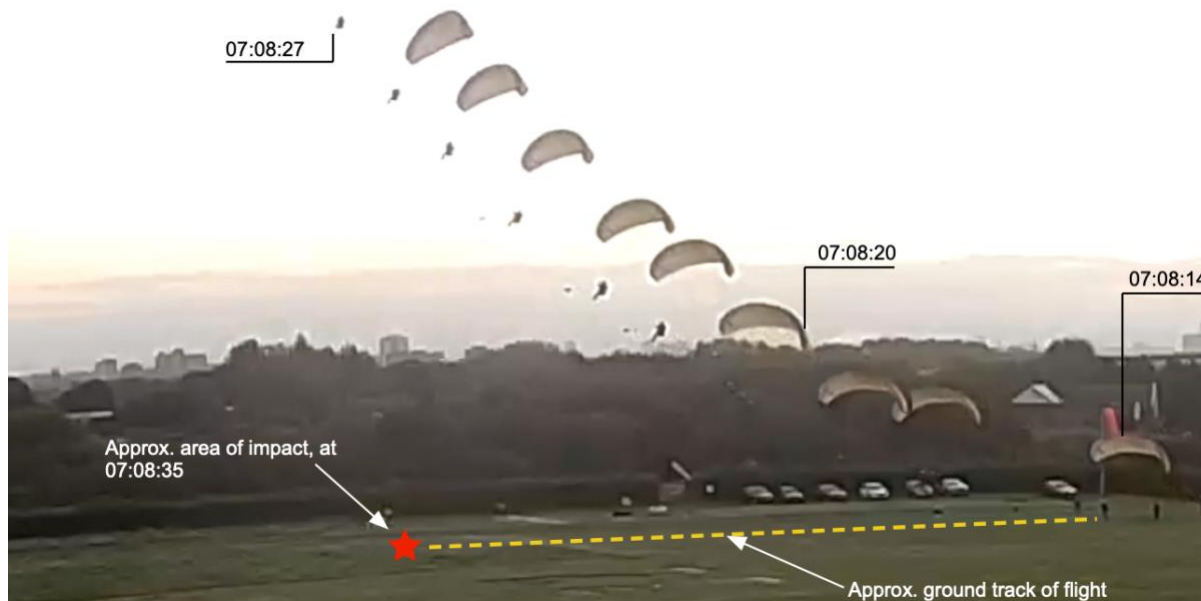
2.7.7 In Fig. 3, the flight sequence is illustrated on the composite image. This is compiled with stills captured from the tower camera's video recording. It shows the portion of the flight under tow, and the approximate area of impact following the incident.

Fig. 3. Composite image of Pilot A's flight sequence captured by airfield camera, produced from stills.

The Investigation determined from the video footage that the steeper climb trajectory began when Pilot A was approximately 30 to 40ft AGL and deviated from the advice in the Technical Manual (that tensions can be increased after 100ft). It is noted that the increasing tension did not result in immediate weak link activation, as the weak link did not activate until the pilot was approximately 150ft AGL.

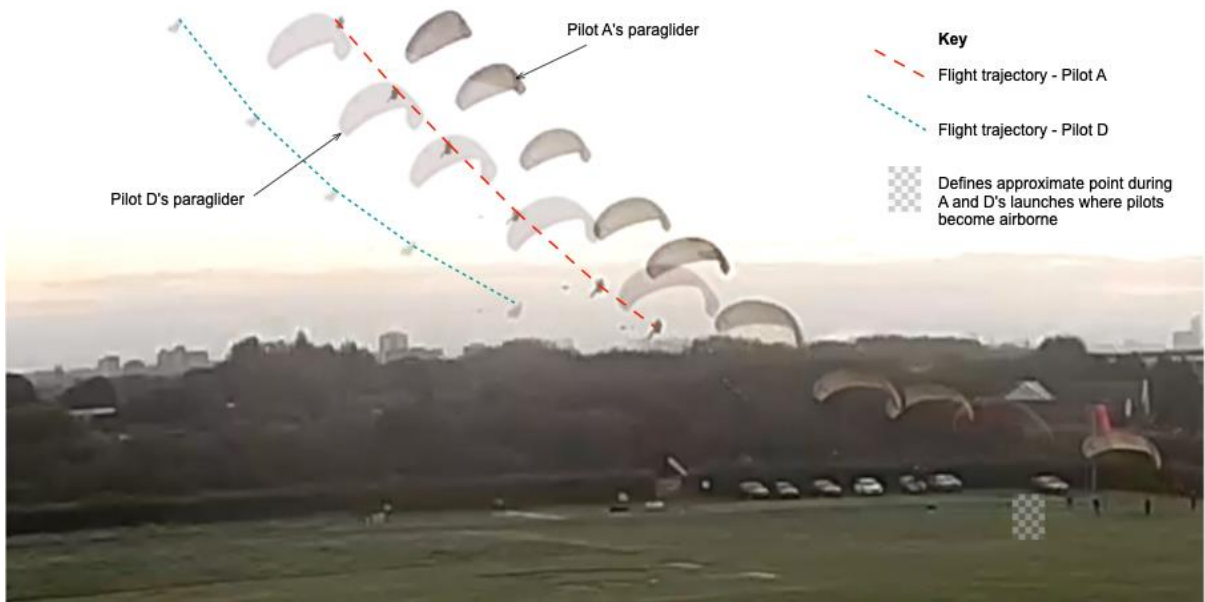
A composite image was put together from the tower's video recording, comparing Pilot A and Pilot D's towed trajectories. This is shown at Fig. 4.

Fig. 4. Composite image of flight trajectories of Pilots A and D captured by airfield camera, produced from stills.

It is apparent from analysis of the camera footage that Pilot A's initial climb trajectory was slightly steeper than that of Pilot D – Pilot A had achieved a greater height above the ground than Pilot D at a comparable horizontal distance from their respective launch points. The Investigation determined that the tow tensions associated with a steep climb trajectory would lead to an increased likelihood of a weak link activation. However, Instructor C did not report that the tow tensions were excessive. The trajectory lines, when compared for the latter visible part of the tows show a similar climb trajectory; however, Pilot A's paraglider was sitting slightly further back behind Pilot A than Pilot D's paraglider was, relative to Pilot D.

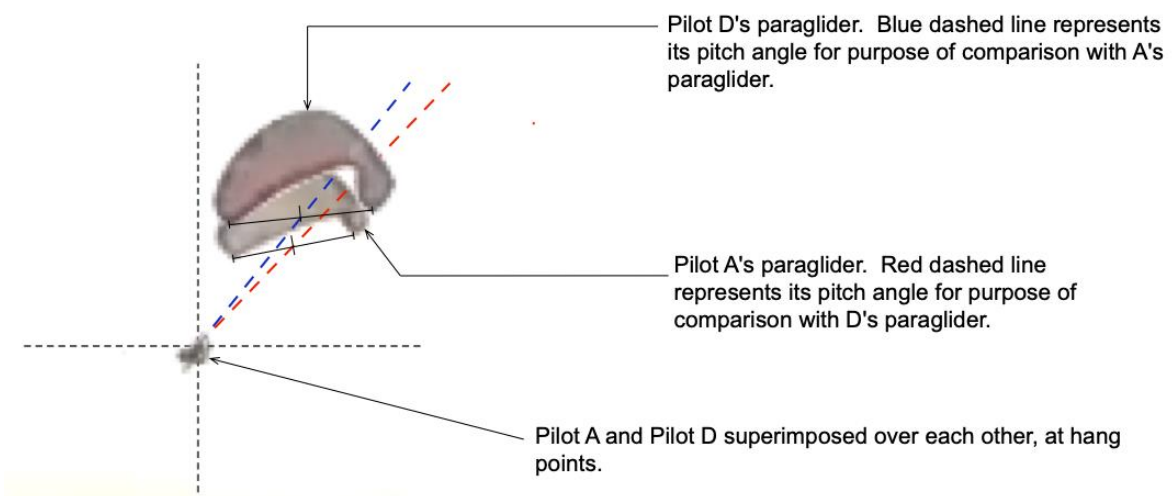
This difference in wing pitch or attitude is illustrated at Fig. 5, a composite image assembled from stills from the tower camera footage of when Pilot A's and D's wings were at similar heights above ground. The central axis point is the approximate position of the harness to riser attachment points of both aircraft. This cannot be perceived with absolute accuracy given the distances from the camera to the aircraft, and the low quality of the enlarged images.

Fig. 5. Composite image showing approximate differences in wing attitudes of Pilots A and D. Comparison of the angles of the red and blue dashed lines illustrate the difference in wing pitch angles. These lines are projected through the half-way point of a notional line drawn wingtip to wingtip of each wing. They are not representative of the centre of the aircrafts' wingspans, which cannot be determined with accuracy from the images.

The Investigation determined that Pilot A's greater rate of climb and greater wing attitude under the same or similar tow force may be attributable to Pilot A's weight and lower wing loading, when compared to the wing loading on Pilot D's wing⁴.
