BHPA Incident Report: GBR-2021-19516

Aircraft Type:	Sky Argos paraglider size L (95-110kg). Serial number 1955-11-0881. Sup'air Altirando airbag harness.
Certification:	EN-C
Manufacture Date:	Date of manufacture May 2014. Hours unknown.
Location:	The incident occurred at a site near Barton on Sea in Hampshire. OS Grid Ref. SZ241929. The site is a south facing sea cliff with a height of approximately 30m above mean sea level. There is a strip of grassland, 40m wide, at the top of the cliff along its length with open access to the public. This is separated from local houses by a road running parallel to the cliff edge.
Date and Time:	Tuesday 10 th August 2021 at approximately 13:00.
Type of Flight:	Ridge soaring.
Persons Involved:	Paraglider Pilot A.
Injuries:	Fatal.
Nature of Damage:	None.
Pilot's Rating/Licence:	Pilot A held a BHPA Pilot rating, passing the exam in May 2011.
Pilot's Age:	62.
Pilot's Experience:	Pilot A joined the BHPA in 2009. Their flying hours and experience are unknown. Pilot A was a member of the Wessex Hang Gliding and Paragliding club. Anecdotal evidence from club members suggests Pilot A was a frequent flyer of the local club sites. In 2015 they attended an

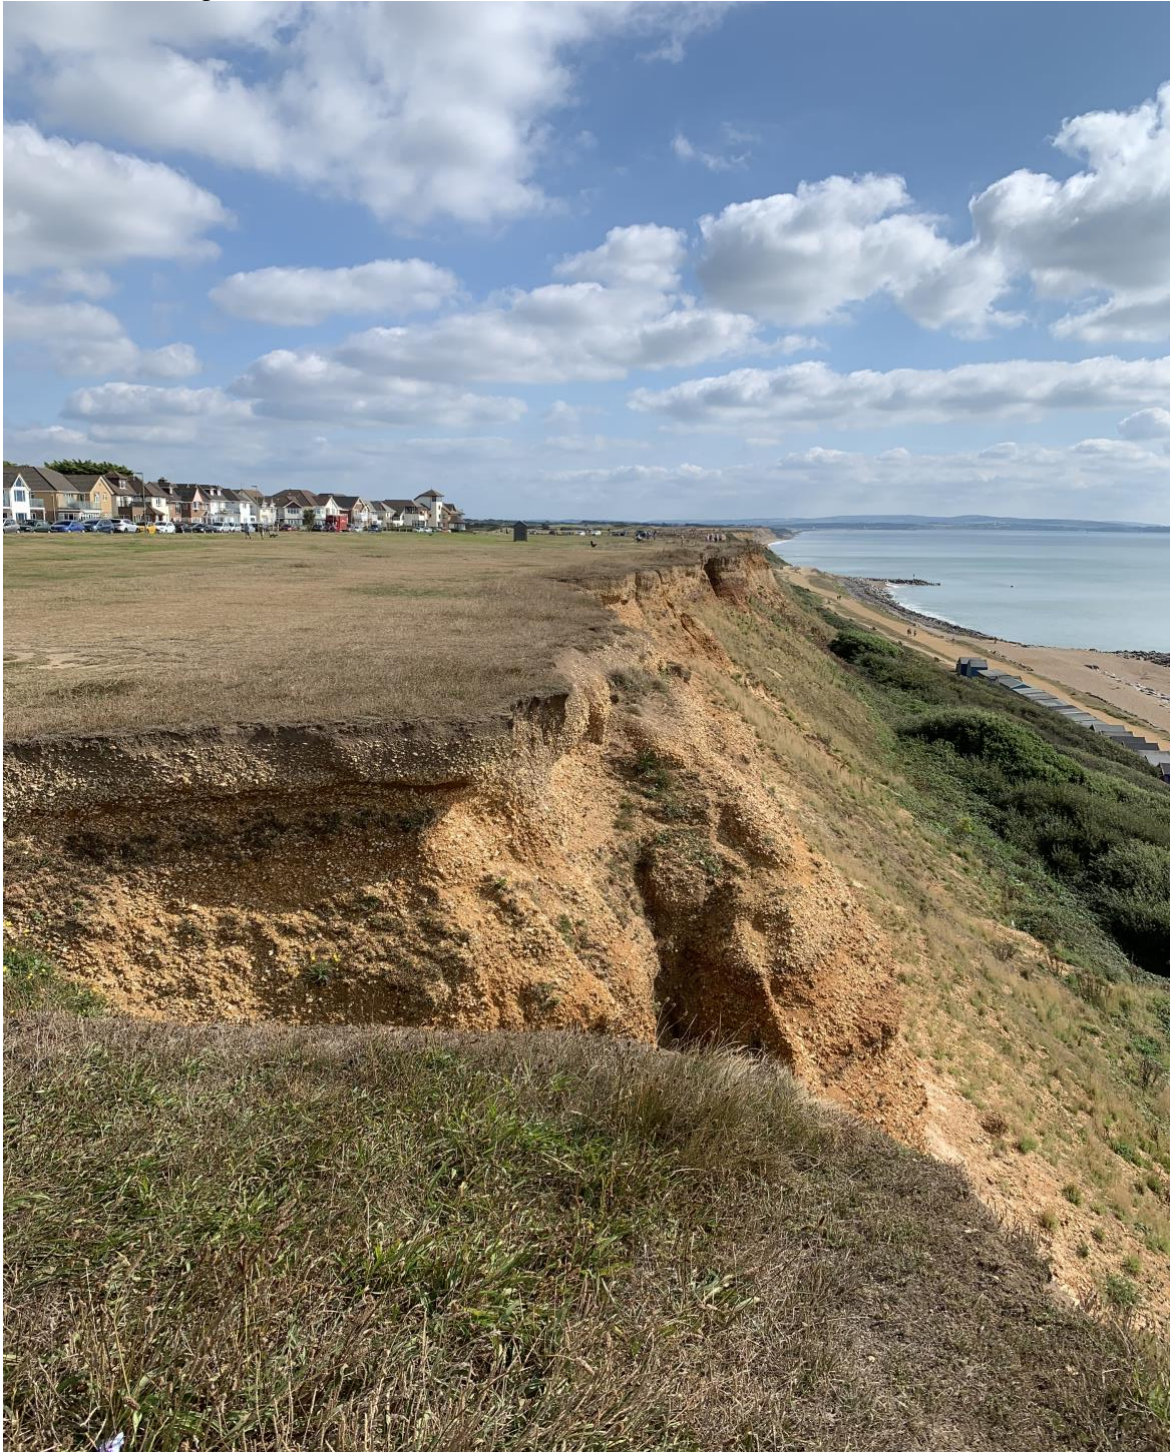
Photo 1. looking east.

Photo 1 above shows how erosion has undercut the cliff edge causing an overhang in places.

There are no obvious areas where the cliff edge is rounded, including in the official take-off area. This makes taking off and landing particularly technical, potentially dangerous, and especially so in stronger wind speeds. This is well known to the club. The following are extracts from the Wessex Club sites guide.

The Investigation found that the nature of the site, in conjunction with the wind speed at the time of the incident, was a significant factor in this incident.

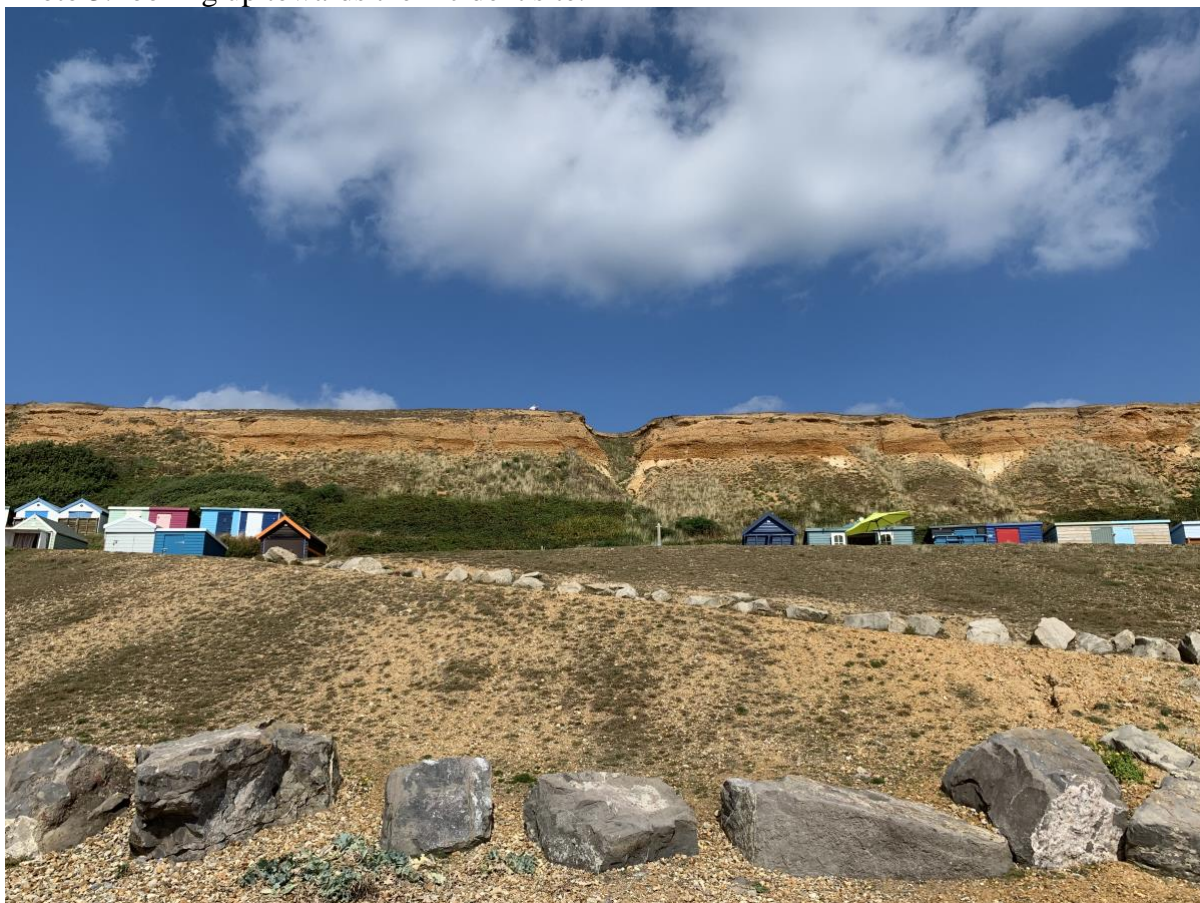
Photo 3. looking up towards the incident site.

At this point the cliffs are approximately 30m above sea level.

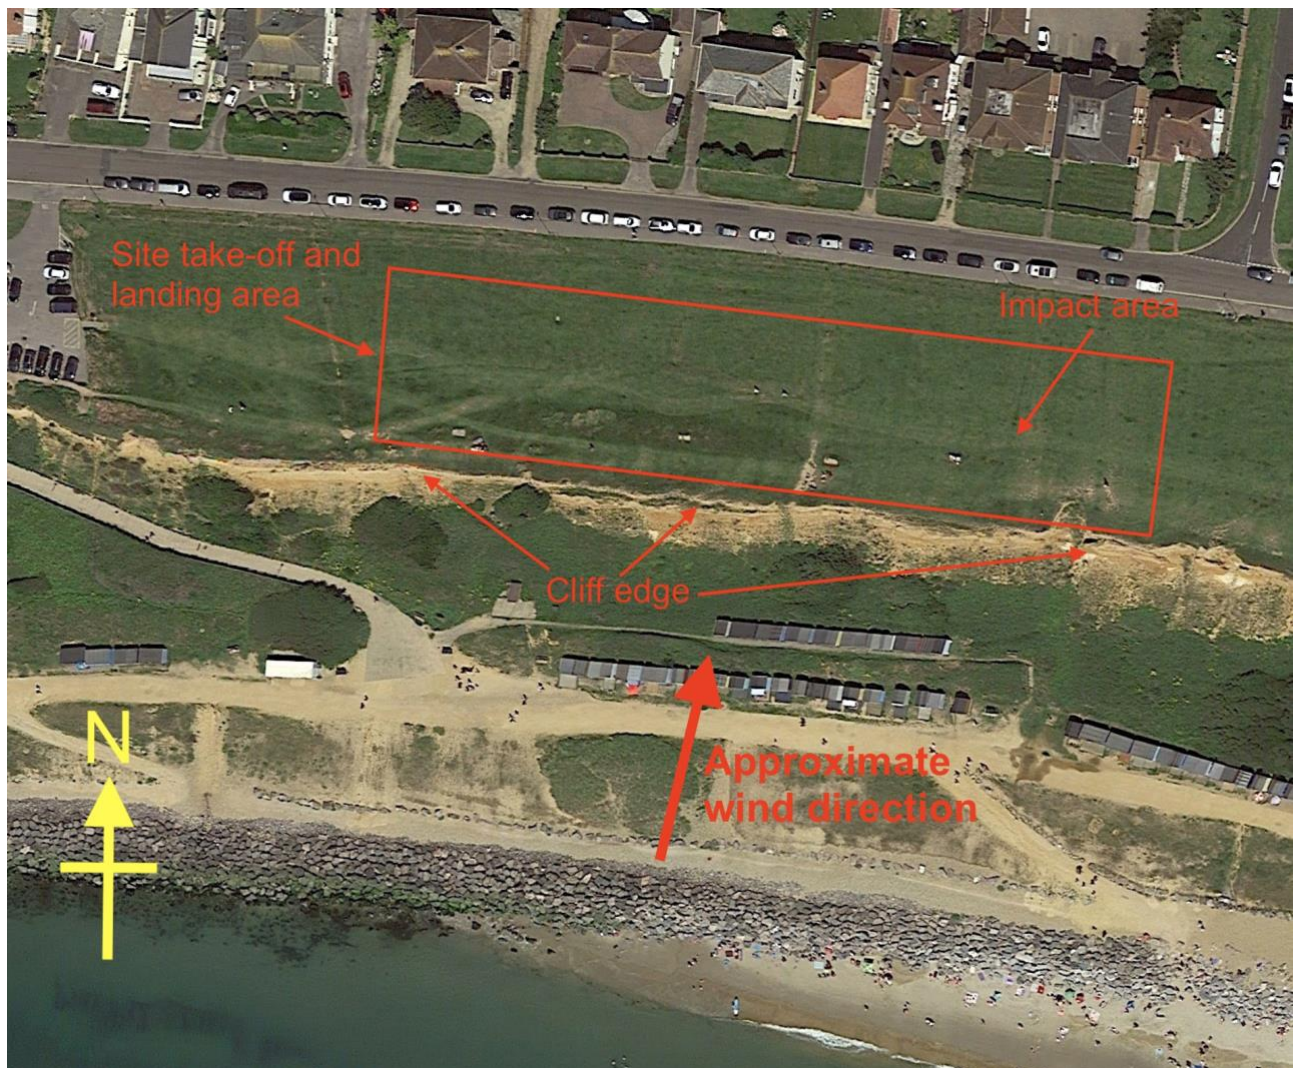
The following Google Earth diagram shows the area from above:

Top Landing must be in the designated areas (within the red bounded areas on the maps). Do not fly more than 12m back from the cliff edge to avoid rotor. Be prepared to drop your wing quickly to avoid being dragged back toward the road. Caution should be exercised on stronger days as venturi may begin to blow you back before landing – if in doubt, play it safe and land on the beach.

It was noted during the investigation that there was an inconsistency in the Wessex club site guide for the Barton-on-Sea site. It states that pilots should take off and land within the designated area, which is approximately 30m deep by 145m long. It goes on to say that pilots must not land further than 12m from the edge of the cliff to avoid the rotor turbulence. The depth of the designated area is nearly three times that of the stated safe landing zone.

The Investigation recommends that the Wessex Paragliding and Hang Gliding Club undertake a review of the site guide for Barton-on-Sea, to establish whether changes are necessary to clarify the advice given.
