Published date	12/07/2021
Document number	SUPAIR_2021_06_001
Page number	1/2

SAFETY CHECK REQUEST

SUBJECT : WALIBI LITE harnesses manufactured before 2019

Request to check the extraction of the rescue parachute on WALIBI LITE harnesses manufactured before 2019

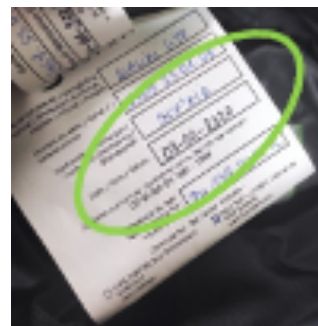
You can find the date of manufacture on the label in the back pocket of the harness.
