**British Hang Gliding and Paragliding Association**

# **REPORT**

**Investigation of a Paragliding incident  
which occurred at Tinto Hill, Lanarkshire  
on 30<sup>th</sup> September 2011  
in which the pilot suffered fatal injury.**

BHPA investigation serial number: IR 11/094

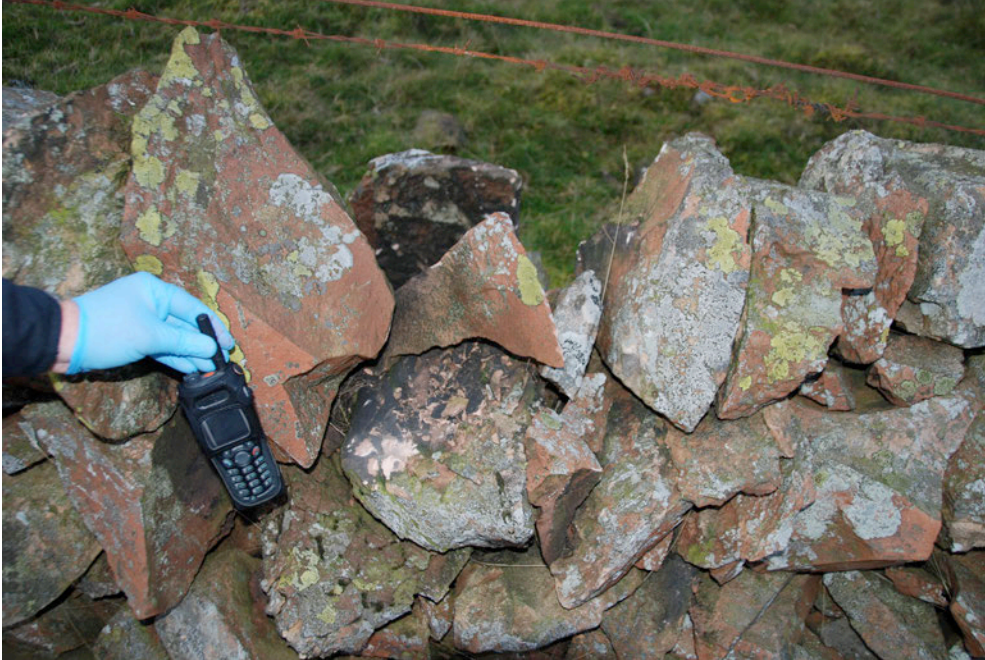
There was significant damage to an area of dry stone wall on top of the hill consistent with having been struck by a hard object. See Photo 1 below (all photos courtesy of Lanarkshire police).

Photo 1, showing damage to wall with police radio shown for scale.

Considering the ground marks, the damage to the wall and the nature of the injuries sustained by Pilot A, it is likely he crash-landed just in front of the wall before being dragged into and then over it by the strong, gusty wind.

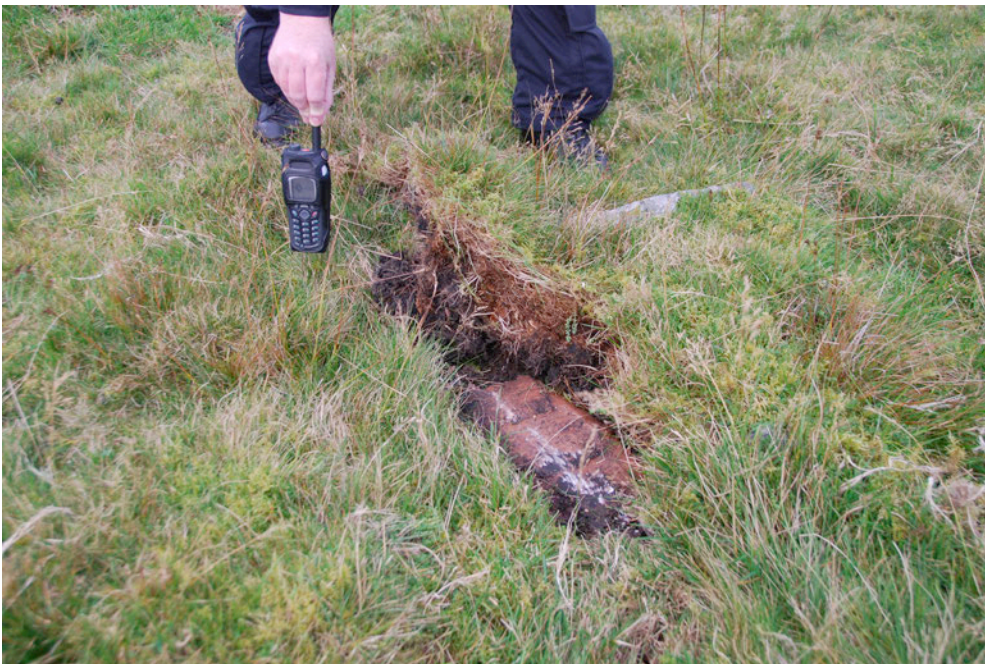
Approximately two metres in front (on the south side) of the damaged part of the wall there was a gouge in the turf revealing the underlying rock, again consistent with a heavy impact. See photo 2 below.

Photo 2, showing damage to turf with police radio shown for scale.

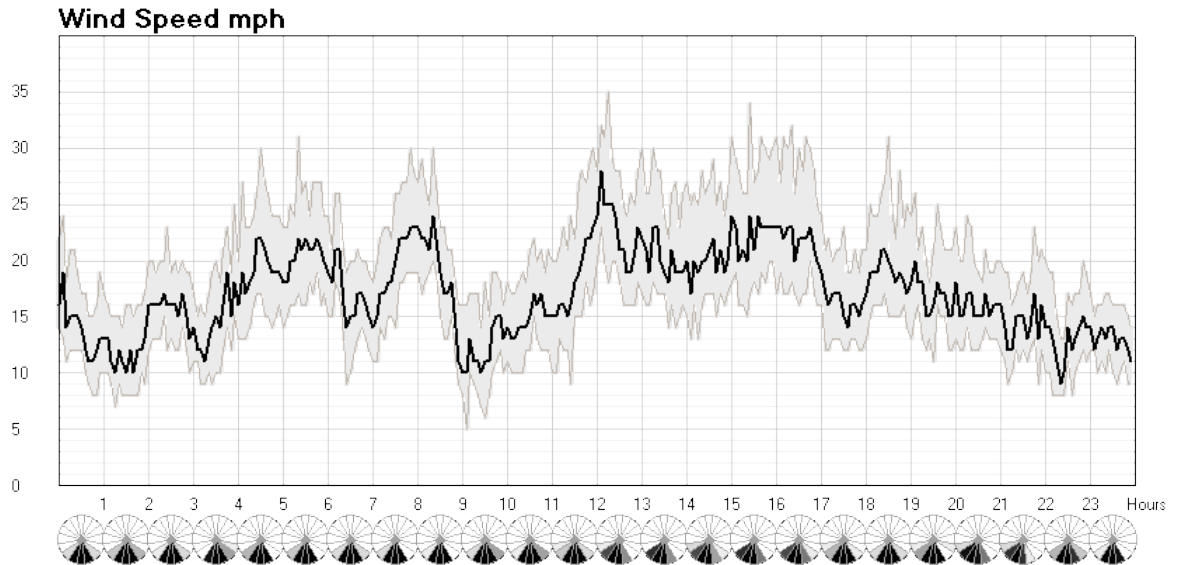
Wind speed varied significantly throughout the day. At times during the morning the wind averaged only 10mph. However, from 9.30am onwards the wind strength gradually increases with a peak average of 28mph (gusting to 35mph) at 12.15. During the period Pilot A was in the air, sometime between 15.00 and 16.00, the average wind speed was between 22 and 24mph with gusts well in excess of 30mph.

The graph below, taken from the weather station, shows the average wind speeds for the day in question including gusts and lulls.

**2.5** The Investigation considered the weather conditions. The weather on the day was bright with a gusting southerly wind. At the time of the incident the wind was gusting between 17 and 30+ miles per hour, the average being approximately 22 to 24 miles per hour. Winds of this strength and gustiness would be considered extremely dangerous and well beyond the safe operating environment for paragliding. The maximum wind speed for safe paragliding is dictated by a number of factors. The normal operational wind range would be considered 0 to 16mph. Within this range the glider can (with proper training) be safely controlled and launched. From 16 – 20mph, and with an increased level of expertise and skill, the glider may still be launched safely. However, in this wind range there are other risks such as the increase in the level of turbulence caused by ground features and the fact that the pilot would have very little safety margin were the wind to increase, the normal trim speed of a paraglider being in the region of 20 – 23mph. Another important factor is the gustiness of the wind. Due to the turbulence associated with gusts it would generally be considered safer to fly in a constant wind of 16-17mph than in a wind of 8-15mph. On the day concerned the wind range (gustiness) was in excess of 17mph.

The readings from the weather station, evidence from the two witnesses and the fact that Pilot A was blown back over the hill top despite the use of his speed bar and having his glider in ‘big ears’, confirms that the wind was of a strength that was unsafe for paragliding.

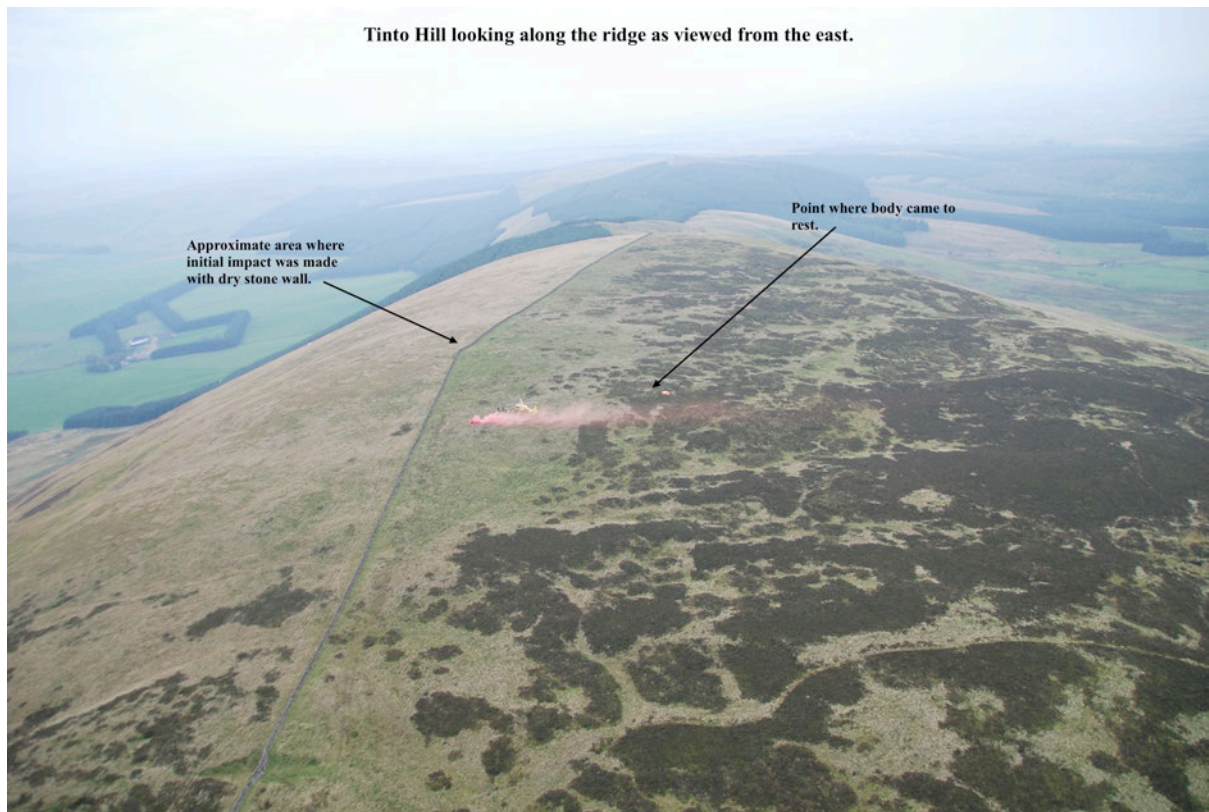
Photo 3 below shows the area where the incident occurred as viewed from the police helicopter.
