SAFETY ADVISORY

Issued by Angus Pinkerton Chairman Flying and Safety Committee 30th April 2024

Aluminium components: Brummel hooks & other parts

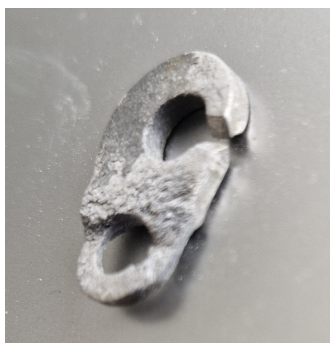
A pilot flying a paraglider at a coastal site recently reported a failure of the aluminium Brummel hook (sometimes called sister hooks) that connected his paraglider's speed bar. This pilot flew regularly at the coast, and when checking found that the hooks on both sides had been badly corroded, almost certainly as a result of repeated exposure to sea air. The connection point was enclosed in a neoprene sheath and the damage was not apparent until the covering had been peeled away.

All pilots should take the time to closely examine their Brummel hooks, carabiners, and any other components that may be affected. If you fly at the coast, the safe working life of these items will be significantly reduced. If you have any doubts they should be replaced.
