SAFETY ADVISORY

Issued by Angus Pinkerton - Chairman of the Flying & Safety Committee. 16th September 2024.

PARAGLIDER “MAILLON / QUICK LINK” CONNECTORS.

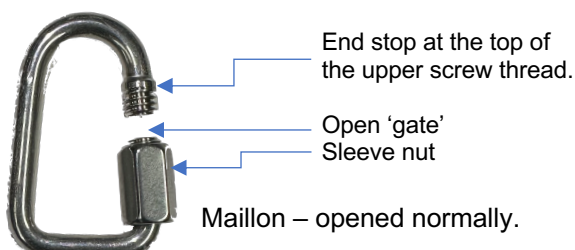
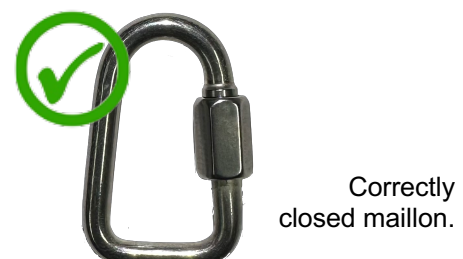
For a maillon to function as a load carrying connector, the long, threaded sleeve nut must bridge the “gate” (the short open portion). Maillons have been known to unscrew over time, so they should be regularly checked and tightened appropriately (being careful not to over-tighten). If no manufacturer’s guidance is available on the correct tightening torque, the BHPA Pilot Handbook recommends nipping up the nut to be finger-tight, and then giving a further one-eighth turn with a small spanner.

- 1) As part of your daily inspection, check your maillons are in good condition and are properly closed. A correctly closed maillon is shown in the ‘green tick’ photograph below.
- 2) If the threaded sleeve nut can be finger-turned with ease, fully exposing the lower screw thread and opening the maillon, remove the maillon and replace it. Inform your manufacturer or dealer, and report the issue via the BHPA’s online incident reporting system.
- 3) If you have reason to open a maillon (for example to change a damaged paraglider suspension line) take heed of the manufacturer’s instructions when re-closing the maillon. Be careful not to apply such torque that the threaded nut is wound above the lower screw thread. If in doubt, consult a paraglider service centre or your paraglider supplier.

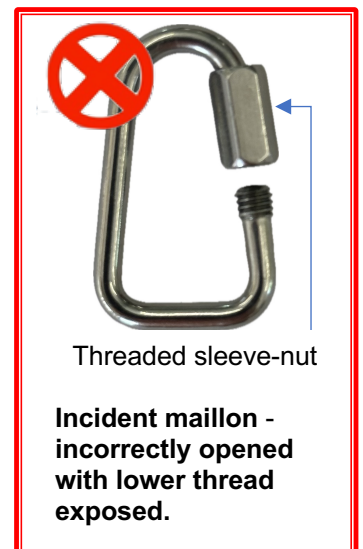
Recent Incident Reports have reported a small number of cases where the threaded sleeve-nut on a steel connector (known as a “maillon” or “quick link”) could be easily wound by hand beyond the top of the upper screw thread, to a point where it fully exposed the lower screw thread - opening the maillon in a way it is not intended to be opened.

The maillons featured in these Incident Reports were all used to connect paraglider suspension lines to risers. In all incidents, the end stop at the top of the upper thread did not function as it should – it allowed the continued turning of the nut past the end stop, exposing the bottom thread and opening the maillon in a way it is not intended to be opened. This is illustrated in the adjacent photograph.
