Changing lines on paraglider wings

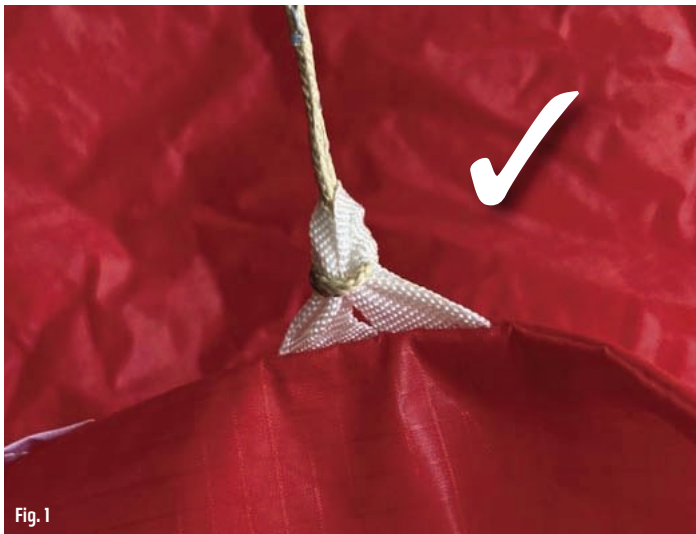
Fig. 1

When using a 'lark's foot' loop to the line attachment tab on the canopy, the line must pass through the loop created in the line attachment tab webbing material. The line's lark's foot must be arranged so that it is looped around the line attachment tab material (Fig. 1). After passing through the small webbing tab, it must not be arranged so that the line material bears on itself. Fig. 2 shows a lark's foot wrongly positioned on the attachment tab loop. Although the line passes through the tab loop correctly, the position of the lark's foot creates a potential wear point because it is wrapped around itself.

Replacing a worn or broken top gallery line will inevitably involve disconnecting and re-connecting lower gallery lines at several junctions and to the riser. This must be done with care and attention, ideally somewhere where the wing can be fully laid out. If in any doubt, consult the wing manufacturer, your dealer or a service centre.

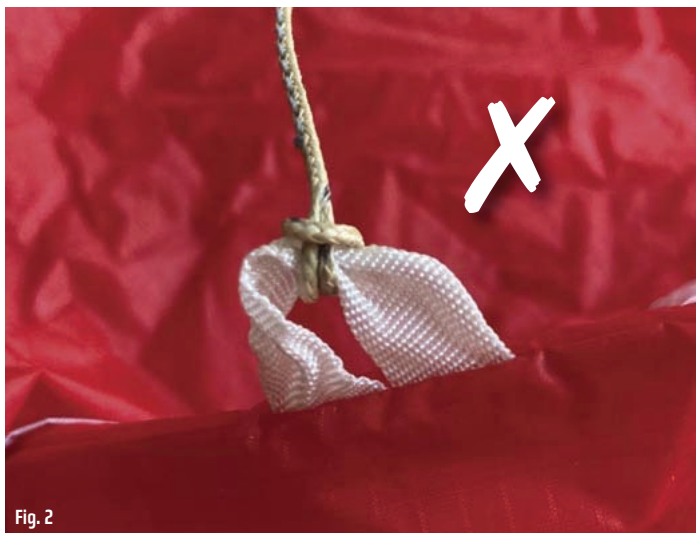
Fig. 2

Constant loading and unloading in normal flight, or the shock loading of a rapid canopy reopening, may exert significant stress on the line at this wear point. In an Ozone report into a US fatality in November 2020, lines fitted incorrectly to the tabs were identified as one of three significant factors in the incident.
