REPORT

**Investigation of a hang gliding accident
which occurred at the Long Mynd, Nr Church Stretton
on 26th May 2013
which involved serious injury to the pilot.**

BHPA investigation serial number: IR13/062

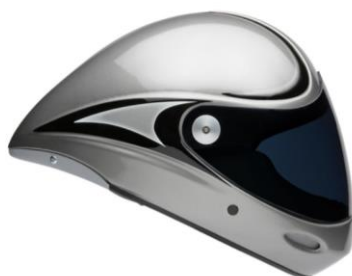
Picture 2: Icaro 4fight LT (Long Tail) integral helmet.

The pilot's helmet also suffered damage to the rear. This was reported as matching the raised assemblies on the underside of the glider's nose plate. *'Apart from the squashed tailcone, it had light surface scratches (marks on paintwork), as if made by nose wires, and a deeper scratch (through paint into the shell) of approximately rectangular cross-section 1mm deep ~3mm wide, 5-10cm long, behind and slightly above the left ear.'*

Icaro 4fight LT (Long Tail) integral helmet. This is an EN966 certified helmet. It features a one-piece glass-fibre composite shell.

The puncturing of the nose cone indicates that the glider's nose came down with considerable force and hit the rear of the helmet. This may have driven the helmet tail into the vertebrae. Whether the glass-fibre helmet 'tail' would have spread, absorbed or concentrated this force is a matter of conjecture. Other possibilities are that the glider nose's impact with the helmet led to a twisting injury, or that the top edge of the carbon fibre back plate in the harness was driven into the area during the impact. Or that the damage was caused by the pilot's body continuing forward after the pilot's head had impacted the ground. However, the pilot clearly recalls feeling a sharp blow to the back of his head, and given that the video still clearly shows the glider's nose down in this area, the helmet tail being driven into the neck seems the most likely explanation.

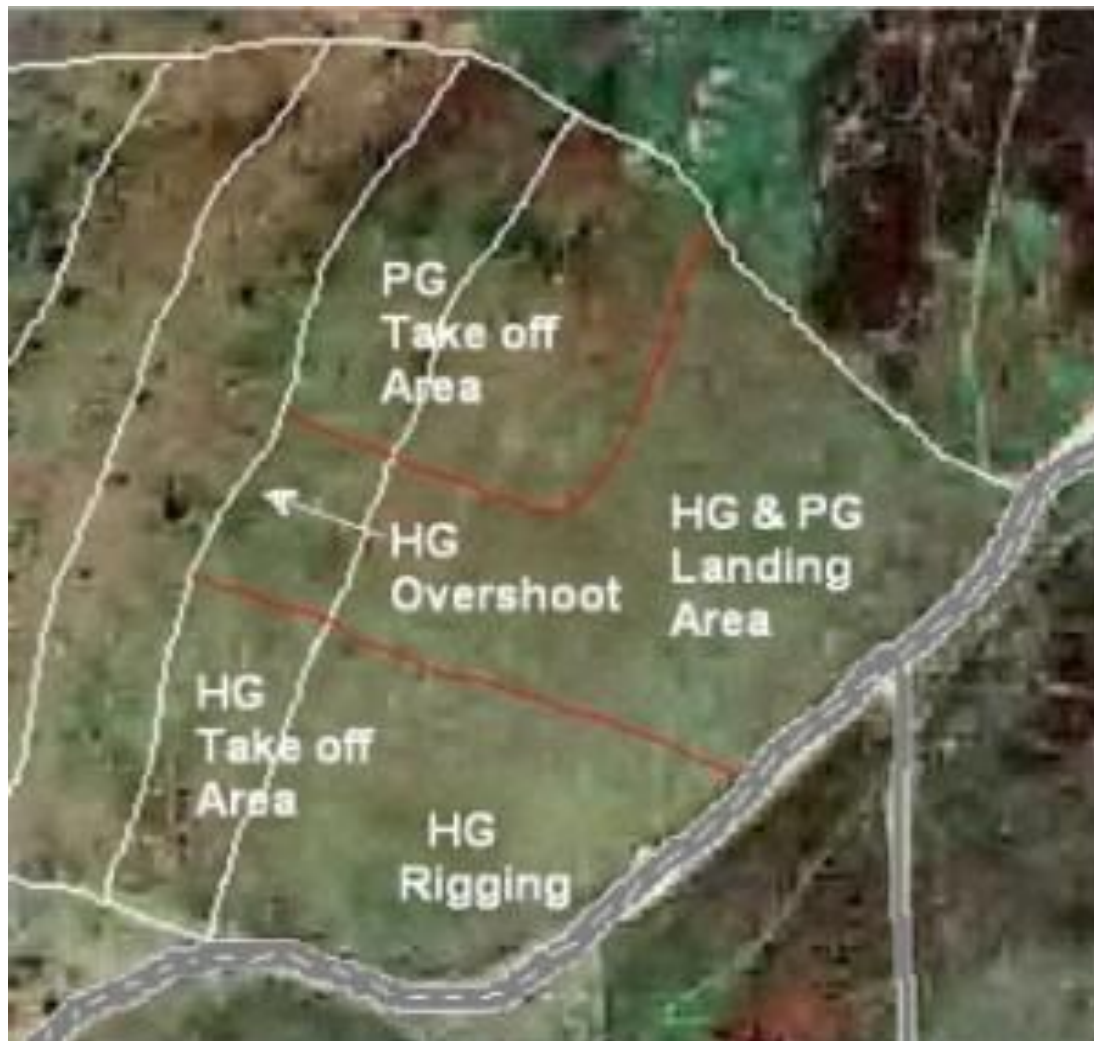
Picture 3: Diagram from LMSC site guide showing the specific areas.

Because the field is used intensively by both hang gliders and paragliders, the LMSC has formalised a site layout to allow safe co-existence. The boundary line between the paraglider area and the hang glider overshoot area is marked by large white markers which can be seen on the satellite image.

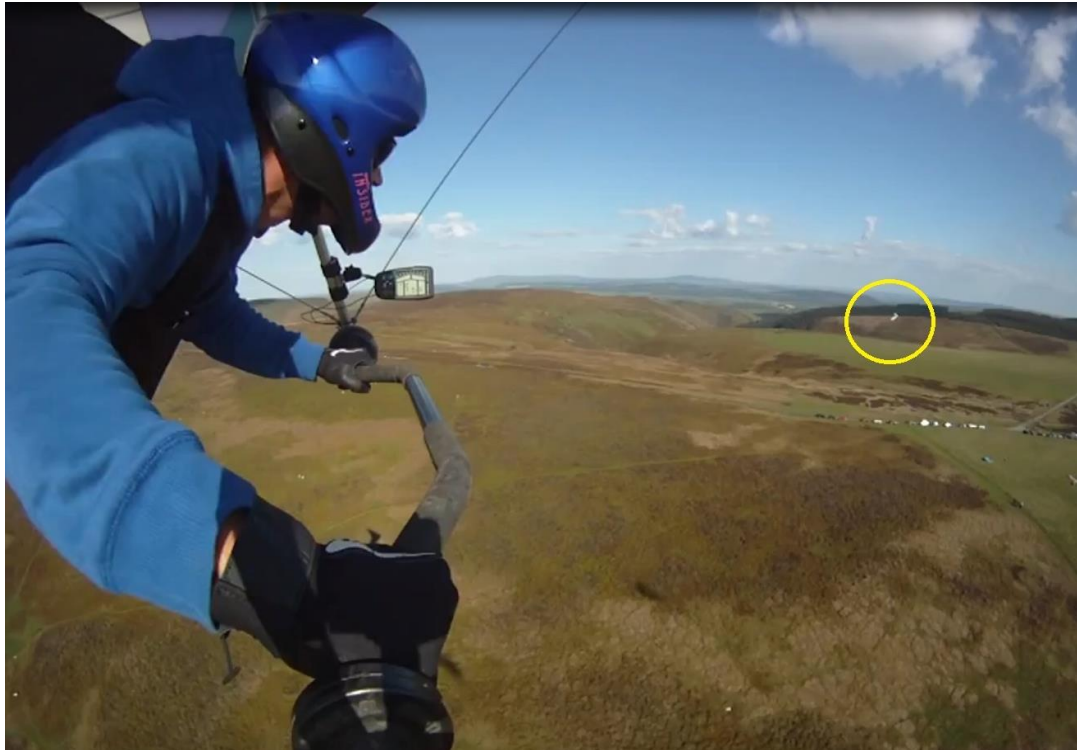
Pilot B turned cross-wind before reaching the back of the field, in order to avoid overflying Pilot A. He then made his final turn to line up into wind over the hang glider overshoot area. He touched down with one foot, but was on sloping ground and was forced to overshoot. He subsequently made a safe bottom landing. The two gliders were never closer than 100feet apart.

Picture 13: Picture from Pilot B's glider as he crabs towards the field NE corner. Pilot A circled.

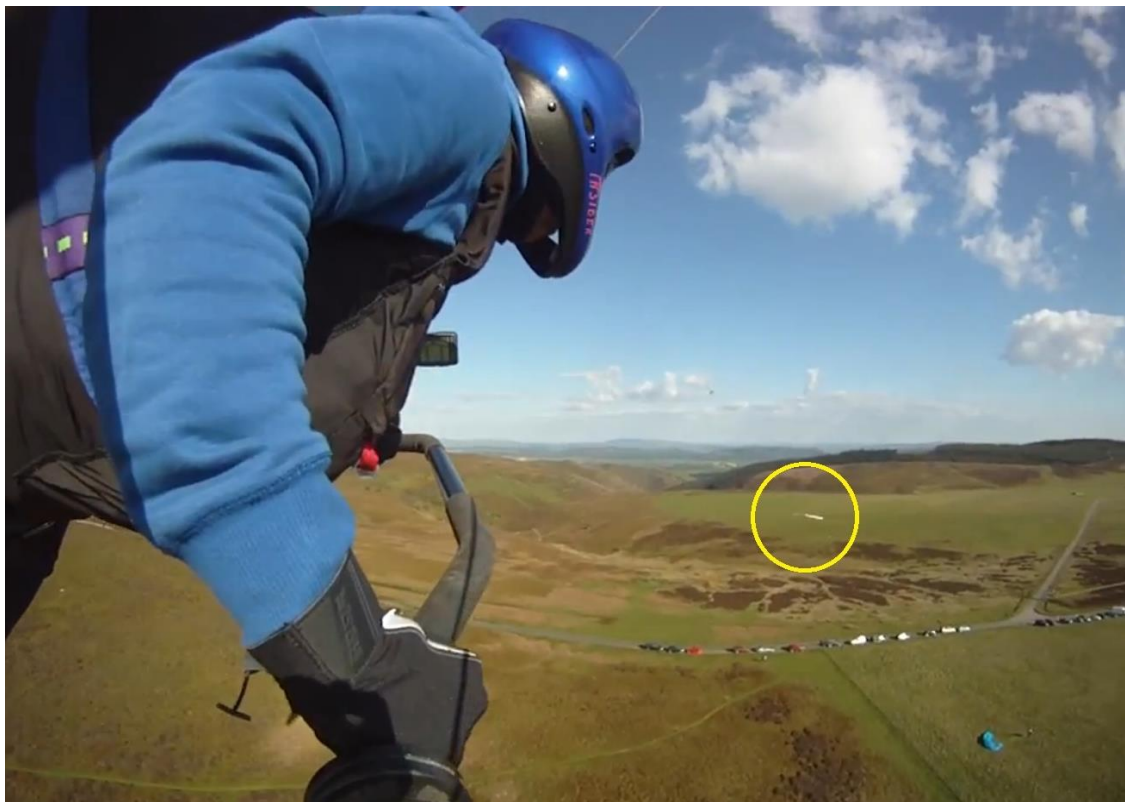
Picture 14: Picture from Pilot B's glider as he crabs towards the field NE corner. Pilot A circled.

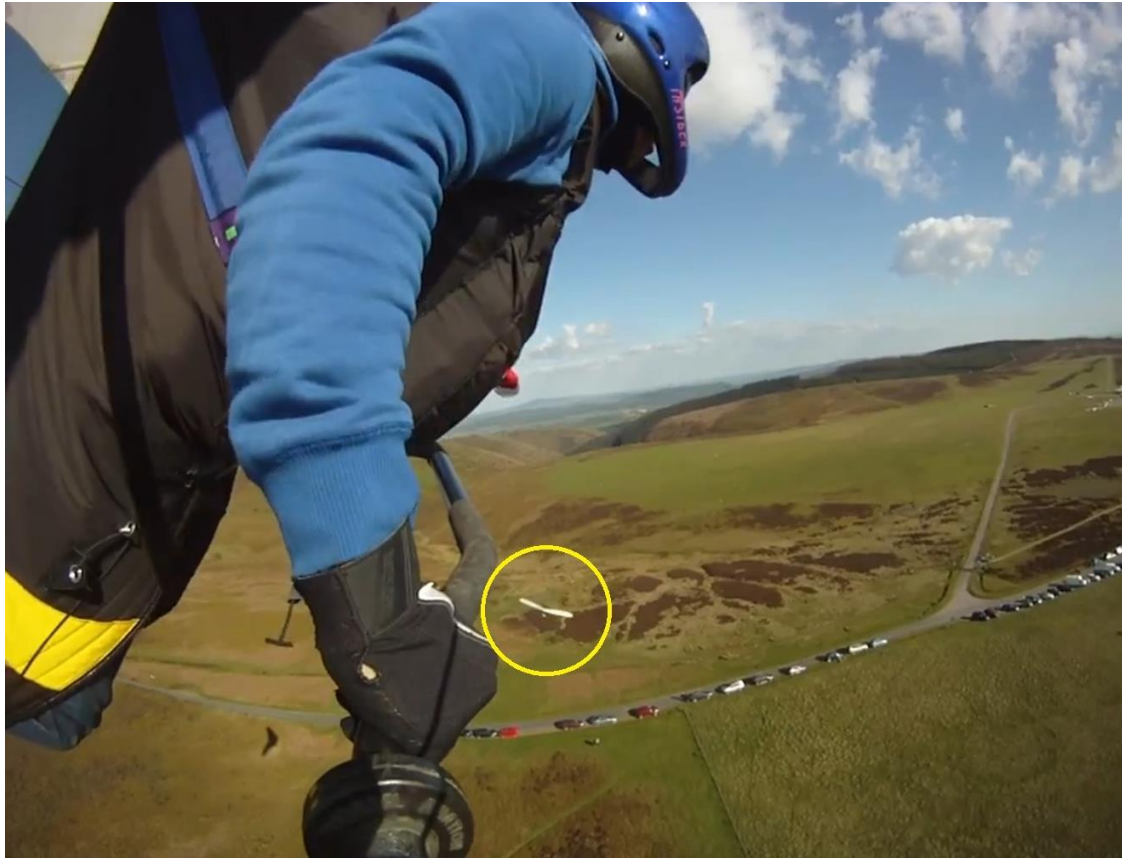
Picture 15: Picture from Pilot B's glider as he crabs towards the field NE corner. Pilot A circled.

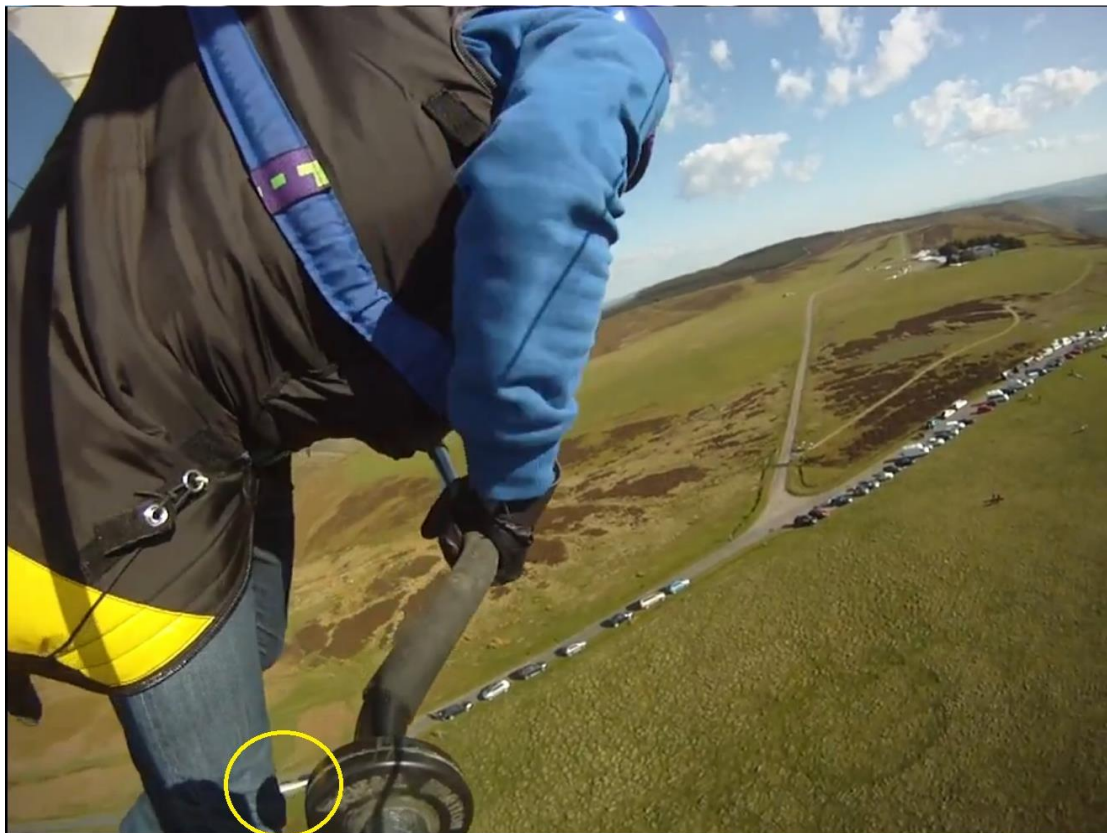
Picture 16: Picture from Pilot B's glider as he crosses the Northern boundary fence. Pilot A circled.

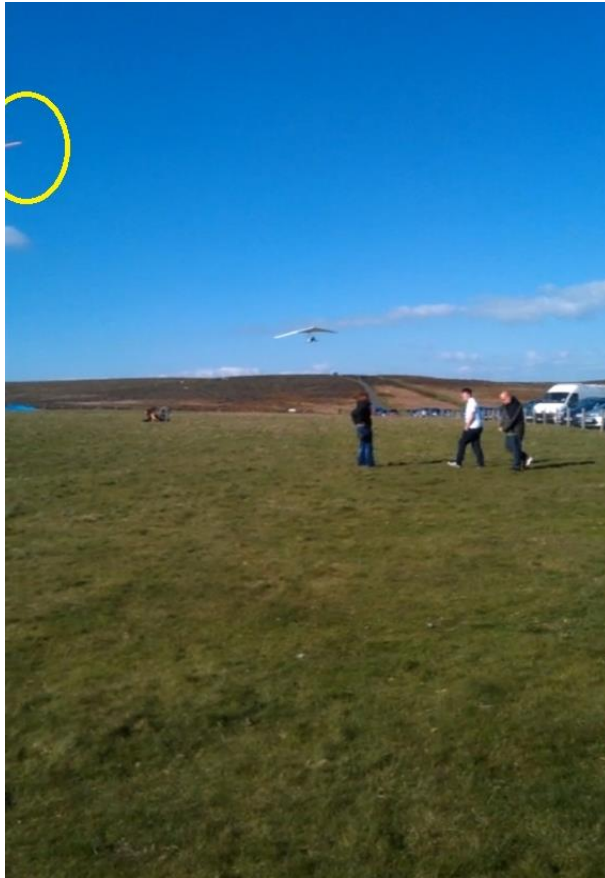
Picture 17: Picture from the ground. Pilot A in upper centre of picture. Pilot B's wing tip circled.

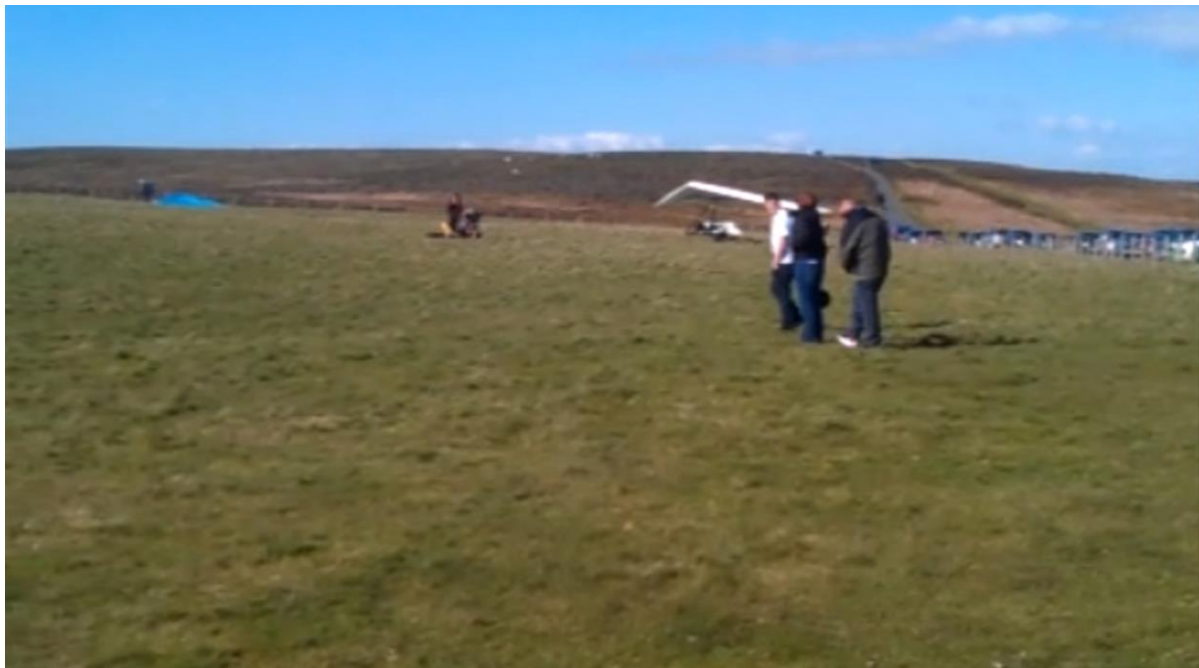
Picture 22: Corresponding external view of picture 21.

Eventually two previous events were found where the pilot's head had got in front of the nose in a landing incident. The common unusual feature in all three events was that the pilot was landing with his hands on the base bar. Analysis showed that the likelihood of the pilot's head getting in front of the nose is significantly increased if the pilot has his hands on the base bar during the initial impact. The pilot is likely to rotate head down around his hands, and there is then no impediment to his forward progress. If the pilot had his hands on the uprights, then the tendency in an impact is for his upper body to be restrained and for his head to be up. Even if he is propelled in front of the uprights, the pilot is then likely to impact into the underside of the glider.

Picture 21: Pilot A: Slider fully back, hands on base bar

BHPA recommendations (Pilot Handbook Chapter 11) are that the pilot should complete turning finals and that the pilot should then [snip] • *Move your hands to the uprights, level with your head.*

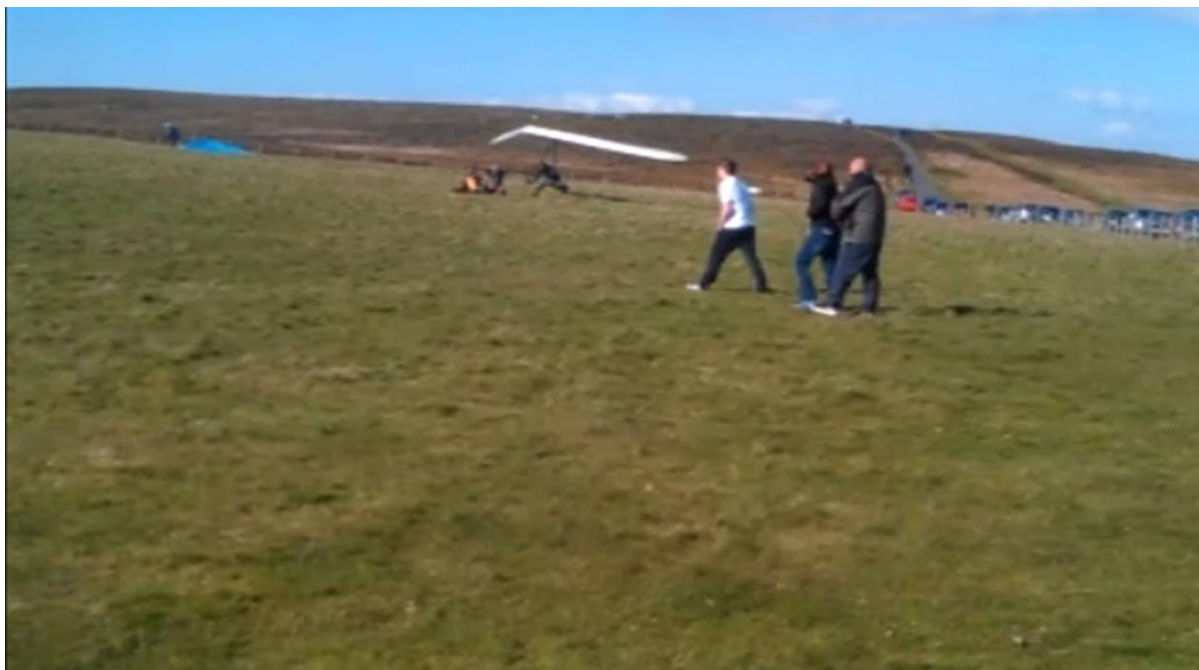
Picture 24: Corresponding external view of picture 23.

Picture 23: Pilot A: The moment the slider moves forward, shoulders up, hands still on base bar

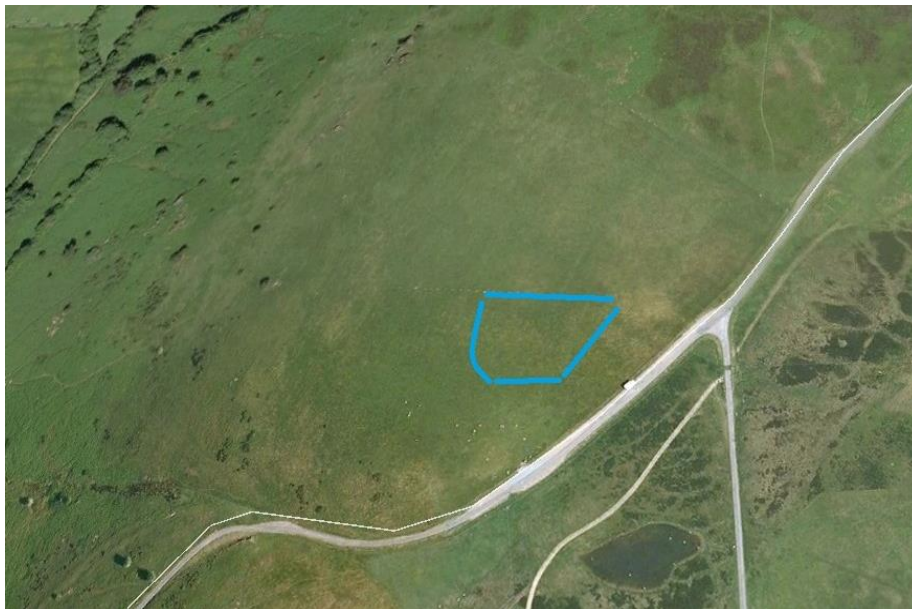
Picture 27: The actual usable hang glider top landing area.

The hang glider landing approaches at the Long Mynd were established sometime around thirty years ago, when hang gliders had an 8/1 glide angle, perhaps 10/1 glide at best. Glider performance has continued to improve, whilst the size of the landing area has remained static – or has in fact shrunk, as the available area is now divided into hang glider and paraglider areas. Thirty years ago virtually the entire area inside the fence was available as a hang glider top landing area: now only about half of the area is available. In easy soaring conditions (18mph plus) the increased difficulty is masked by the low forward ground speed. But in lighter wind conditions – as experienced at the time of this accident - it becomes important. The hang glider pilot needs to arrive, pointing in to wind, in the hang glider landing ‘strip’, low enough to avoid an overshoot. The actual area in which a safe landing is possible measures approximately 200feet by 150feet. Undershooting puts the hang glider dangerously close to the vehicles parked on the roadside, the fence, and the dead air zone. To the left (South) the ground slopes away into the gully with the road. To the right (North) is the ‘Paraglider Only’ zone. And in front the land slopes away.

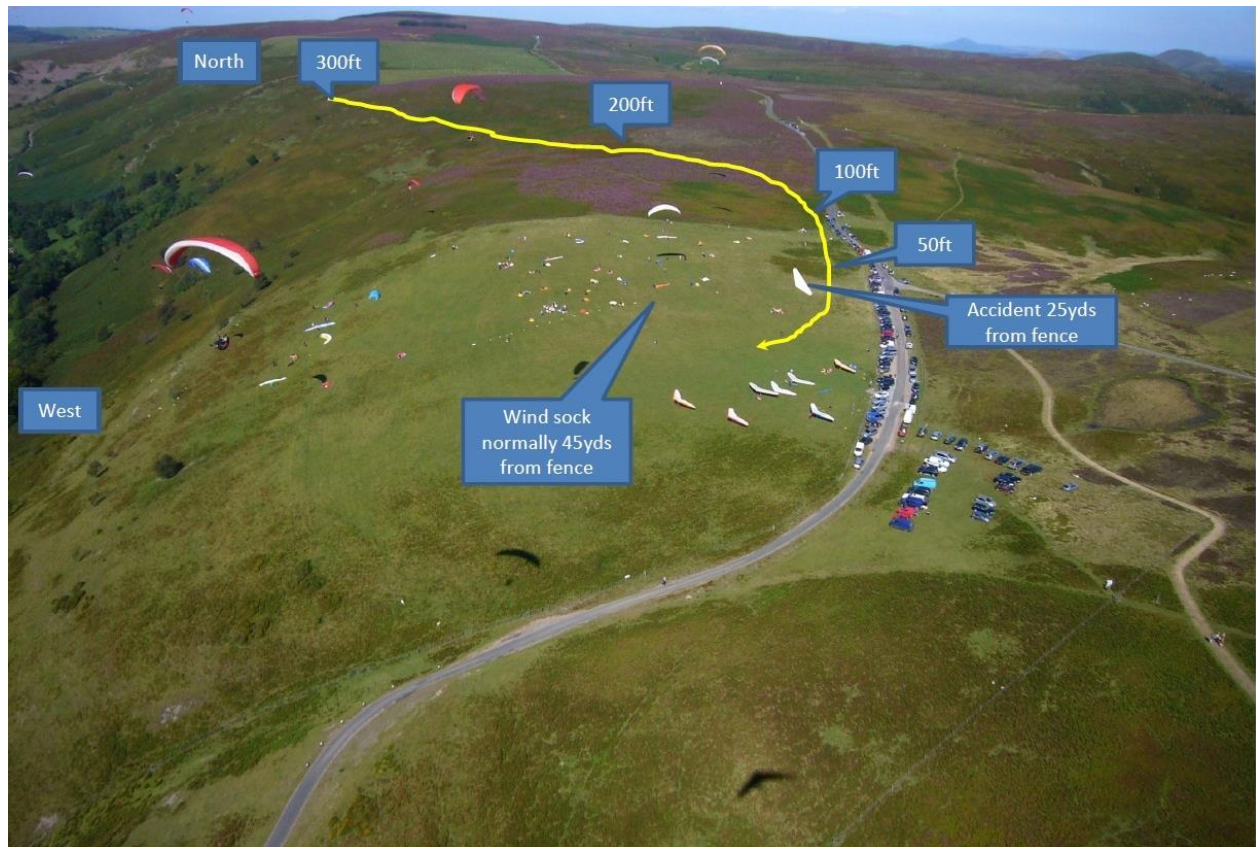
Picture 28: Normal top landing approach at the Long Mynd (Note. Picture is not from the day of the accident.)

A good flight plan for a top-landing approach in lighter conditions with a high performance hang glider would involve the HG pilot turning finals behind the road at 100 feet, crossing the road (in the landing position) at twenty feet and stopping somewhere around the middle of the field. However, the land at the Long Mynd falls away behind the landing area and the descending air has claimed many hang glider uprights in the past. This history almost certainly applies to hang gliders approaching in stronger winds, where rotor and dead air areas would be more pronounced. But this, and the fact that there are generally cars parked alongside the road (which is in use), has meant that a tracking approach above or slightly in

front of the road is the norm – which therefore requires a low final turn (~ 40 feet) and short final approach. (The final turn is through considerably less than 90 degrees, which is beneficial.)
