# REPORT

**Investigation of a paragliding (mini-wing) accident  
which occurred at Pendle Hill, Nr Clitheroe  
on 4<sup>th</sup> December 2013  
which involved the death of the pilot.**

BHPA investigation serial number: IR 13/155

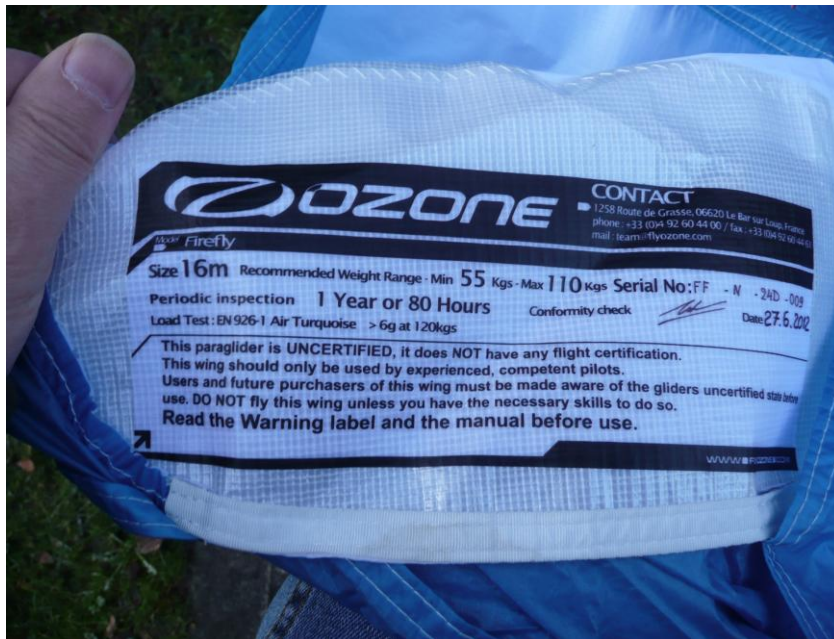
Fig 3: Data placard on Pilot A's canopy.

The glider was manufactured in June 2012. Pilot A bought it brand new and unflown in November 2013, to replace his existing glider which was an identical make and model. He had flown the new glider on a small number of occasions prior to the accident.

A detailed examination of the glider was carried out after the accident. It conformed to specification in every respect, with no defects.
