## **British Hang Gliding and Paragliding Association**

#### **Investigation of a paragliding tow incident which occurred at Darley Moor Airfield, on 13<sup>th</sup> September 2019 in which the pilot suffered serious injury.**

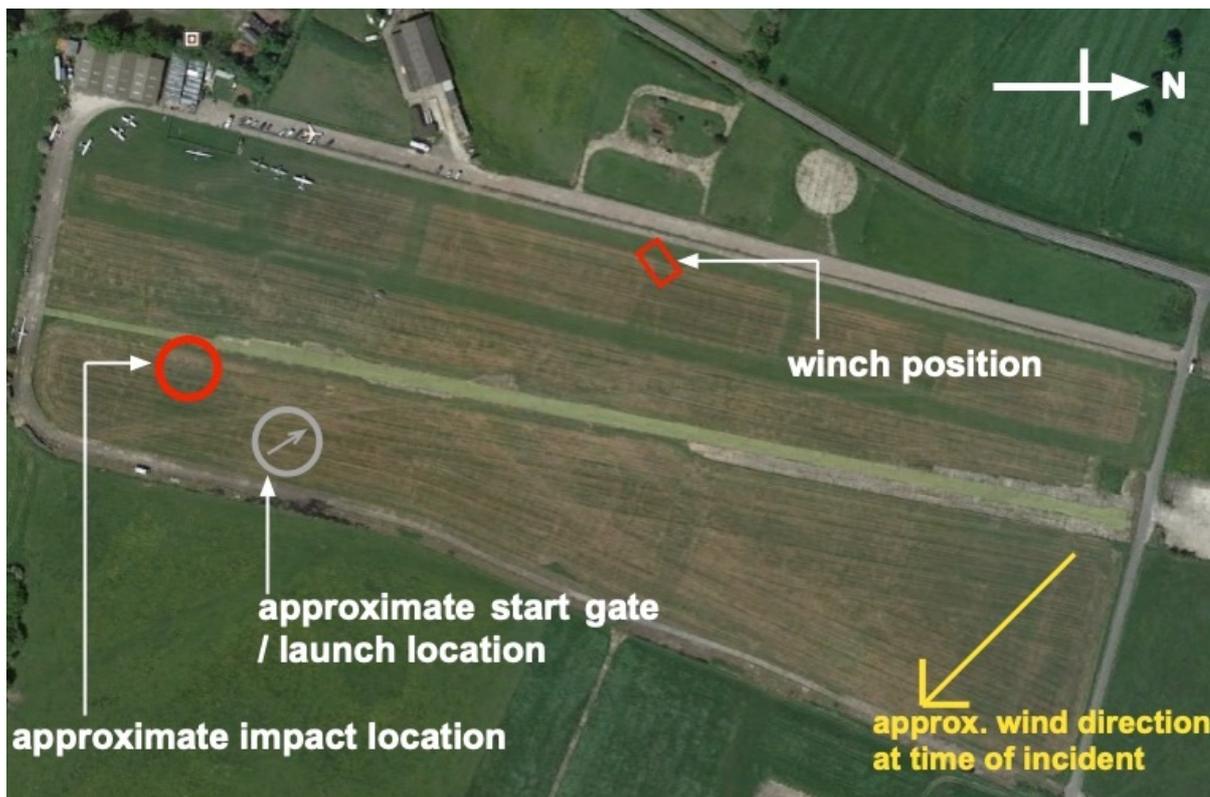
Fig 1: Site photograph (source Google Earth). Approximate wind direction at time of incident, and incident location are shown.

The school operates on the airfield at Darley Moor, near Ashbourne in Derbyshire. The airfield is used for flight training for tow-launched paragliders and hang gliders, paramotors and powered hang gliders, and flexwing and three axis microlight aircraft. It has an elevation of 580 feet above mean sea level and has two principal runways on an approximate north-south axis, length approximately 650m.
