## Safety Advisory: Paraglider speed systems and risers

ALL PARAGLIDER PILOTS SHOULD READ, DIGEST AND TAKE ACTION ON THE CONTENTS OF THIS NOTICE AND KEEP IT FOR FUTURE REFERENCE.

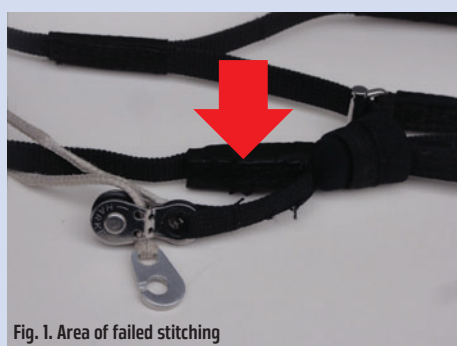
Fig. 1. Area of failed stitching

Like many other models, both these wings use 'skinny' risers, which means there is a relatively small area of stitching where the speed system pulleys are attached. This area (Fig. 1) is put under considerable stress when the speed bar is applied and requires regular checking. A contributory

Both Gin and U-turn have taken steps to reinforce this area, but it is very likely that other models may also be liable to similar stresses. The FSC strongly recommends that all pilots inspect their speed systems regularly, including peeling back any protective covers, carefully inspecting the stitching and checking the webbing tabs for wear.

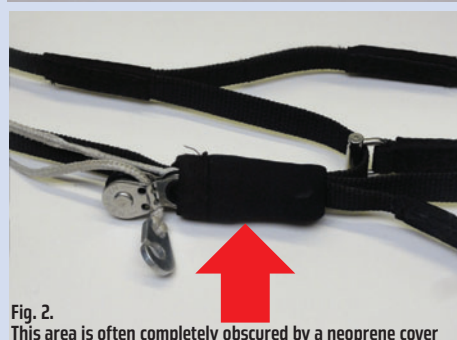
Fig. 2. This area is often completely obscured by a neoprene cover

factor is that the pulleys and stitching on many gliders is concealed beneath a neoprene sheath or cover (Fig. 2).
