Ozone Paragliders Safety Notice

Neoprene Speed Wing Brake Handles

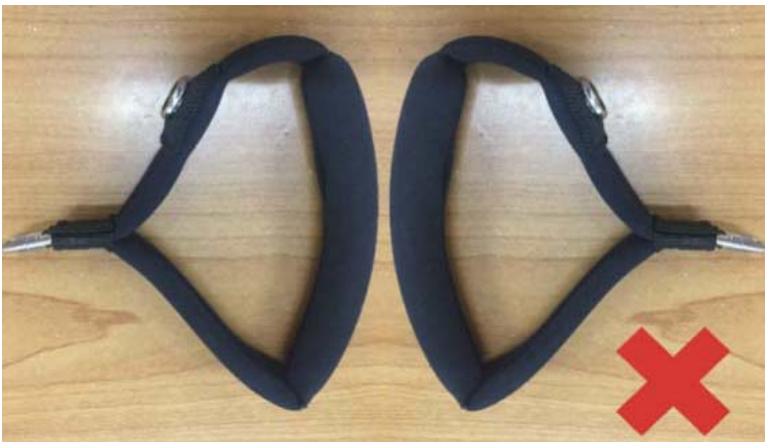
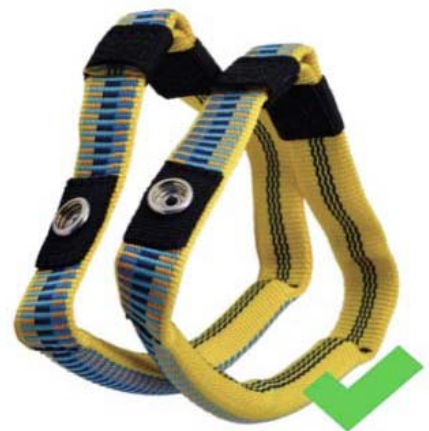
A structural failure of a Neoprene Speed wing brake handle has been reported. After further investigation we have found that it is possible for the overall strength of the handle to be insufficient, especially after ageing.

You should no longer fly with these handles. Before the next flight you **must** replace the Neoprene handles with the standard webbing version. Please contact your Ozone dealer to arrange replacements.

Action Required: Remove and destroy the neoprene handles and contact your Ozone dealer to obtain replacements.
